A SURVEY OF BUILDING DAMAGES
IN SEPTEMBER 6,1975 LICE (TURKEY)
EARTHQUAKE

Erhan Karaesmen^I

SYNOPSIS

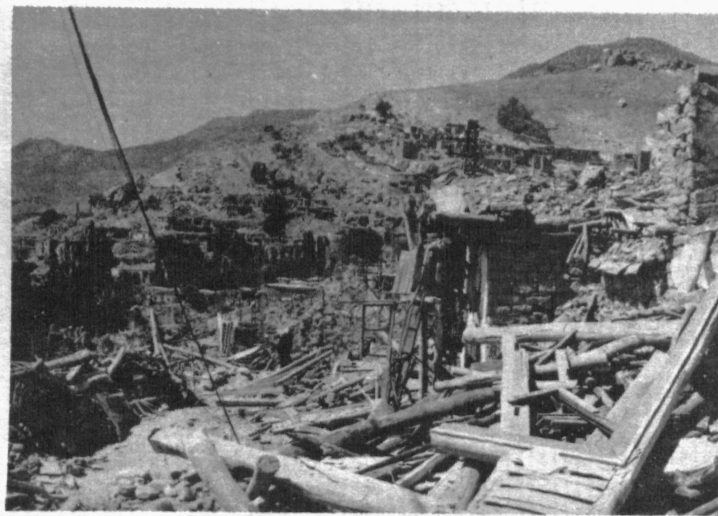
Figure-2-

As for the earthquake behavior of the buildings; the unmortared, irregular stone masonry dwellings proved to have very little earthquake resistance as could be expected. (Figure 2). Mortared stone walls showed a greater resistance especially when they had continuous concrete or timber lintels (Figure 3). Government buildings of brick construction were not collapsed but received partial damage because of the poor corner detailing of the walls. (Figure 4)

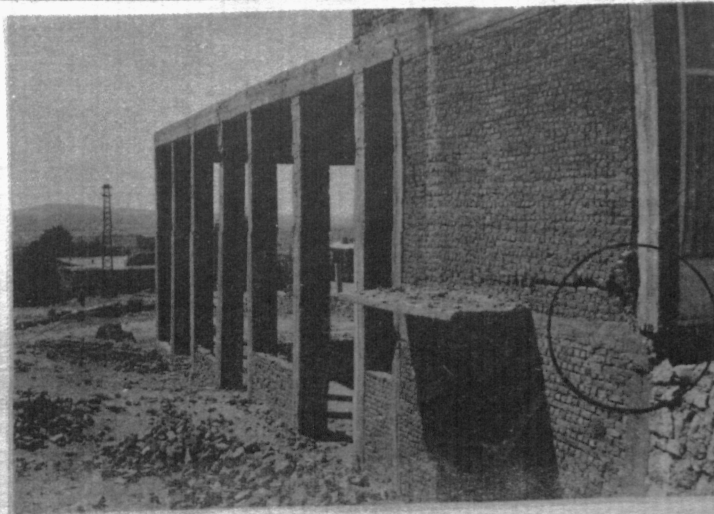
Figure-5-

In this particular region, the construction quality of reinforced concrete structures is also inadequate. The connections between columns and beams are poorly constructed. Figure 5 shows the slipping out of a very poorly connected reinforced concrete column in an unfinished public building.

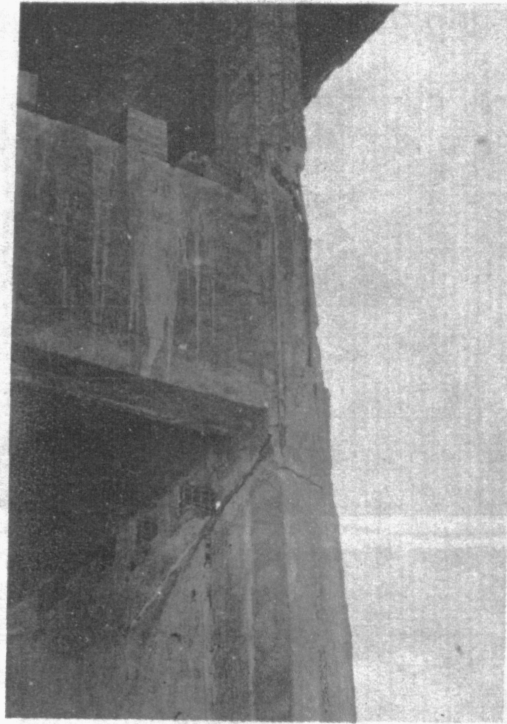
Figure-6-

This three storey building (one basement-two floors above ground) suffered serious damages. All the columns of the top floor were ruptured at the head and at the base. (Figure 6) Ruptures occurred under typical tension effect of combined bending and axial load action. No damages were observed at the lower floors of the building. A vertical cross section of the building and a plan showing column locations at the top floor are given in Figure 7.

For an estimated concrete compressive strength of 100 kg/cm² and steel yield strength of 2400 kg/cm², these moments were computed as 4.5 tm. and 2.7 tm. respectively for each type of columns.

By application of limit analysis the horizontal load which should create ruptures in all columns of the top floor has been computed as 54 tons. The total weight supported by those columns at the moment of earthquake was estimated as 386 tons. Thus, the lateral collapse force was found to be 14 % of the vertical load.

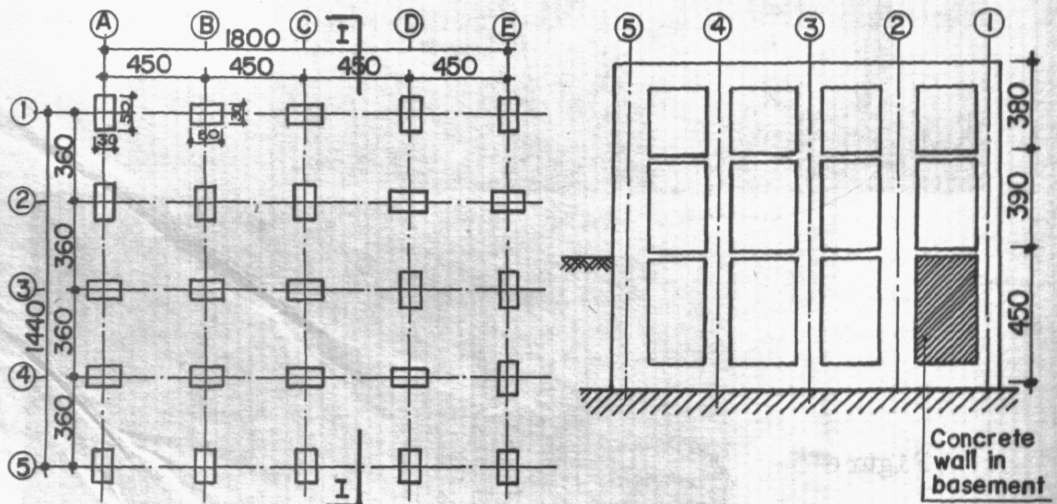
Figure-7-

Only two types of column were used in this floor. Those having a greater stiffness in the direction of (x) which is parallel to earthquake direction and the others having a greater stiffness in the direction of (y). The use of correlation of "bending-axial load interaction" permits the
