HONOMU, HAWAII EARTHQUAKE OF APRIL 26, 1973

N. Norby Nielsen^I, Augustine S. Furumoto^{II}, Walter Lum^{III} and B.J. Morrill^{IV}

SYNOPSIS

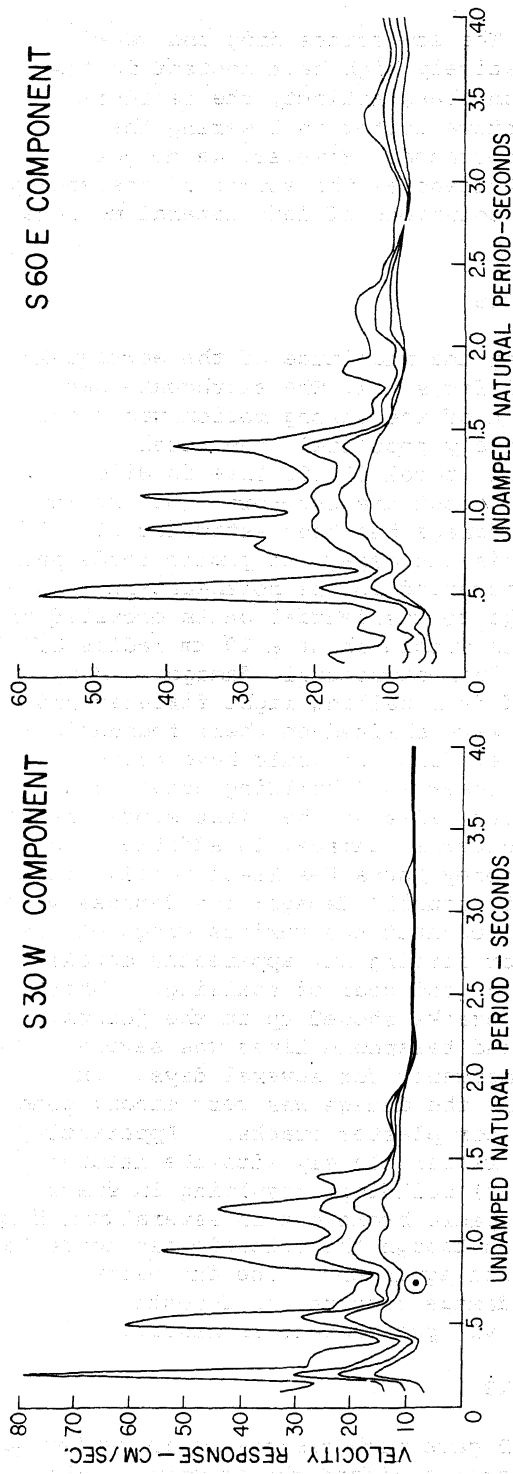
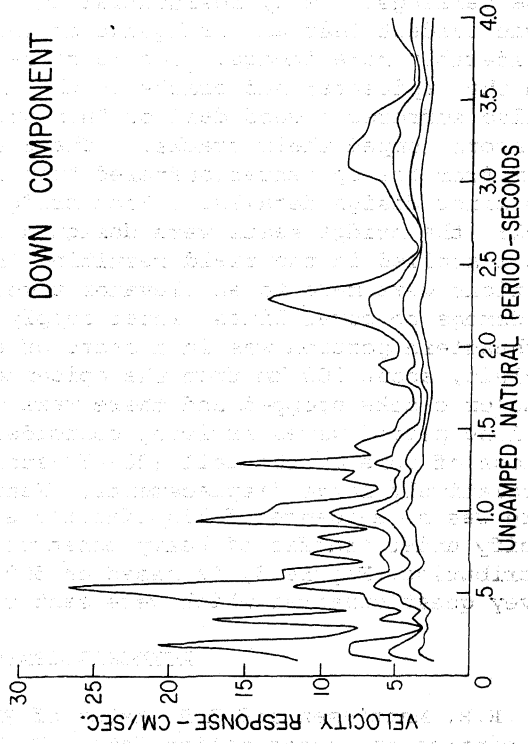
FIGURE 1: VELOCITY RESPONSE SPECTRA
 FOR EARTHQUAKE OF 4/26/73
 AT KILAUEA, HAWAII

VELOCITY RESPONSE SPECTRA
 HAWAII, CAMPGROUNDS, 4/26/73
 0, 2, 5, 10 PERCENT CRITICAL DAMPING

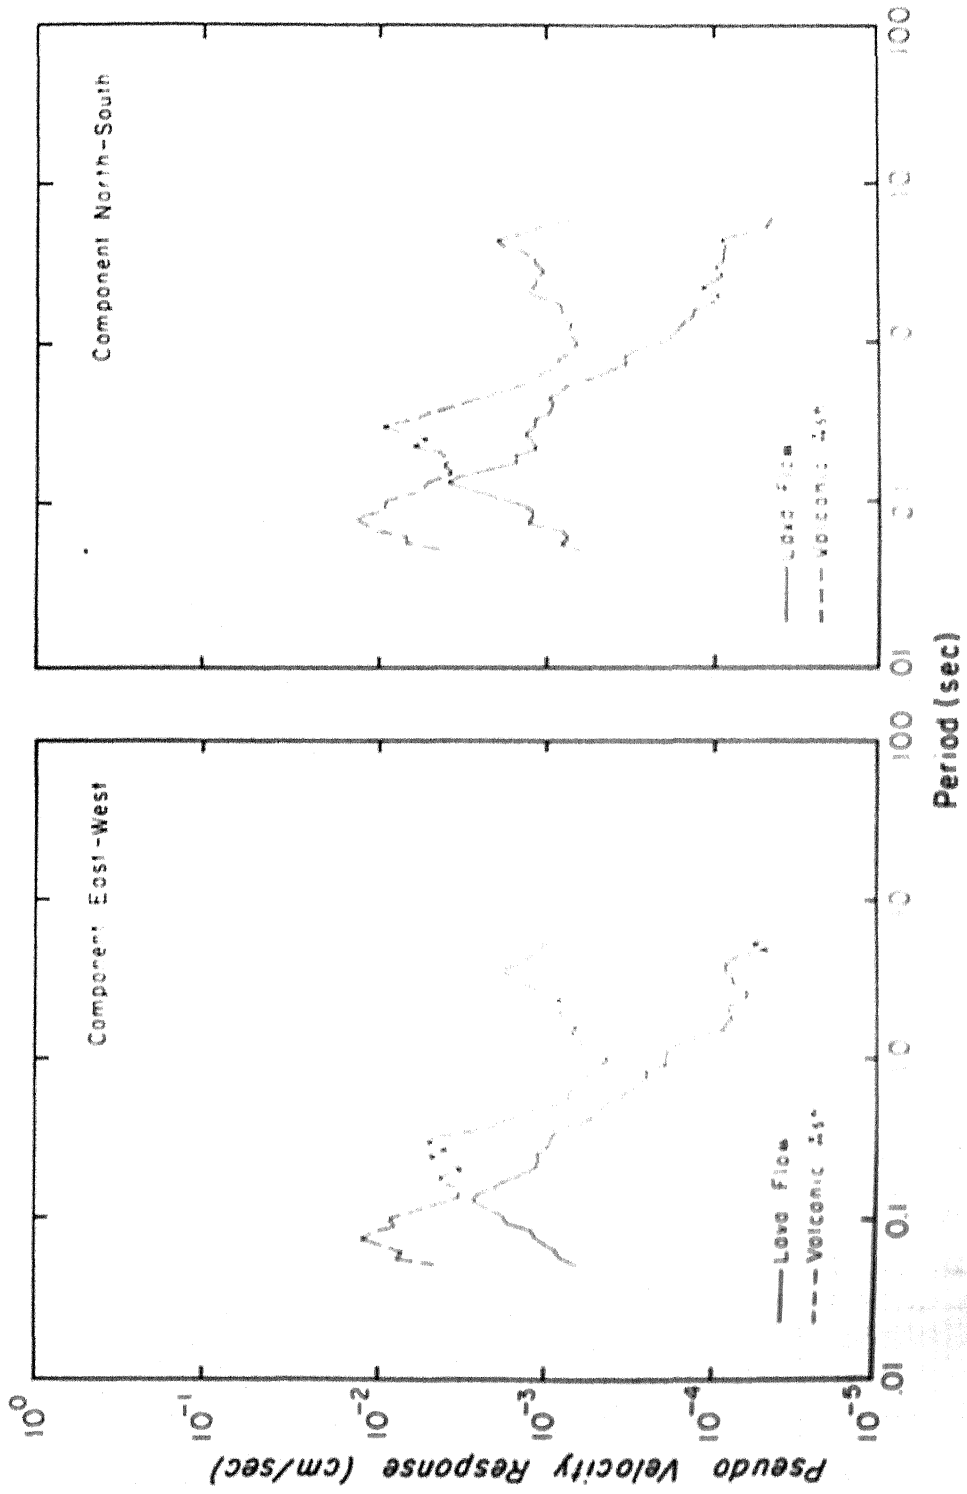
FIGURE 2: RELATIVE RESPONSE ON VOLCANIC ASH AND LAVA FLOW AT HILO, HAWAII

The seismic data from a selected aftershock, which was approximately 50 km from two of the aftershock monitoring stations, was analyzed by deriving a pseudo velocity response (PSRV) spectrum from the data. One station was located near the Hilo campus of the University of Hawaii on a deep, weathered lava flow; the comparison station was located in the northern part of Hilo on a relatively extensive volcanic ash bed. The PSRV spectrum is derived from the seismic trace by digitally filtering the data and calculating the peak response of a series of single-degree-of-freedom systems to the ground motion. The systems were arbitrarily damped at 5 percent. Figure 2 shows the PSRV spectrum derived from the horizontal data. The spectrum for the lava station indicates a single response peak in the period range of 0.3 to 0.1 sec, with attenuation (or reduced response) at the shorter and longer periods. The spectrum for the ash station is markedly different than that found on the lava. The response is complex with at least three bands of periods with high response. These bands are found in the 0.09 - 0.07, 0.50 - 0.03, 5.0 - 3.3 sec ranges. The motion on the ash was at a considerably higher amplitude than that on the lava.

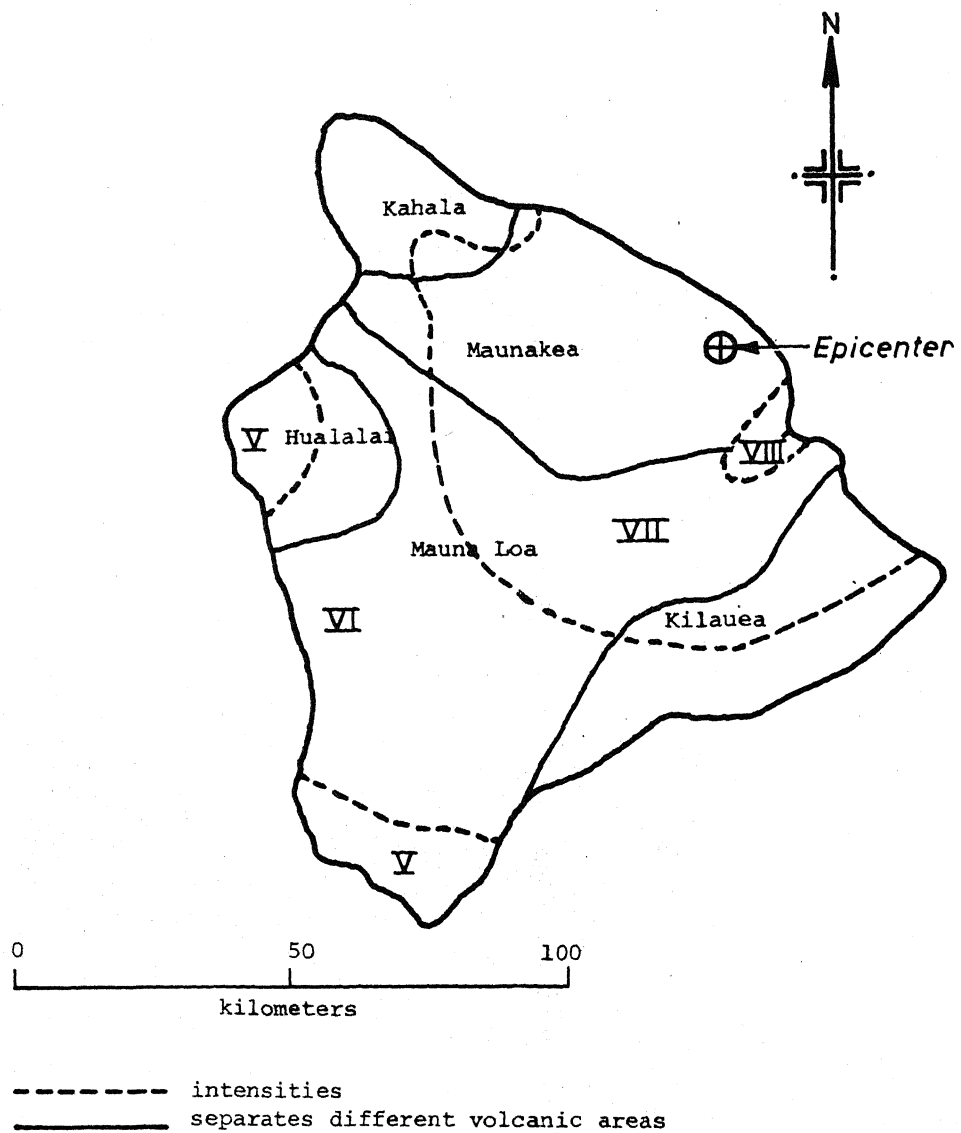
FIGURE 3 SEISMIC INTENSITIES, ISLAND OF HAWAII

Damages were rather minor considering the magnitude of the earthquake (6.2). This can be attributed to several facts. 1) The earthquake was very deep-seated (50 km); 2) The duration of the strong motion was short (7 sec); 3) The island of Hawaii is sparsely populated; the total population of the island is 70,000, of this total 30,000 live in Hilo. There are very few tall buildings in Hilo; most are one- or two-storey residential units. The total amount of damage has been estimated at \$6,000,000. A significant portion of this was damage to public roads and bridges. Numerous land and rock slides occurred in the northeastern portion of the island. Most of the damage to residential units occurred to buildings located on volcanic ash deposits within about a 20 km radius of the epicenter. There was a good deal of "non-structural" damage. Many students in school buildings were injured from falling light fixtures and false ceilings. Many residential units were shifted on their foundation; it was evident that an earthquake of longer duration would have caused considerably more damage. One 15-storey shear wall building about 18 km from the epicenter had cracks in the shear walls at the first storey level; it also suffered a good deal of "non-structural" damage, in addition its elevators jumped their tracks. The 8-storey Mauna Kea Beach Hotel, about 75 km from the epicenter suffered "non-structural" damage; the damages were from minor design details. Foot bridges connect the various wings of the hotel; the bridge seats were designed for sliding but apparently dowels were installed in the field resulting in a good deal of spalling. Where additions were made to an elevator tower cracks showed up in the joints. The damage to power lines, water supply and telephone lines was severe. The northeastern portion was in a state of emergency for several days. In Honolulu, about 300 km from the epicenter, the damage was very minor; some pendulum clocks stopped and there were minor plaster cracks. Apparently, the long period waves arriving coincided rather closely with the natural periods of some of the tall (20-30-storey) buildings resulting in sways of relatively large displacements. Near panic broke out in several buildings. There was no evidence of liquifaction even though the volcanic ash tends to liquify under traffic of heavy construction equipment. The intensity distribution, Figure 3, is based on 500 damage reports and Geodetic Survey questionnaires which were sent to all postmasters in Hawaii.
