A MACROSEISMIC STUDY OF NOVEMBER 6, 1975 ROORKEE EARTHQUAKE,
ROORKEE, INDIA

SYNOPSIS

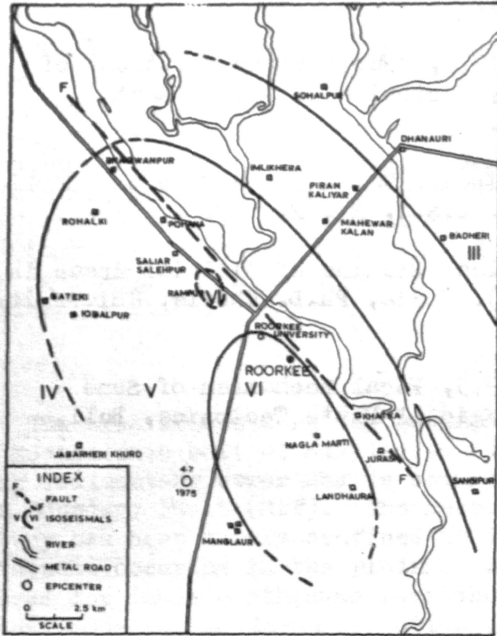
The Modified Mercalli intensity scale was used in preparing the isoseismal map. The earthquake was felt strongly in Roorkee and its surrounding villages. A questionnaire was sent to the Post Masters of the adjoining districts of Roorkee. No significant damage was reported. An extensive survey of the damage was made in and around Roorkee immediately after the earthquake. Figure 1 shows the isoseismal map based on these field observations. The maximum M.M. intensity of the earthquake is estimated to be VI. The general pattern of the isoseismals is NW-SE, which is parallel to the direction of the Roorkee fault mentioned earlier.

FIG. 1 - ISOSEISMALS OF NOV. 6, 1975
ROORKEE EARTHQUAKE. ROORKEE
FAULT IS ALSO SHOWN IN THE FIGURE

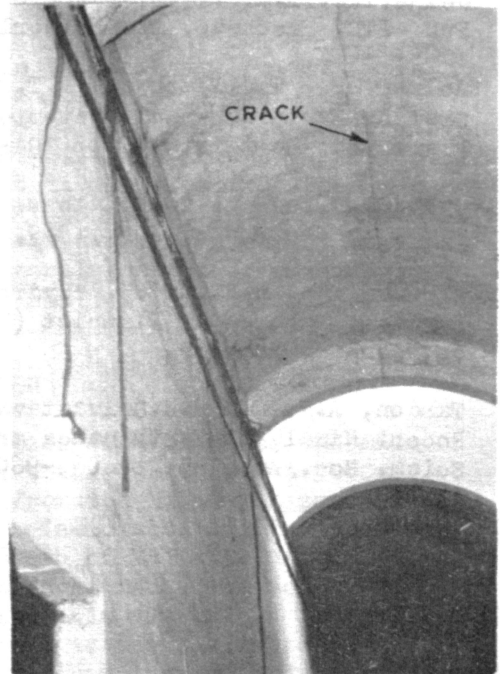
Administrative Building Complex, University of Roorkee: This building which housed the famous Thomson College of Engineering is about 120 years old. It is built around a quadrangle. The north block of the building has a central corridor with rooms on both sides of the corridor and a verandah in front. The height of the building is about 10.5m. The construction is in mud mortar with thick walls (50 to 75cm). The roof consists of jack arches supported in rolled steel joints. The sky light openings are provided at various points in the roof. The south block of the building is partially double storeyed. Extensive damage was confined to the roof with similar jack arch construction and upper story of this block. A crack about 1.5 to 2.0mm wide developed at the crown in the arch roof of a 28m long gallery (Fig.2) in the east-block. The crack runs for the entire length of the N-S oriented gallery. Disjoining at the corners of two walls with opening of about 2cm width was also observed in the upper story. Chipping of the plaster and diagonal cracks at the openings were observed at many places. Almost all the sky-light openings at the roof developed cracks.

FIG. 2 - CRACK DEVELOPED AT THE CROWN
IN THE ARCH ROOF OF A 28 M
LONG GALLERY

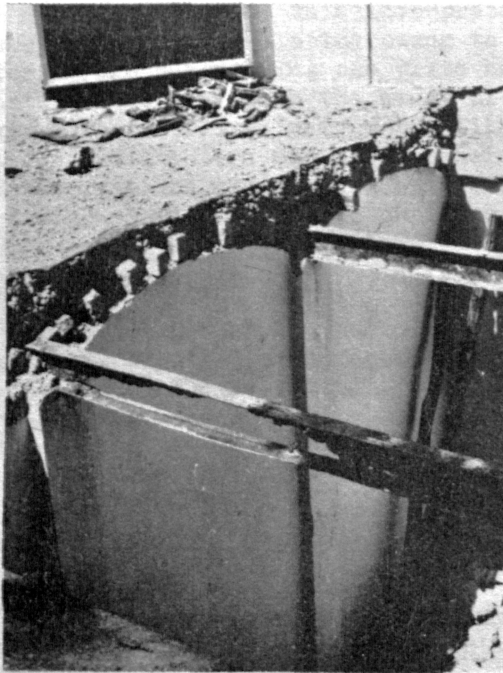
Vice-Chancellor's Lodge, University of Roorkee: This is the oldest building in the area. It is a single storeyed construction with jack arch roof. Chipping and fall of plaster was observed at many places. At some openings diagonal cracks were also observed. In some of the walls, vertical cracks running from roof to floor were observed particularly at corners. In the roof of one of the rooms, the tie rods were detached from the main girders. This occurred due to rusting of the rods at ends. The girder webs when opened out by removing the masonry on either side showed varying degree of rusting along the length and even complete vanishing of web at many points, as shown in Fig. 3.

FIG. 3 - AN OPENED VIEW OF THE
GIRDERS SHOWING RUSTING AND
VANISHING OF GIRDER WEBS

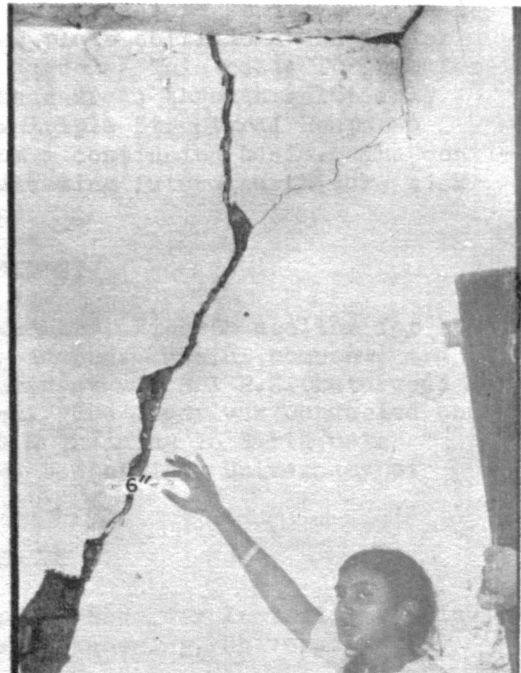
Chipping of plaster, development of minor cracks, etc., was observed in many old buildings in the area in the vicinity. Most of the barrack type constructions with dome type arch roof supported on walls suffered damage. A 47m high R.C.C. tower with rectangular plan (under construction near to top) situated about 100m from University administrative building did not suffer any damage. Moreover about 1.5km West of Roorkee terrace little or no damage was observed. Even some of the precariously hanging projections remained intact. However, further west, the damage increased and was significant in Rampur village about 6km from the bluff (Figure 4).

FIG. 4 - DIAGONAL CRACKS AND FALL
OF PLASTER IN A BRICK MASONRY
HOUSE AT RAMPUR VILLAGE

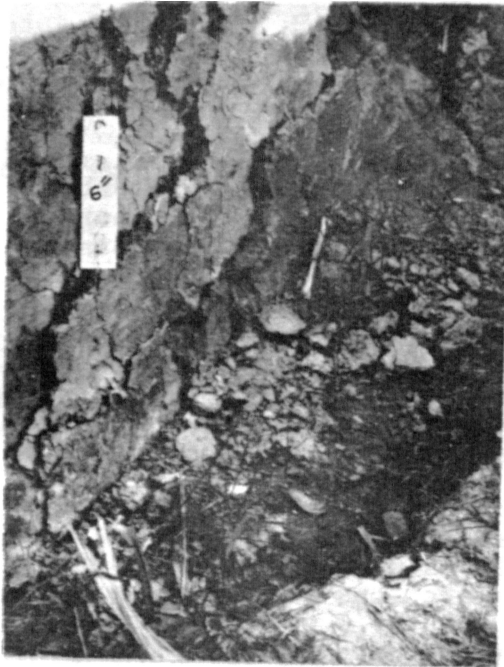
Damage Around Roorkee: The maximum intensity is mainly confined to NW-SE direction and decreases rapidly in directions perpendicular to it. Most of the construction in the SE side of Roorkee consist of mud houses and only a few houses are in brick and mud mortar with very poor construction. Most of the mud walls developed cracks and a few of them collapsed (Fig. 5). The damage in the brick houses in the form of fall of plaster at many places, the diagonal and vertical cracks starting from the openings were observed.

FIG. 5 - WIDE CRACKS AND PARTIAL COLLAPSE OF MUD WALL NEAR POHANA VILLAGE

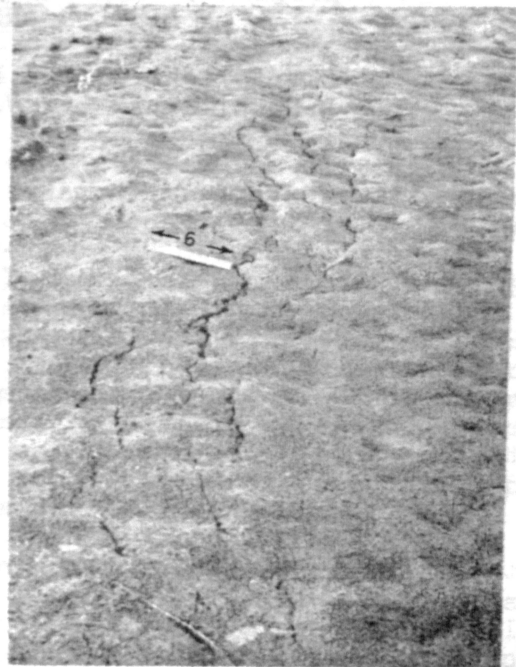
Fissures were observed in the sand flats on the bank of Solani river (Figure 6) about 8km southeast of Roorkee. The fissures are subparallel to the Roorkee fault.

FIG. 6 - DEVELOPMENT OF FISSURES ON THE BANK OF SOLANI RIVER ABOUT 8 km S.E. OF ROORKEE

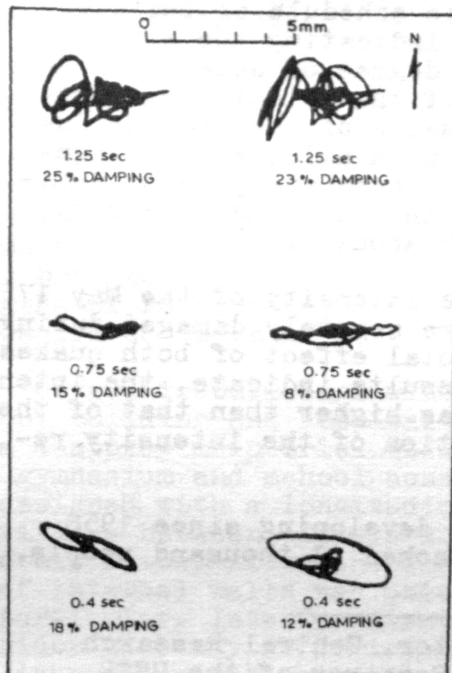
The earthquake was recorded clearly on a Multiple Structural Response Recorder installed at the premises of the Earthquake School, University of Roorkee, Roorkee. The records are shown in Figure 7. The structural response results are given in Table 1. A large drop in the peak acceleration response (S_a) values with increasing periods is observed. Such a behaviour is expected when the recordings are very close to the epicenter. Therefore the above findings confirm that the epicenter of this earthquake was very close to Roorkee. Amongst the events so far recorded by MSRR installations in India (Agrawal, 1974), this earthquake is associated with the highest response values, although the magnitude of the event is small as compared to others. On the basis of the comparison with other earthquakes recorded on MSRR, the epicentral distance is expected to be within about 5km from the instrument site. The nature of recording on MSRR may be used to infer the direction of fault plane (Agrawal, 1969). In the present case it suggests a fault strike roughly at an angle to the N-S direction.

FIG. 7 - RECORDS OF STRUCTURAL RESPONSE RECORDER INSTALLED AT THE UNIVERSITY OF ROORKEE
