THE MAY 6, 1976, FRIULI - EARTHQUAKE  
ASSESSMENT AND INTERPRETATION  
OF BUILDING DAMAGE

Presentation by  
Dr. Ernst C. Glauser

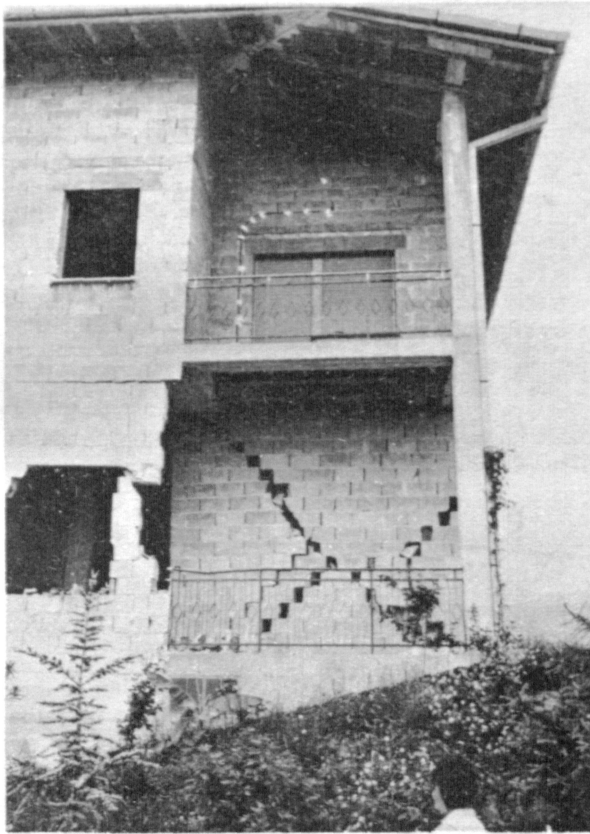
Walls and partitions consisting of brick and masonry are both rigid and brittle. Where the walls are insufficiently strong or where many openings exist, the masonry walls are no longer able to absorb horizontal forces. When overstrained, these walls crack mostly crosswise under  $45^\circ$  (Figure 1), the cracks spreading, either along the mortar joints or in the bricks. Because of the brittle nature of masonry constructions, the cracks widen, joints gape open or the walls concerned even collapse. In a skeleton construction, the reinforced concrete framework can in certain cases continue to uphold the weight of the buildings. For purely masonry construction, on the other hand, at least a partial collapse of the building is unavoidable.

Figure 1  
Dwelling house with workshop  
near Artegna. Basement in  
reinforced concrete and the  
upper stories in masonry  
without framing. Typical  
diagonal cross cracks in a  
wall of the ground floor.

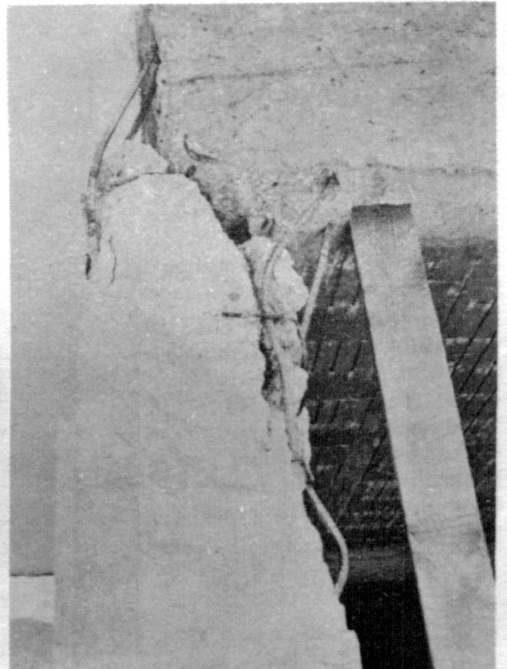
Since reinforced concrete columns are, in general, considerably more flexible than walls, the latter carry practically the entire earthquake force. However, in open constructions the entire stress is carried by the columns. The free-standing reinforced concrete columns of one-storey storage sheds were mostly strong enough to absorb the stress without being destroyed, in many cases even without incurring lasting cracks. By partial stiffening, for instance by means of an annex or installations or heavy rigid upper floors, higher stress results, which usually leads to plastic deformation at both ends of the columns. Hence, the reinforcement, overstressed by tension, can buckle as a result of the alternating action (Figure 2). The related cracking of the concrete and the buckling cannot be significantly reduced even by means of closely spaced stirrups.

Figure 2  
Shearing-off of a column at its  
connection with the crossbrain  
due to insufficient stirrups.

The ability of the resulting plastic joint to rotate is, however, increased and a shear failure prevented.

In the event that it is impossible to design the columns, taking actual earthquake forces into consideration, then at least the plastic deformation of the columns in all directions must be guaranteed. The movements should not be hindered by any secondary elements. An improved building method for the prevention of collapse could, therefore, be to shape the columns in a manner that the plastic hinges, necessary to absorb energy, are formed in the crossbeams.

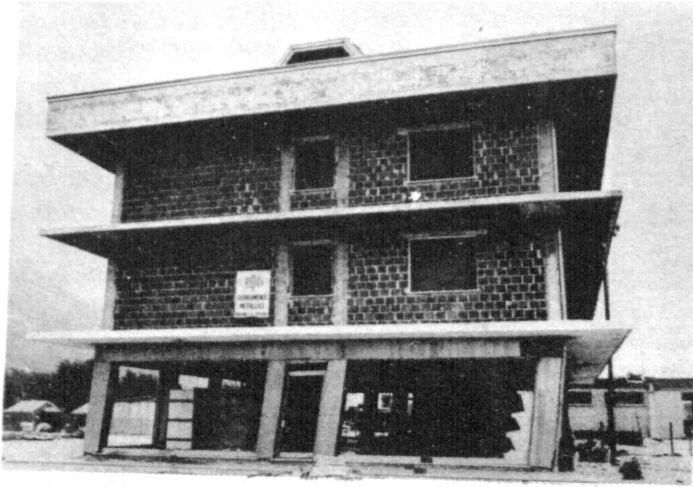
Open or only slightly stiffened ground floors, mostly for commercial use, are particularly vulnerable. The locally severe destruction in the area of such weak spots caused the collapse of entire buildings or made their demolition necessary, even with otherwise only minor damage, because restoration would have been too difficult (Figure 3).

**Figure 3**  
 Three-storey dwelling house with shop in the ground floor near Artegna. Reinforced concrete frame with brick partitioning walls in the upper floors and mostly open ground floor. Plastic hinges at bottom and top of the ground floor reinforced concrete columns caused large deformations. No damage in the upper floors.

Greatly differing conditions of rigidity in a supporting structure result in local weak spots which are the first to be overstrained in an earthquake and plastically deformed. Hence the stronger parts of the building are no longer irreversibly deformed and energy absorption is limited to the weakest building parts. Consequently, an evenly distributed plastification of the entire structure is necessary to ensure that destruction remains within acceptable limits.

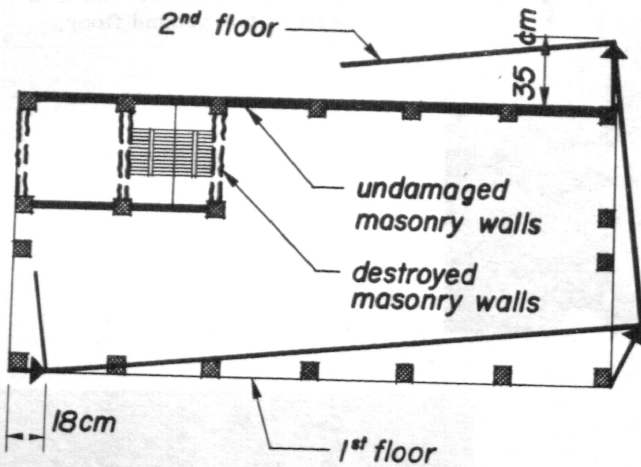
From the point of view of the structural system, many symmetrical structures suffered damage due to the additional twisting motion of the building around its vertical axis. As a result of the superimposed movement, some parts of the building are relieved whilst others are considerably more deformed than they would be due to translational movements only. Torsional loads are caused by the unsymmetrical layout of the structural system, but also by contingencies arising in the rigidity and execution of partitioning walls and additional fittings (Figure 4). The consequences of torsional strain can only be met by appropriate consideration in the design including provision for sufficient torsional rigidity of the building. Due to the incalculable influence of secondary elements, which are not designed to carry vertical loads, an asymmetry in the ground plan can hardly be excluded.

**Figure 4**  
 The ground plan of the dwelling house with the open ground floor shown before. Twisting of the building around the staircase stiffened with masonry walls.

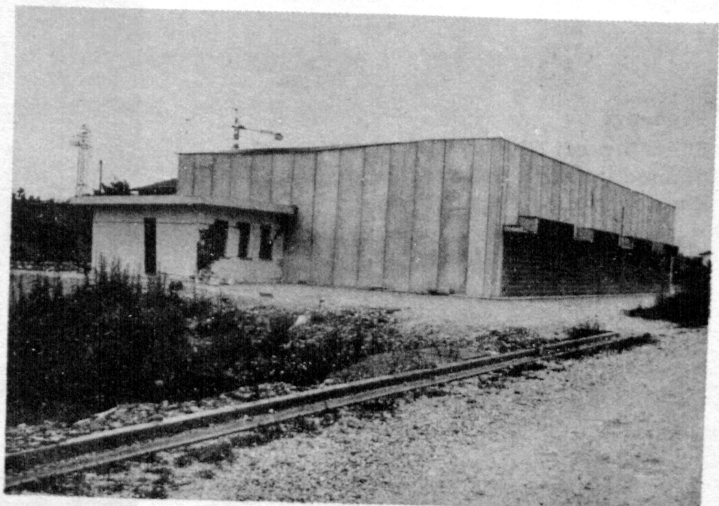
Severe damage could be located in structures composed of building sections with greatly differing rigidity due to diverse types of construction (for instance, reinforced concrete frame and pure brick) or which varied considerably in their design (Figure 5). This damage occurred because the individual deformation of each component was obstructed.

**Figure 5**  
 Prefabricated storage shed with brick annex in Gemona. Side wall panels slightly caved in by impact with rigid annex. Upper part of the annex shorn off and pushed over by the impact force due to insufficiently wide joints.

This problem can be overcome by so arranging the joints as to divide the structure into sections, each with its own clearly distinct vibration behaviour. The joints should be made adequately wide since numerous uncertainties make an exact calculation impossible. It must be taken into consideration that, for example, the deformation usually provided for in a homogenous supporting structure can turn out to be considerably larger due to the formation of cracks or plastification. An adequate freedom of movement, therefore, allows for greater plastification and a larger capacity to carry earthquake stress.

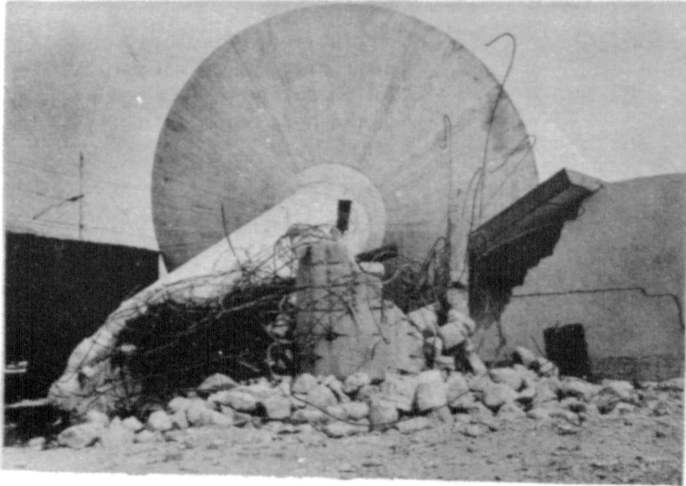
Figure 6

Special structures (e. g., bridges and water towers) (Figure 6), because of their unusual form and distribution of mass, necessitate a dynamic analysis which takes the vibration behaviour of the structure and the real properties of an anticipated earthquake into consideration.

Overturned water tower belonging to the Italian State Railways in Gemona station. Foot of the shaft completely destroyed and concrete shattered.

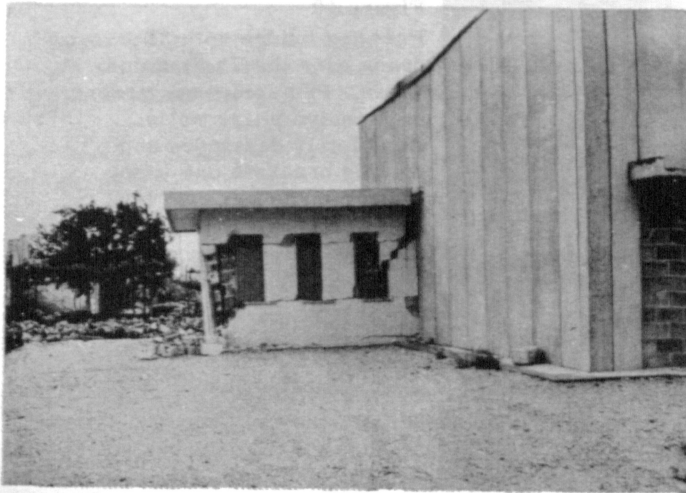
Figure 7

All the components and fixtures, in particular dividing walls, attached façade slabs, coverings, pipes and other fittings, which form part of a structure, influence the response of the supporting structure (Figure 7). These secondary structural elements are generally not included in the analysis of the supporting structure and, therefore, not designed against earthquake forces. They can, even when subjected to only slight movements, suffer damage which produces an increasing alteration in the vibration behaviour. It cannot be predicted whether this influence will prove to be positive due to greater absorption of energy or negative due, for example, to added torsional motion. As far as possible, in order to ensure that secondary elements survive earthquake loads without substantial damage, they should be analysed and designed together with the supporting system.

Prefabricated storage shed in Gemona as shown before. The supporting frames and the wall panels generally not damaged because of energy absorption in the material of the joints between the single panels.

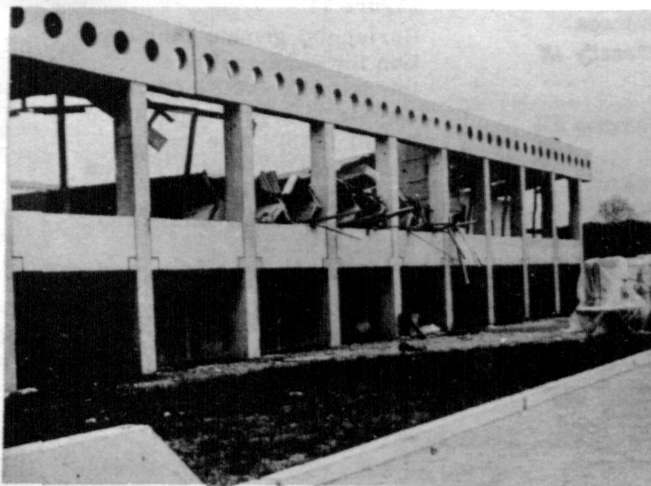
Figure 8

structural elements. Load bearing connexions should be properly designed against the expected dynamic forces. Purely friction-type joints are no longer sufficient to transfer the forces that arise, even from only weak earthquake loads (Figure 8).

Heavily damaged prefabricated factory shed near Osoppo with roof girders fallen down. Friction joints insufficient to provide structural stability.

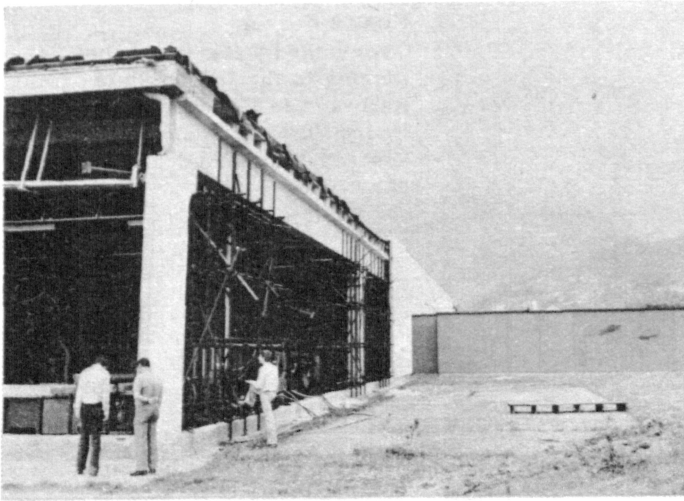
Building parts (such as prefabricated façade slabs and dividing walls and fittings, particularly machines, storage racks and pipes), which are not part of the supporting structure, are usually either directly or indirectly connected to it. Due to the action of the earthquake, much damage occurred through the displacement or collapse of façade slabs which were unconnected or insufficiently secured (Figure 9). The actual displacement occurring at the fixation point, which can be considerably larger than the one of the ground shock, must be taken into consideration in the fixation of secondary elements.

**Figure 9**  
 Prefabricated factory shed near Artegna. Wall panels fallen out during the earthquake because of insufficient fixation.

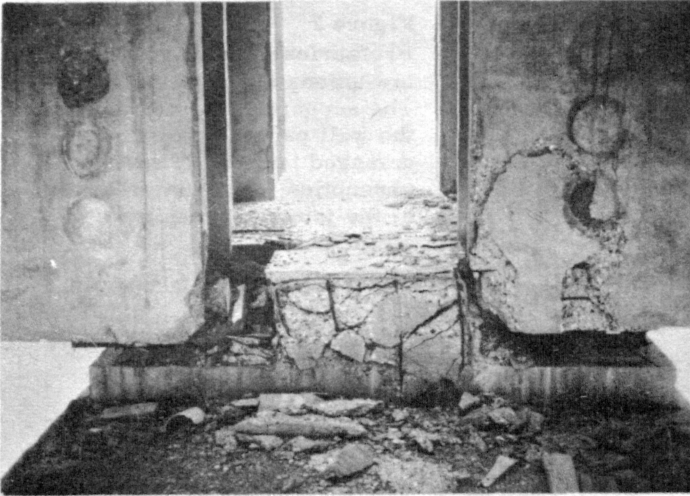
As opposed to the old stone arch bridges, a good number of newly erected reinforced concrete bridges incurred damage which was chiefly limited to the bearings and abutments (Figure 10). From the point of view of mass arrangements, bridge constructions come under the heading of special structures, since here the generally heavy girders in beam and slab bridges rest on comparatively high and therefore flexible piers. It is impossible to achieve with conventional methods a stabilization of the huge mass forces that occur when the structure is subjected to earthquake shocks. It should be noted that the reinforced concrete bridges hit by the earthquake in Friuli suffered severe damage which will be difficult to repair, but they were by no means in danger to collapse.

**Figure 10**  
 Freeway bridge with 32 spans over the Tagliamento River. Prefabricated girders on massive pillar walls. Completely destroyed supporting brackets due to the impact of the girder. Left bridge girder slipped from its bearing.

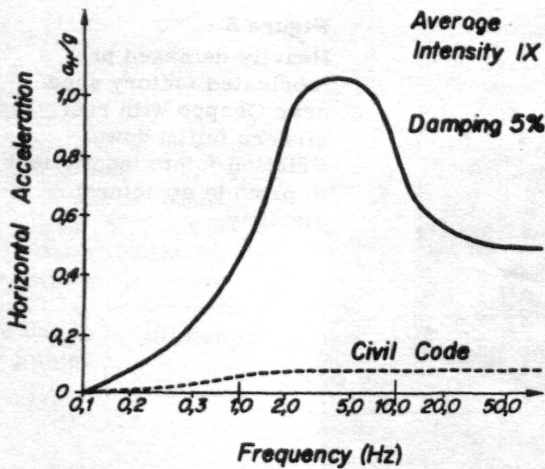
The Italian State Administration has enacted special regulations for earthquake-prone areas and has repeatedly brought them up-to-date. Using the Code, design earthquake loads are determined by statical or dynamic analysis. An average horizontal acceleration will result, which is about 7 percent of the gravity acceleration  $g$ . Comparison of horizontal design accelerations given by the Code with those produced by an earthquake with the Intensity IX (Figure 11) shows large discrepancies.

The Code values are significantly smaller because it is assumed that strong energy absorption will occur due to inelastic behaviour of materials and elements. But this means that the structure must be capable of absorbing the appropriate energy. Consequently, plastic deformation and therefore damage or maybe even collapse can result.

**Figure 11**  
 Horizontal ground acceleration for earthquakes of intensity IX (MSK) (U. S. Atomic Energy Commission, WASH 1255). The dashed line gives the design ground acceleration according to the conventional aseismic building code.
