GROUND FAILURE DURING KINNAUR EARTHQUAKE OF JANUARY, 19,
1975 HIMACHAL PRADESH, INDIA

L.S. Srivastava^I and S. Singh^I

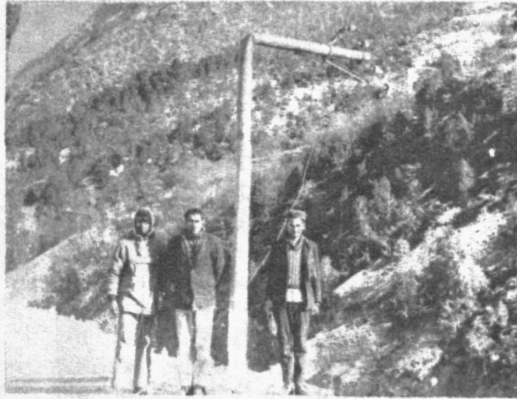
FIG. 1 - TELEGRAPH POLE BENT DUE TO IMPACT OF A FLYING ROCK FRAGMENT

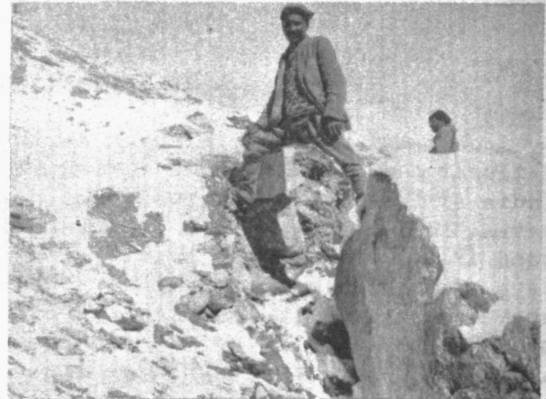
FIG. 2 - DISLODGING AND SHIFTING OF A BOULDER AT THE TOP OF A BRIDGE AT LEO

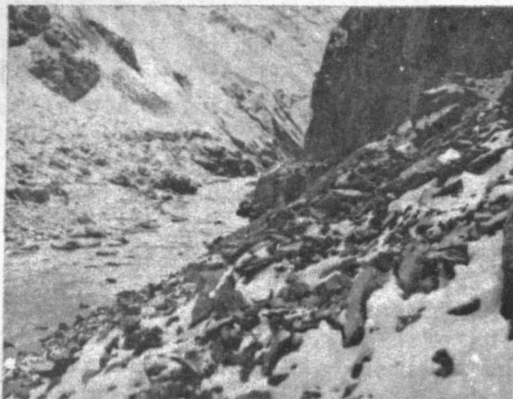
FIG. 3 - CASCADED QUARTZITE FRAGMENTS ALONG HINDUSTAN - TIBET ROAD BETWEEN CHANGO AND SHALKAR

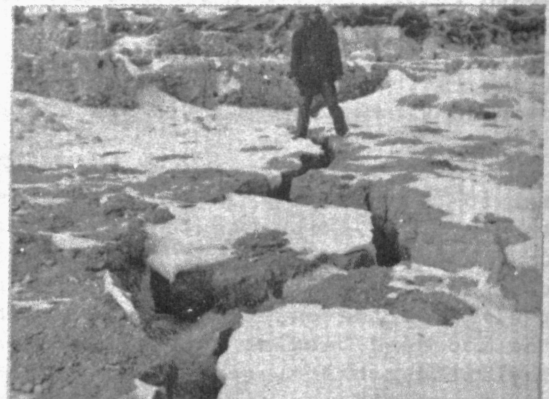
FIG. 4 - GROUND FISSURES IN GLACIAL MORaine CUTTING ACROSS KAURIK

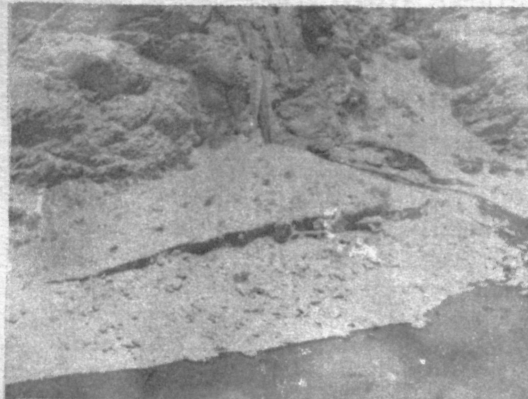
FIG. 5 - GROUND FISSURES IN SPITI RIVER BED TRENDING N 20° BETWEEN CHANGO AND MALLING

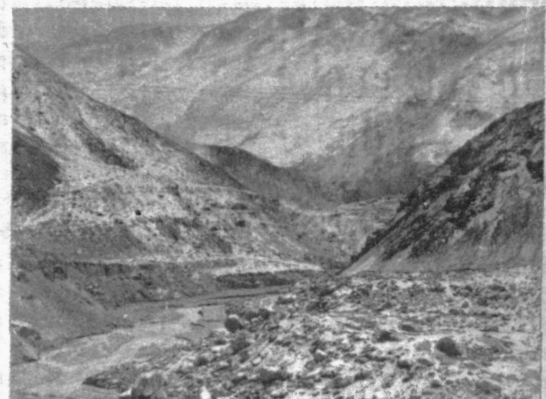
A major landslide dammed the Parachu Valley (Fig. 6) creating a reservoir behind it. The dam was approximately 60m in height and 150m in length. In about six days the impounded water started flowing from the opposite bank and carved out a new meander which joined the original river course 500m downstream of the dam. Loosening of the rock masses and readjustments resulted in changing the seepage outlets from higher levels to lower levels in some of the surface springs in the area.

FIG. 6 - DAMMING OF PARACHU DUE TO A HEAVY LANDSLIDE BETWEEN SUMDOH AND KAURIK
