GUATEMALA EARTHQUAKE OF FEBRUARY 4th , 1976. DESCRIPTION AND ANALYSIS  
OF DAMAGES CAUSED ON BUILDINGS

by  
José Herrera Cano \*

SUMMARY

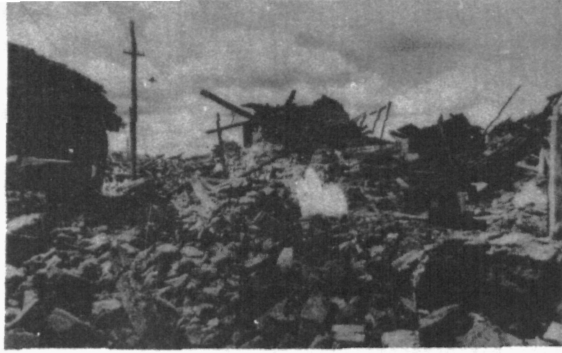
Most of the observed damages in the city as well as in country areas correspond to the typical houses made of "adobe" with wooden roofs and clay tile covers. Figure 2.

Coming back once more on the problem of "adobe" old buildings, it was detected that the "adobe" had been kneaded in such a way that frequently they contained pine fibres. The soil used to prepare the mud had generally very few clayey components, thus resulting loose "adobes" with brittle failure. Joints among the adobes were wider than they generally are in other Latin American countries, thus producing an inadequate linking among the elements. Besides these there is the rainy season, beginning in May and lasting four to five months, that causes damages in walls and foundations and leaves them in inferiority of conditions.

Nearly all these habitational units with adobe walls and clay tile covers were destroyed and are responsible for the dead and wounded. Some of these houses suffered important damages in their walls but did not collapse because they had an horizontal frame on top of their walls on which the wooden beams of the roof rested. Undoubtly such wooden frame has behaved as an upper enchaining element making the walls to work as a whole and thus preventing them from failing.

Fig. 2 - Failure of adobe made houses.

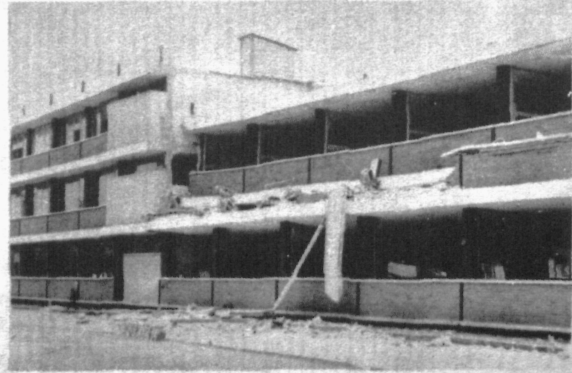
The behaviour of buildings with brick masonry walls and reinforced concrete structure was fairly acceptable having only been observed the breakage of window glasses, plasterings, coatings and interior walls. However, some of these buildings collapsed partial or totally due to the existence of a non-rational combination of structural and non-structural elements producing varying rigidities. Figure 3. Some capitals of their columns also failed due to the condition of short column. Figure 4.

Fig. 3 -Xavier College  
Failure of its central  
part.

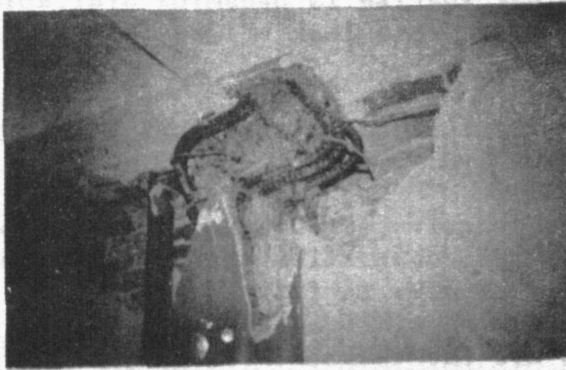
Fig. 4 -Short column- Failure of  
its capital.

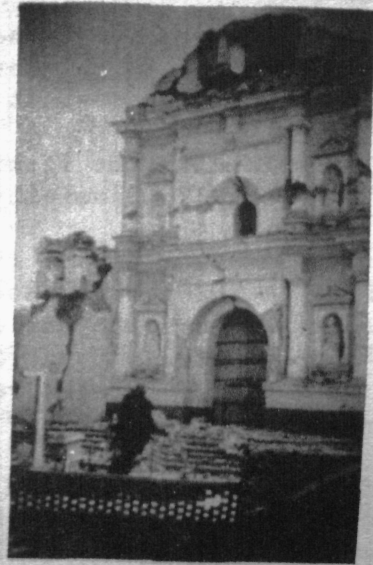
Losses of the cultural patrimony are beyond any possible valuation. Figure 5.

Fig. 5 - Damages in a church
