PERFORMANCE OF BANCO CENTRAL RELATED TO FAULTING

Loring A. Wyllie, Jr.^I, Filadelfo Chamorro^{II}, Lloyd Cluff^{III}, Marvin R. Niccum^{IV}

SYNOPSIS

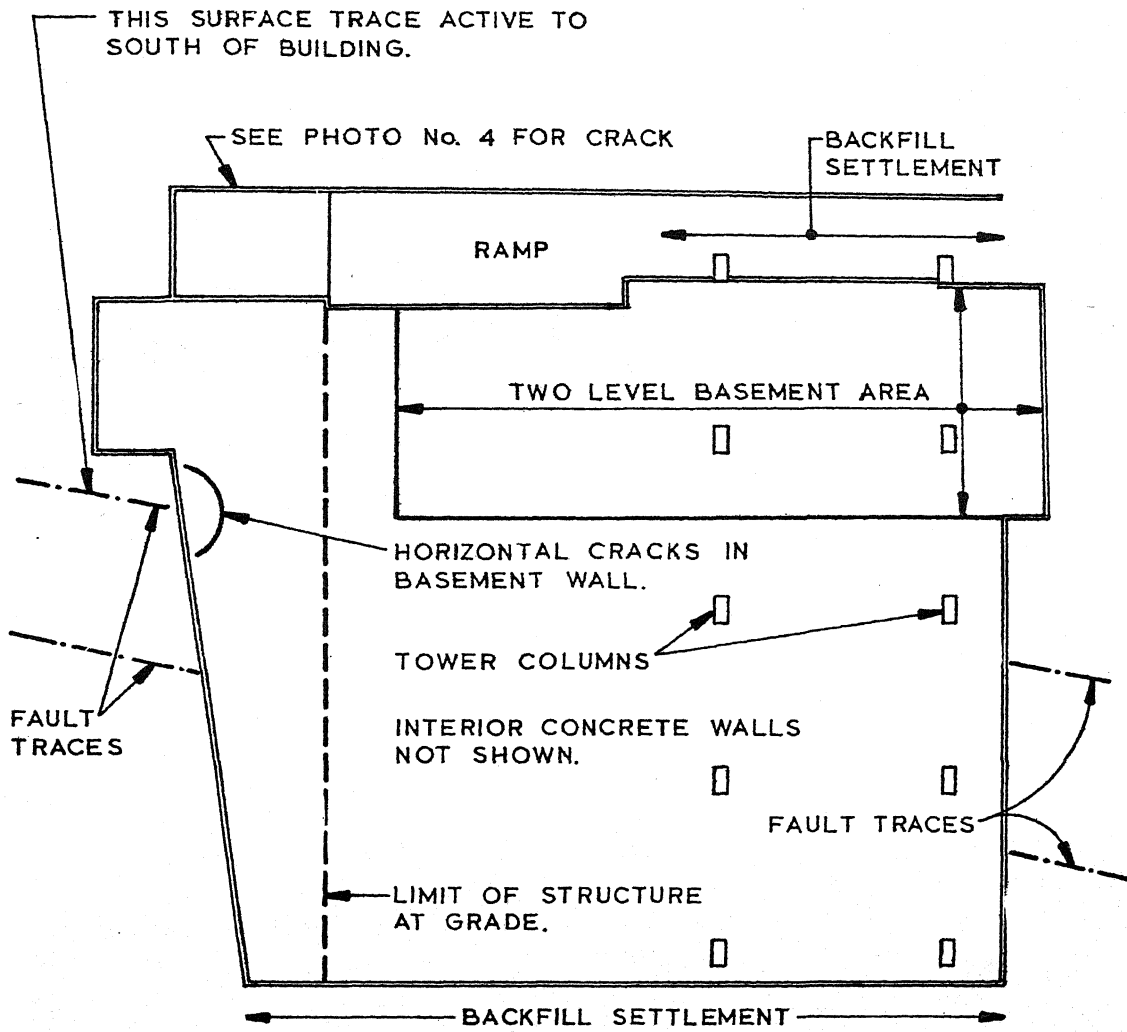
FIGURE 1.
 PLAN OF BASEMENT OF BANCO CENTRAL

The basement of the Banco Central building is shown in Figure 1. The basement is 9.40 meters (31 feet) deep with an intermediate mechanical level in the northwest corner. The exterior walls are 45 centimeters (18 inches) thick with many interior concrete walls both 45 centimeters (18 inches) and 20 centimeters (8 inches) thick. The basement contains numerous heavy security walls as it houses the repository of reserved and uncirculated currency for the Government of Nicaragua. The basement slab and first floor slab are both 45 centimeters (18 inches) thick and contain substantial reinforcement. The footings are spread footings at a depth of 2.3 meters (7.5 feet) below the basement slab and are interconnected with seismic tie beams.

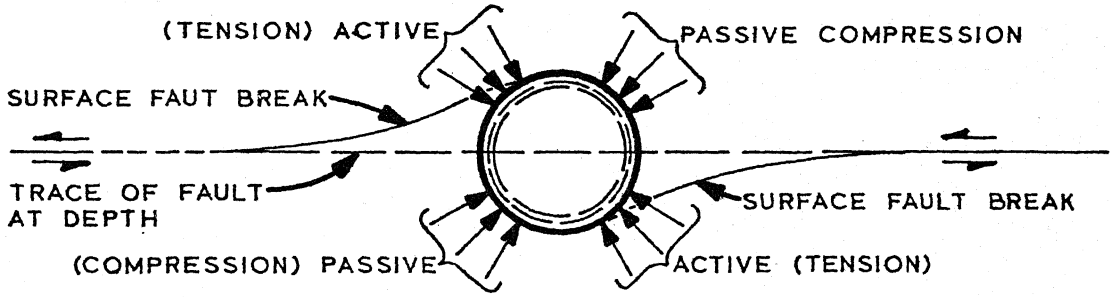
FIGURE 2.
 IDEALIZATION FROM MODEL STUDIES (REF. 3)

Completely independent of the Banco Central investigation, model and finite element analytical studies were reported discussing the effect of fault displacement underneath a rigid circular structure⁽³⁾. The qualitative idealized pressures resulting from this independent study are illustrated in Figure 2 and are also mentioned in the companion paper in the Proceedings. The active pressure zones, which reflect a reduction in at rest pressures or a tensional tendency in the soil, correspond to the east and west sides of the Banco Central where settlement and ground cracks were observed. However, pressures on the west side also must have increased significantly at some period during the earthquake to cause the failure and inward movement of the retaining wall next to the ramp. The passive or increased pressure areas that the study indicated correspond to the north

and south sides of the bank, where no soil distress was observed. It appears that the 1972 fault displacements were insufficient to develop any substantial passive pressures. The one area of observed basement wall cracking due to high earth pressures does not appear to directly correlate with the independent studies, although the fact that the structure was not completely within the fault zone undoubtedly affected this observation.

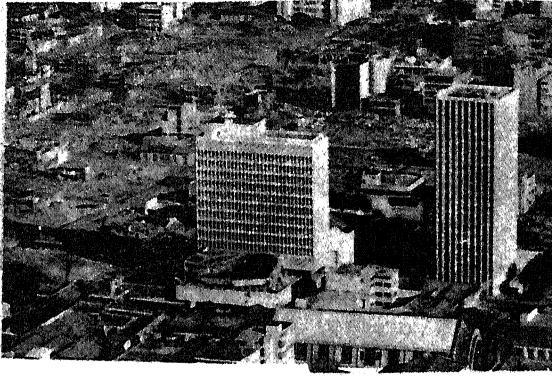
Photograph Number 1. View of Banco Central from south. Banco de America to right. Banco's fault goes from lower left to upper right.

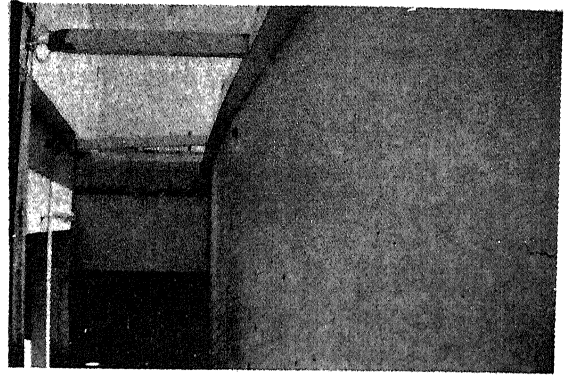
The basement complex was also inspected in detail by several of the authors at the request of the owner in light of the possible fault intersecting the building's base. The retaining wall at the west end of the structure providing basement access for vehicles sustained considerable damage, as seen in Photograph Number 2. The wall bowed inward probably 10 to 15 centimeters and struts at the top to the building failed. The other exterior walls had no evidence of cracking except one area on the south wall where fine horizontal cracks at about 40 centimeter centers suggested high earth pressures. After the fault trenching, this area was shown to be exactly in line with the active fault trace, as indicated on Figure 1. No corresponding area of horizontal cracking was present on the other side of the building. The only other cracking of concrete basement walls discovered was of such a random and minor nature that it could not be correlated with the seismic event.

Photograph Number 2. Retaining wall at ramp, looking south. Struts have failed at top and wall has bowed in. Note horizontal cracking.

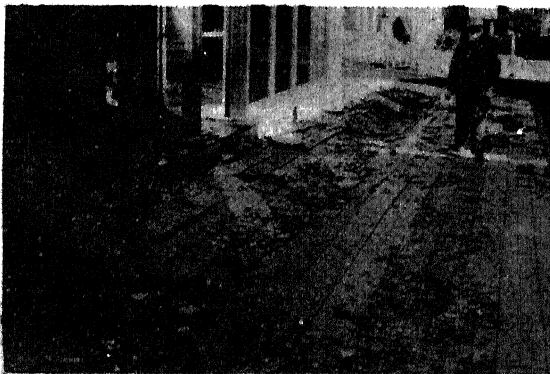
Observations on the ground around the site were also noted with interest. Settlement was noted in the backfill immediately east of the structure, as seen in Photograph Number 3. During trenching operations a small diameter broken water pipe was noted in this area. Erosion of backfill from the pipe trench under the sidewalk probably accounted for a portion of this settlement after the shaking had ceased. Similar settlement was noted at the top of the ramp at the west end of the structure. No broken water pipe or sub-surface erosion was found in this area. Along the west exterior wall south of the retaining walls adjacent to the ramp, a sizable crack was noted at the wall line in a surface driveway, indicating a tendency of the earth to separate from the structure. This is shown in Photograph Number 4. Similar settlement or cracking was observed along the north or south basement wall lines.

Photograph Number 3. Sidewalk settlement on east side just outside basement wall.

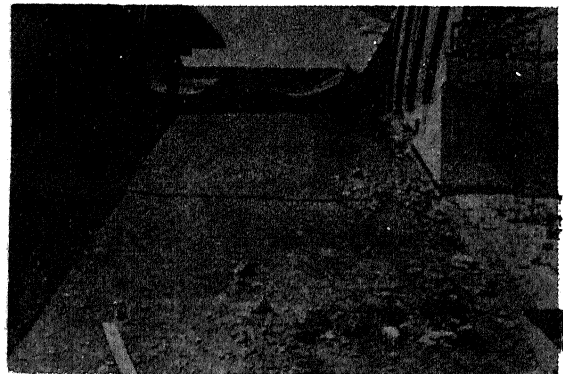
Photograph Number 4. Crack in driveway covering enlarged basement area at west perimeter near south corner. Wall at right is end of top of retaining wall see in Photo 2.
