BANCO CENTRAL DE NICARAGUA: A CASE HISTORY  
OF A HIGH-RISE BUILDING THAT  
SURVIVED SURFACE FAULT RUPTURE

Marvin R. Niccum<sup>I</sup>, Lloyd S. Cluff<sup>II</sup>, Filadelfo Chamorro<sup>III</sup>, Loring  
A. Wyllie, Jr.<sup>IV</sup>

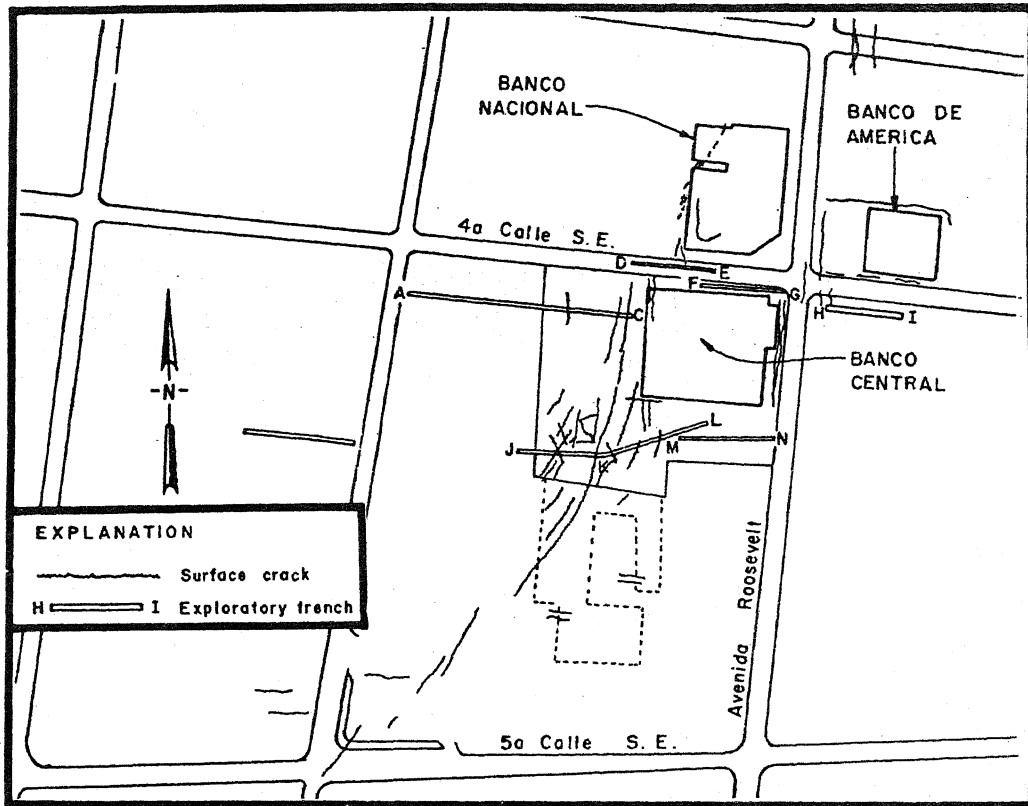
Figure 1 MAP OF SURFACE CRACKS AND TRENCHES

A plot was made of fault cracks near the property that showed more than a centimeter of lateral displacement, vertical displacement, or gap (Figure 1). Photographs of the excavation for the basement of the Banco Central indicated the fault crossed the basement; these photographs were studied to make a first approximation of the fault location. Trenches were excavated to examine the fault that was believed to pass under the bank building.

The trenches indicated on Figure 1 were excavated and examined to help determine the width of the fault zone and the amount of displacement per event. Detailed logs were prepared for all the trenches; an illustration of the type of geologic data recovered from the trenches is shown on Figure 2.

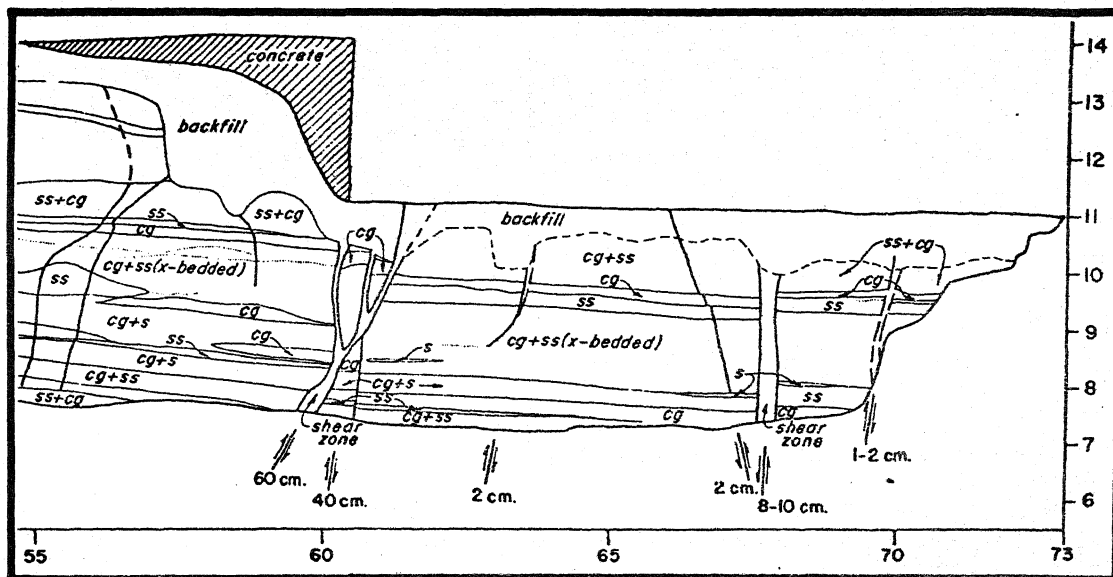
Figure 2 DETAIL OF TRENCH LOG

Figure 2 shows that gouge zones occurred between stations 60 and 70. The gouge zone at station 60 experienced minor displacement in the 1972 earthquake. The surface cracks deviated from the trend of the fault here, and went around the west side of the bank. The gouge zones between stations 65 and 70 had experienced faulting in the past; however, unbroken, cemented breccia in the shear zone, lack of disruption in the shear zone, and lack of disruption in the backfill and the asphalt of the bank parking lot indicate no displacement during the 1972 earthquake. A new crack can be seen at station 67. The apparent vertical displacement is less than 1 centimeter on the beds it cuts. The cracks between stations 55 and 60 have refracted through beds of varying hardness. Other cracks, which have undergone multiple displacements in the past, have progressively larger displacements in the lower beds.

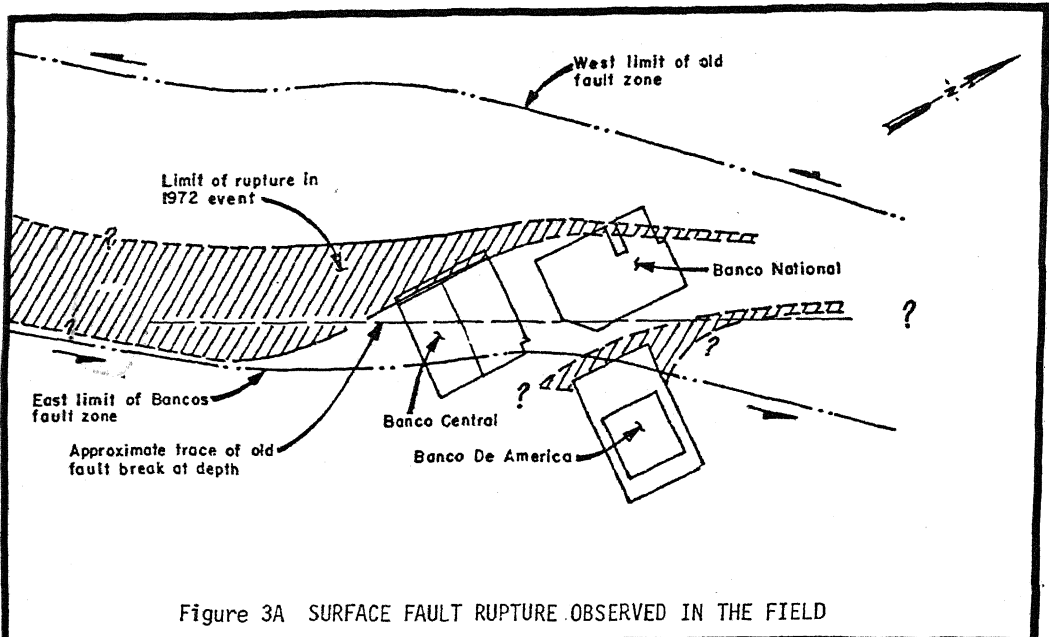
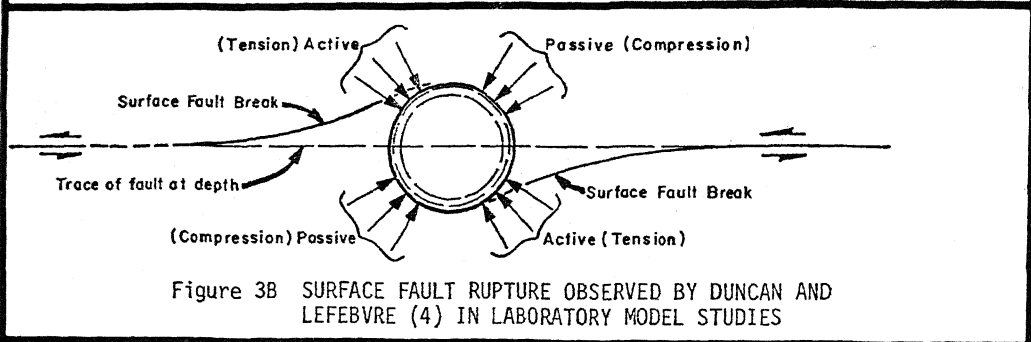
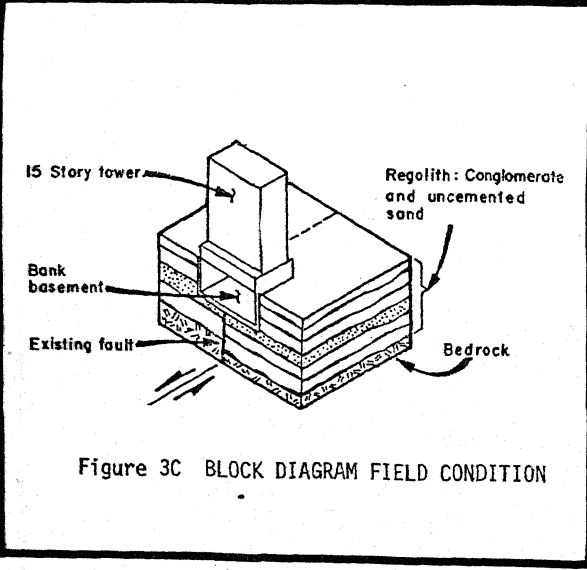
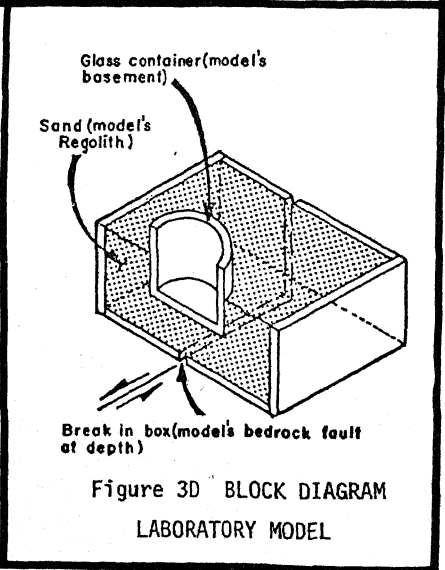
Figure 3 COMPARISON OF FIELD AND LABORATORY MODELS

The Bancos fault consists of numerous en echelon faults and fractures in a 70-meter-wide zone (Figure 3A). The fault zone is irregular, but generally trends about N30E. Individual surface cracks are generally oblique to the zone and have a more northerly orientation. The fault has ruptured at the site at least seven (and probably more) times in the past 25,000 years. Each event appeared to have no more than 1 to 5 centimeters of vertical displacement. The 1972 displacement was about 17 centimeters left lateral.

The Banco Central building is partially in the fault zone and partially in the unbroken alluvium east of the fault zone. Two large fault cracks were found in trenches on either side of the Banco Central; since the amount and sense of displacement is the same on both sides of the building, it is reasonable to assume the traces are continuous under the building (Figure 3C).

Plan views of the Banco Central area and a model (4) are shown similarly oriented on Figures 3A and 3B. Figures 3C and 3D show idealized block diagrams of both the model and the field condition. There is a left slip at depth along one fault trace in the model; however, at the surface, the fault divides and passes on opposite sides of the modeled structure (Figure 3B). The forces on the structure can be divided into quadrants that are oriented about 45 degrees from the fault trace. In two quadrants, the earth moves toward the modeled structure to produce passive (compressional) pressures. In the remaining two quadrants, the earth moves away from the structure, producing active (tensional) failures.

The field conditions were more complicated than the model study due to the strong foundations of the adjacent Banco Nacional, and a deep, strong basement under Banco de America (Figure 3A). In the model study, the sand modeling the regolith was homogeneous. In the field, there were three regolith conditions: 1) strong, previously undeformed beds of conglomerate (cemented gravels) alternating with uncemented sand outside the fault zone, 2) weak, deformed and fractured beds of conglomerate and sand in the fault zone, and 3) very weak vertical zones of fault gouge on the large fault traces in the fault zone.
