THE INELASTIC RESPONSE OF REPAIRED REINFORCED CONCRETE BEAM-COLUMN CONNECTIONS

by
Polat Gulkan^I

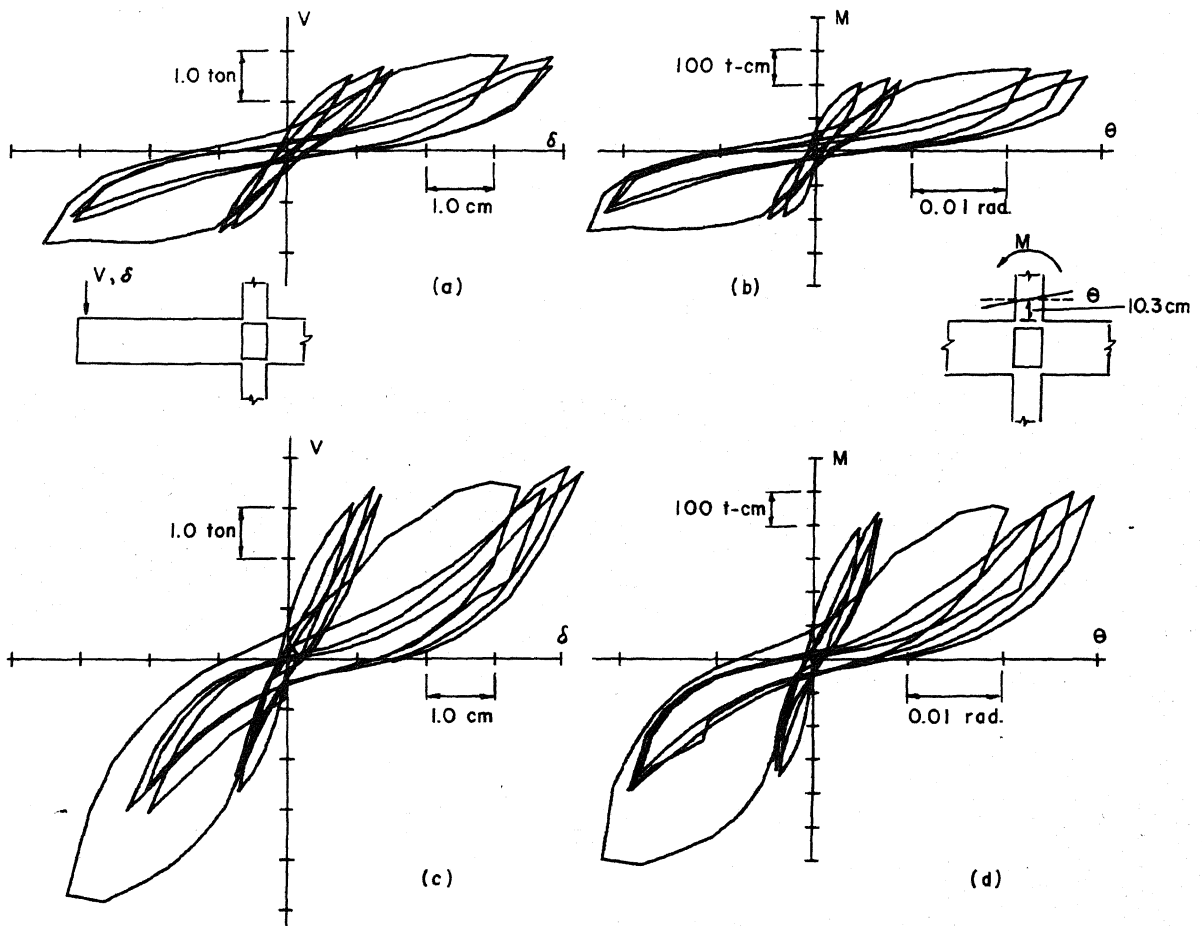
FIG. 4 - EXPERIMENTAL RESULTS FOR SPECIMENS 3N AND 3M

A summary of experimental results is given in Table 1. The load-deflection diagram for the left beam and the moment-rotation curve for the upper column for specimen 3N are shown in Figs. 4a and 4b, respectively. Drawn to the same scale, similar curves are given for the same specimen (now designated as 3M) after repair in Figs. 4c and 4d. The failure moment computed for the column with nominal material properties is 240 t-cm for Section A-A and 520 t-cm for Section C-C (Fig. 2) assuming that old and new concrete form a homogenous cross section. Experimental results indicate that these values could be developed and that there was no serious loss of strength after a few cycles past yield. In general, cracks in the column of the repaired specimen were initiated from previous cracks in the original member. Because of the great difference between the ultimate moment capacities of the columns and the beams (Sections A-A and C-C vs Section B-B in Fig. 2), cracking was confined almost entirely to within the column region immediately above and below the joint core. The presence of the 20 cm long beam stubs on either side of the core prevented the formation of diagonal cracks within the joint. Special precautions taken in the core region prevented the buckling of column longitudinal reinforcement outward. This is the most important reason for the specimen to have maintained its strength.

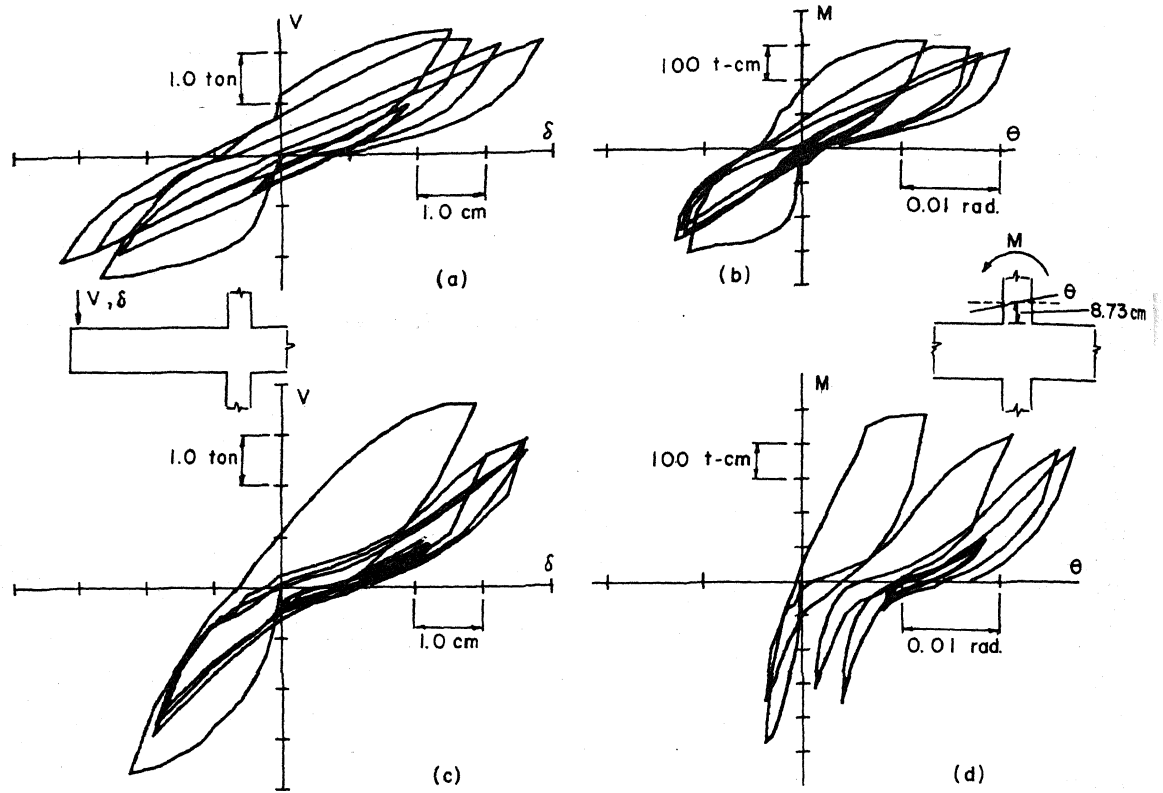
FIG. 5 - EXPERIMENTAL RESULTS FOR SPECIMENS 5N AND 5M

In Figs. 5a to 5d, the same set of results are indicated for specimens 5N and 5M which did not have the lateral beam stub. In both of these specimens there was extensive diagonal cracking within the joint area, especially in the case of 5M. This can be explained in terms of the higher shear forces that must be transmitted through the joint core due to the increased strength of the repaired columns. Since additional ties could not be provided for the joint, there was no increase in its strength, and this forced the failure into the joint. For this particular specimen, the weak link was the joint as illustrated by the 2-3 mm wide cracks that appeared in the diagonal direction in spite of the axial load. Also the full capacity of the columns could not be developed (compare Figs. 5c and 5d with Figs. 4c and 4d).
