AN INVESTIGATION OF MECHANICAL RELIABILITY OF SHEAR WALL  
REPAIRED WITH EPOXY MORTAR

SYNOPSIS

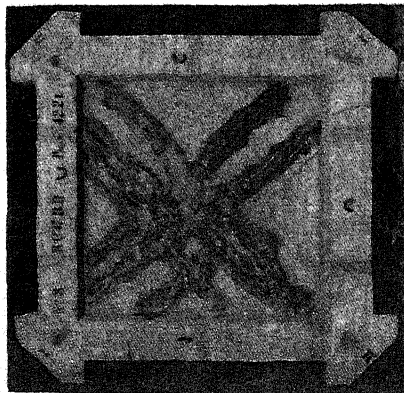
Photo.1 Specimen after Test  
(in CASE RCW-B-II)

As an example, RCW-B-II at test termination is shown in Photo.1, where the pattern of the cracks of before and after repair can be seen. During the loading before repair, for CW-II and RCW-A-II, only two diagonal cracks appeared and widened gradually as the load increased. As a matter of course, the wall with more reinforcement which sustained larger shear deformation has more number of wide spread cracks, and RCW-B-III had the maximum number of seven visible cracks before repair. During the loading after repair, at the loading level lower than that of initial crack in the test before repair, short cracks appeared in some specimens which seemed to already exist before repair but not be repaired. New long cracks across the wall occurred uncon-

tinuously at the repaired zones. Near the maximum loading stage, new short cracks occurred on both sides of the repaired zone where the large stress is distributed. The concrete band adhered with epoxy mortar separated from the wall partially along the diagonal line. In the case of the repaired specimens, at the maximum loading stage, though the widened crack of the wall along the diagonal line is not so obvious as the original one, it induced formation and development of the plastic hinges at the corner zones of the frames, and spallings occurred partially in the inside wall.

- (1) The cracks are V grooved to the depth varying approximately from 1cm to 1.5cm and the width of about 3cm by the use of light chipping hammer.
- (2) After removing the loose concrete and cleaning the repaired zone, epoxy compound is applied to the surface of the groove.
- (3) Epoxy mortar is packed into place closely and the specimens are cured in air under the laboratory conditions for a week until testing after repair.

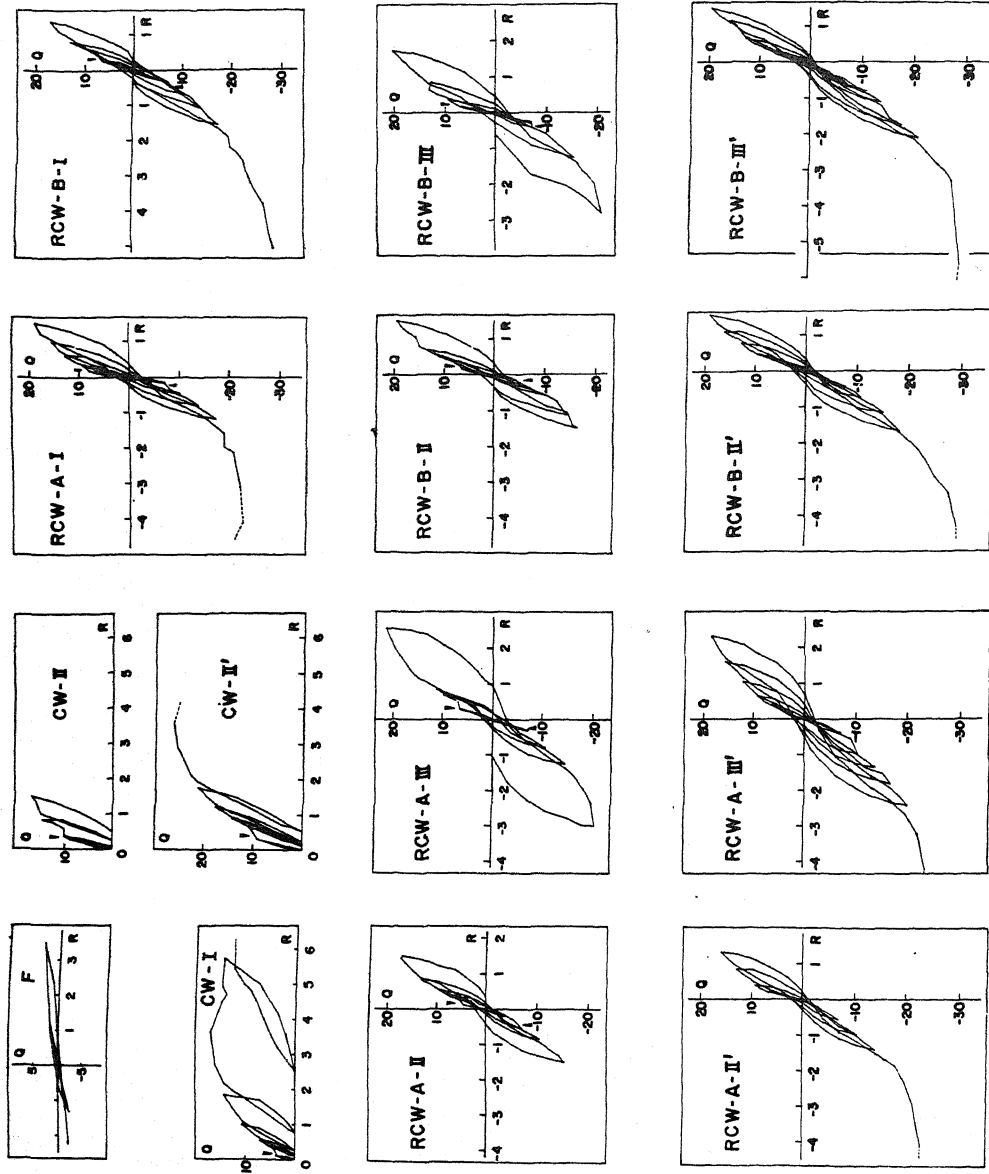
Fig. 2 Shear Force Q vs. Deformation R  
(Q:in ton, R:in  $10^{-3}$ , (') :Initial Crack)

As shown in Fig.2 the characteristics of inverse S shape in the unloading stage were emphasized as the number of cyclic loading increased at high load level. Bars in the cracked zones may have imperfection caused by loss of bond, and the concrete had significant micro cracks. In addition, similar adverse effects may have been introduced by the operation of repair. Since epoxy mortar used for repair has relatively lower modulus of elasticity in spite of its high strength, such stiffness as in the original wall could not be recovered even in the repaired zones which were V grooved and packed by the epoxy mortar.
