COLOUMN-BEAM JOINTS FAILED UNDER SEISMIC LOADING, REPAIRED  
AND RE-TESTED UNDER SEISMIC LOADING

T.Tassios<sup>I</sup>, P.Plainis<sup>II</sup> and G.Vassiliou<sup>III</sup>

SYNOPSIS

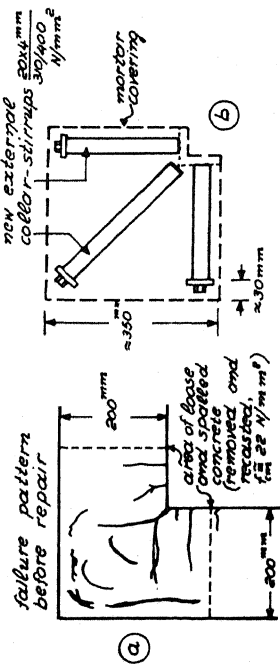
**Fig. 1: Types of damage repaired**

Thus, simpler techniques have been selected for the purposes of this paper in order to repair R.C. elements damaged (Fig. 1) after dynamic and/or static loading.

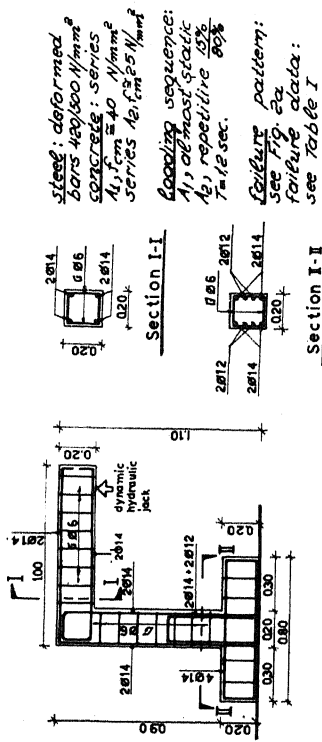
**Fig. 3: Repair of beams (type II)**

Type II (flexural) failure (Fig.1) produced by static loading has been repaired as shown in Fig.3, and retested under cyclic loading. Complete measurements of strains were taken, by means of a oscillograph recorder, both on concrete and the steels (initial bar reinforcements and glued steel sheet). Deflections are shown in Fig.8, compared to those of the initial beam. The final upper limit of cyclic load 154,0 kN was equal to the static strength reached before repair. Five hundred and ten cycles up to this level have created cracks starting from the ends of the glued sheet and the sheet started to slip. At that moment, its stress was equal to  $140 \text{ N/mm}^2$ , while the initial bar reinforcements were restrained slightly over their yield limit. Nevertheless, the beam continued to bear load. In order to produce its failure, a monotonic static load was applied up to 175 kN.

- a) Strength is easily and fully restored, even under high level dynamic loading.
- b) Rigidity seems to decrease considerably. Nevertheless, if the steel sheet were considerably longer, a substantial improvement of rigidity could be possible.

Type "II", flexural, damage (Fig. 3a) has been repaired by means of a steel sheet glued to the bottom of the beam, with commercial epoxy resin (Fig.3b), after removing and recasting heavily damaged concrete.

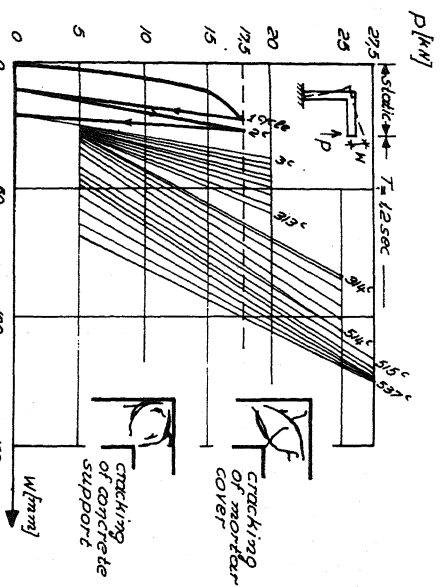
Fig. 6: Deflections during loading of frame A<sub>1</sub>(i) after its repair

(0,1 to 1,3%) and scattered. (Observe the absence of diagonal crack on concrete, Fig.6). The lack of steel in repaired areas may lead to very brittle behaviour, as shown by McCafferty et al. (7), even in cases where epoxy mortars are used.

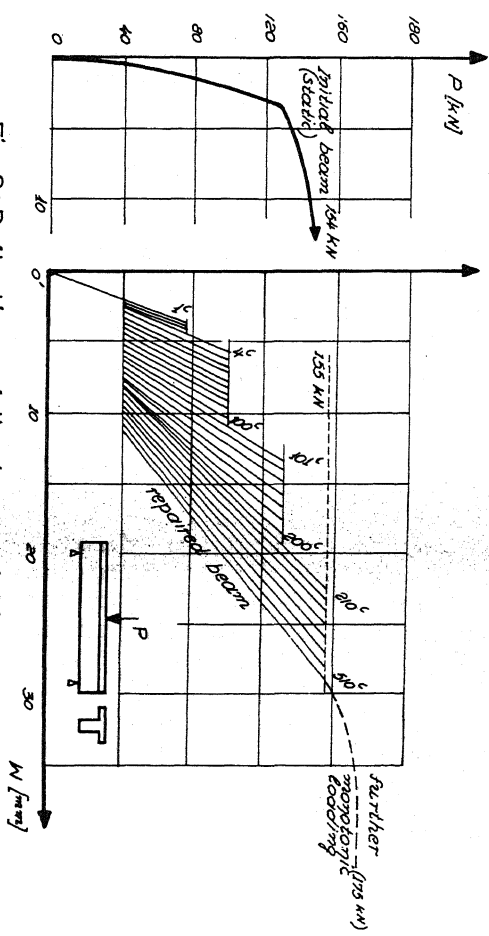
Fig. 8: Deflections of the beam of Fig. 3b retested under cyclic loading

Related to Mr. Seth's comments on how to counterbalance fall of rigidity in case of steel sheet glued for repair against flexural failure, the authors agree in principle but they would like to remind that insufficient anchorage length of the steel plate was the main handicap in this case.

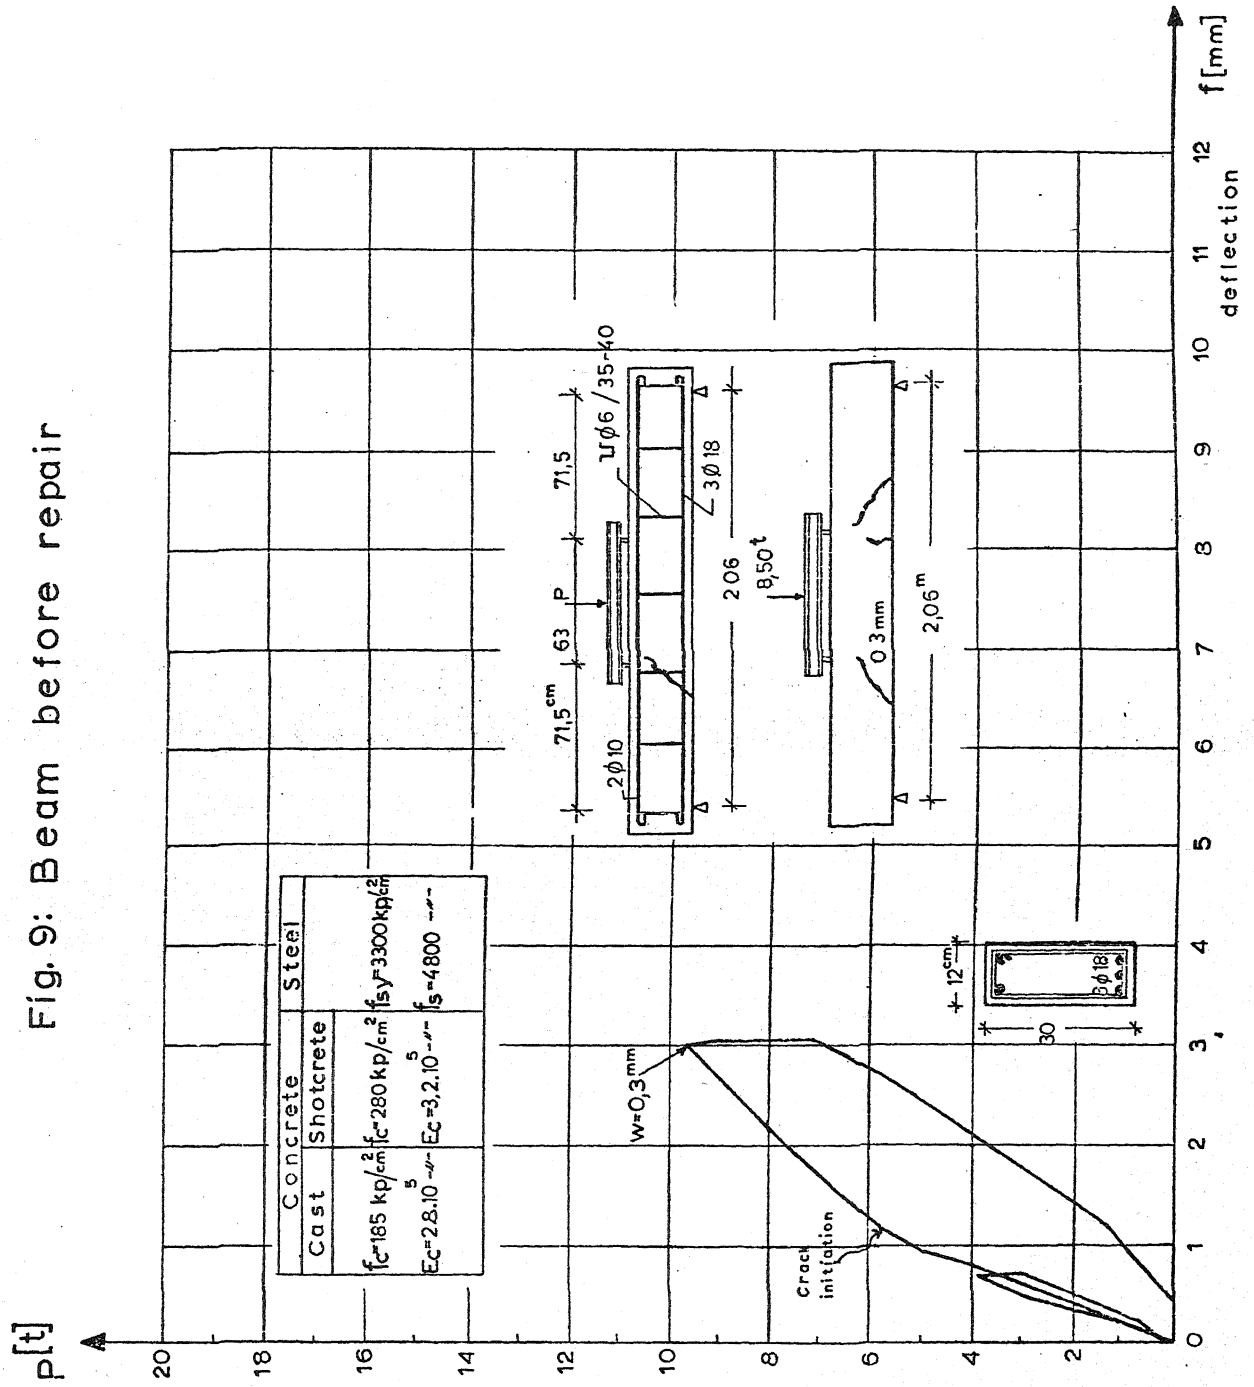
Fig. 9: Beam before repair

Related to Mr. Naik's questions the authors have some experience on external hoops as a repair method for shear inclined cracks of beams, but only under static loading. On Fig. 9 is shown a R.C. beam failed under shear. Repair has been effectuated by means of external hoops, lightly prestressed, subsequently covered by shotcrete (Fig. 10). The effectiveness of this simple method proved to be quite satisfactory: Both bending stiffness and ductility are not affected and the new cracks were due mainly to bending, in contrast to the initial beam. Besides, crack widths were smaller after repair for the same load. It has to be noted, however, that steel strain of the external hoops was rather low (of the order of 0,5 to 1,0%, just before collapse load of the beam).
