## LESSONS FROM STRUCTURAL DAMAGES OBSERVED IN RECENT EARTHQUAKES

Vitelmo V. Bertero<sup>I</sup>, Stephen A. Mahin<sup>II</sup>, and James A. Axley<sup>III</sup>

### SUMMARY

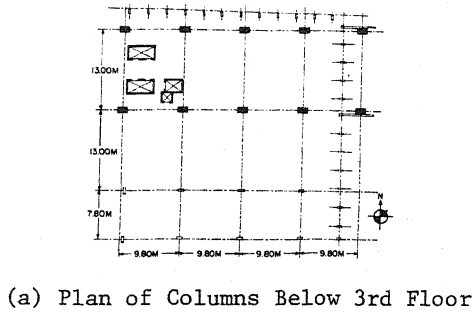
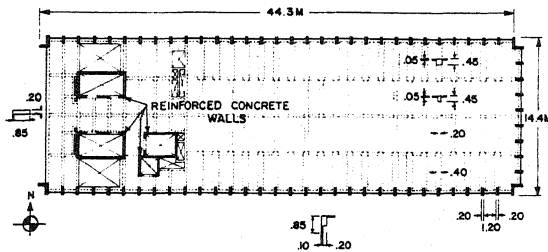
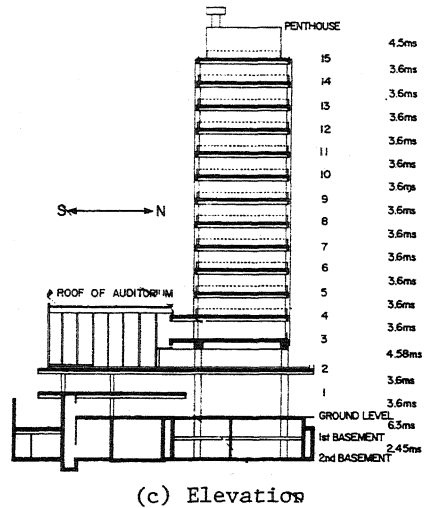
FIG. 2. PLANS AND ELEVATION OF BANCO CENTRAL

Banco Central [11]. The configuration and structural system used for the Banco Central were complex (Fig. 2). In the upper portions of the tower, the floor system consisted of a 0.05 m slab supported by 14 m-long joints having a total depth of only 0.45 m. Closely spaced columns located along the north, east and south sides of the tower were replaced by ten 1 x 1.55 m columns below the third floor. In the bottom two stories, waffle slabs were used to extend the plan of the building considerably to the south. Four elevator shafts, enclosed by reinforced

The perimeter columns between the fourth and fifteenth story suffered extensive cracking. The walls around the elevator shafts suffered cracking and spalling of the concrete and buckling of the reinforcement in the fourth and fifth stories. Transverse cracks, sometimes wider than 10 mm, were observed

across all slabs above the third floor just to the east of the elevator shafts. Hollow clay tile infilled walls (located on the west face of the tower, beneath the windows on the other faces of the tower and around the stairwells) and other nonstructural elements suffered substantial damage.

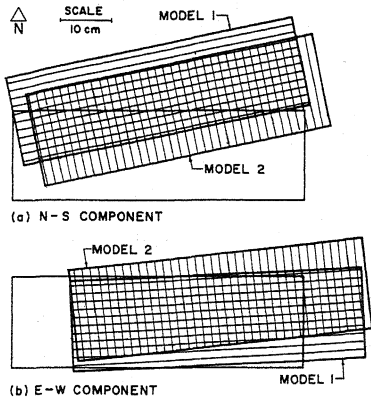
FIG. 3. ROOF DISPLACEMENT OF BANCO CENTRAL FOR ESSO REFINERY RECORDS

the following observations can be made: (1) the substantial change in structural configuration as well as the eccentric location of the elevator shaft walls resulted in substantial torsional response (Fig. 3); (2) the tile partitions lowered the fundamental period about 20% and significantly modified the response (Fig. 3); however, computed elastic forces in these members far exceeded their capacities and they would begin to fail very early in the response; (3) the shear capacity of most columns along the north and south sides of the tower above the third floor would be exceeded assuming peak EW ground accelerations only 40% of those recorded at the Esso refinery; (4) due to the relative stiffnesses of the remaining uncracked members, any additional inertial forces developed in the eastern portion of the tower were transferred primarily back

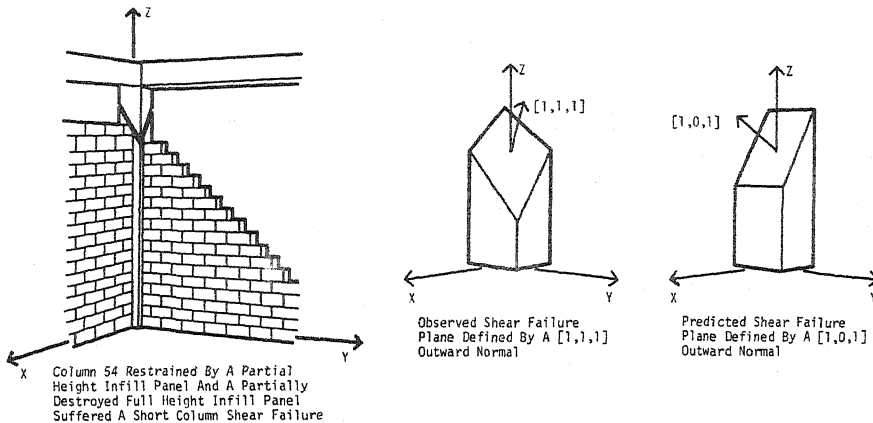
FIG. 8. DETAIL OF THE SHEAR FAILURE OF THE CAPTIVE COLUMN 54

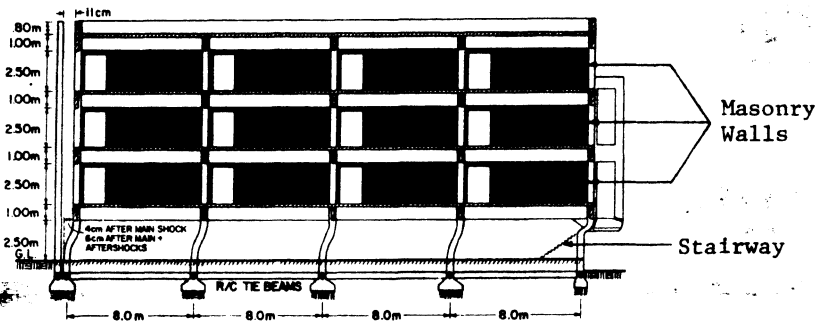
FIG. 9. LONGITUDINAL ELEVATION OF THE ENET NO. 2 BUILDING ILLUSTRATING PERMANENT DISPLACEMENT AFTER EARTHQUAKE

with the structure. A good illustration of this poor performance was that of the Escuela (School) ENET No. 2. This building consisted of a four-story R/C moment-resisting space frame. The first story was left completely open in the longitudinal direction, while the frames in the upper three stories were infilled with masonry walls to provide several classrooms (Fig. 9). These decisions and resulting construction led to a soft first-story building type response to the earthquake. The first-story columns underwent significant inelastic deformations resulting in a permanent horizontal displacement of 40 mm after the main shock and increasing to 60 mm due to aftershocks. Three-dimensional linear elastic analyses were performed assuming different models (neglecting and including nonstructural elements) and using the earthquake ground motion recorded 2 km from the building. Nonlinear dynamic analyses were also conducted. The above analyses lead to the following observations: (1) the linear elastic analyses show the significant effect of the masonry walls located in the upper stories, which not only increased the overall stiffness of the building but, more importantly, significantly changed the modes of vibration, practically converting it to a soft first-story building; (2) the columns of the first story exceeded their "elastic" range; (3) the nonlinear analysis predicted a permanent deformation of 38 mm which is very close to the measured 40 mm; and (4) the columns as designed and constructed were just capable of developing the ductility required which was about 2.5.
