DAMAGE TO LIFELINE SYSTEMS AND OTHER URBAN VITAL FACILITIES
FROM THE TANGSHAN, CHINA EARTHQUAKE OF JULY 28, 1976

Ye Yaoxian^I

SUMMARY

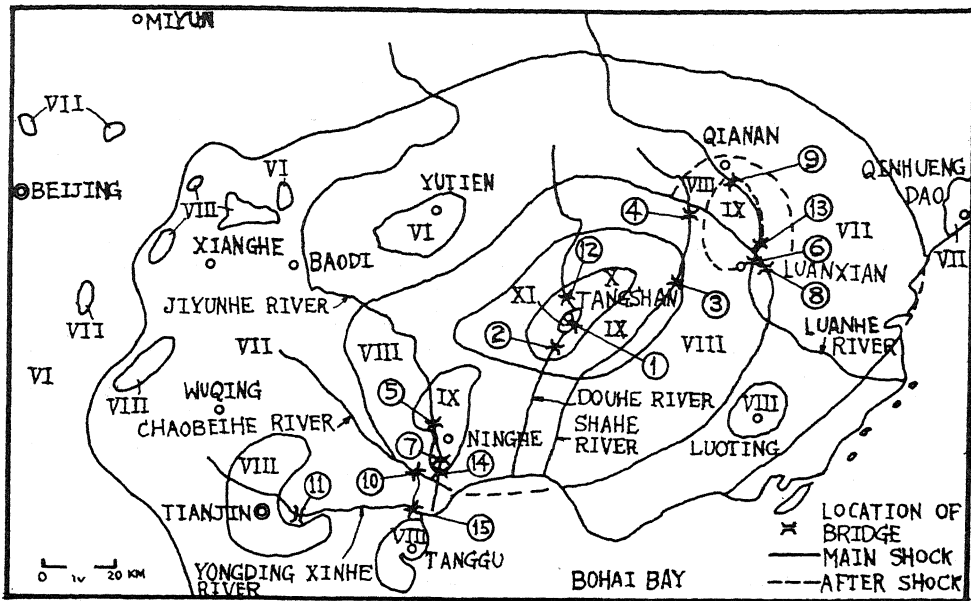
Fig.1 Isoseismals of Tangshan Earthquake and Locations of Bridge

The severe damages were found in highway and railway bridges, which led to the periodical traffic interruption. It has been restored on August 10. The damage percentages in total length of bridges attained to 62 in Tangshan and 21 in Tianjin respectively. A total of 30 highway bridges were severely damaged or collapsed. 40% of railway bridges were damaged. A list of bridges severely damaged in Tangshan and Tianjin is shown in the Table 3. The locations of each bridge are shown in Fig. 1.

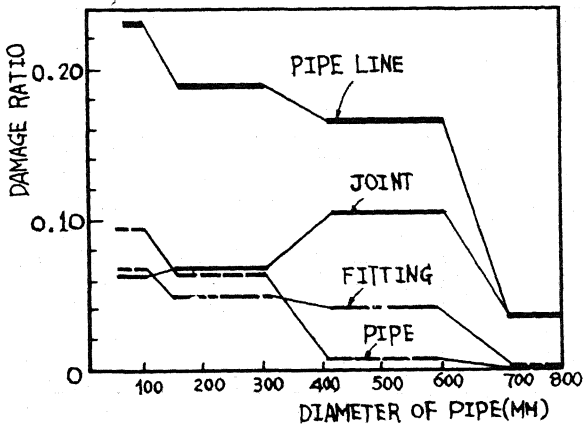
Fig.2 Relation between Damage Ratio and Diameter of Cast Iron Water Supply Pipes in Tianjin Urban Area

The summaries of damages to water supply distribution cast iron pipes with diameters equal to or greater than 75 mm in Tangshan, Tianjin urban area and Tanggu district are shown in Table 2. Fig. 2 shows the relation between the damage ratio of the distribution pipes and their diameters in Tianjin urban area. The damage ratio is defined as the number of failures per unit length (km) of water pipes. The characteristic of the damages may be summarized as follows:

The damage ratio of pipes is decreased with the increase in diameters. There are three kinds of failure for pipeline, i.e. the damage of joints, the break of pipe and the failure of its fittings, such as bends, T and cross sleeves and valves. For the pipes with diameter of 75-300 mm, there is minor difference between the damage ratio of each kinds of failure. While for the pipes with larger diameter, the joint has the highest damage ratio, but the breaks of pipes are few.

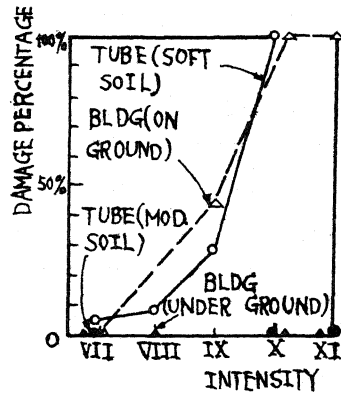
Fig.3 Relation between Damage Percentage & Intensity of Water Well Location in Tangshan and Tianjin

Fig. 3 shows the relation between damage ratio and intensity of the well locations. These indicated that: The damages of well tube mainly depend on its surrounding soil condition, and the damages of well buildings mainly depend on the intensity and the type of structures.
