# DAMAGE TO BURIED UTILITY PIPES IN THE 1978 MIYAGIKEN-OKI EARTHQUAKE

Keizaburo Kubo<sup>I</sup> and Ryoji Isoyama<sup>II</sup>

## SUMMARY

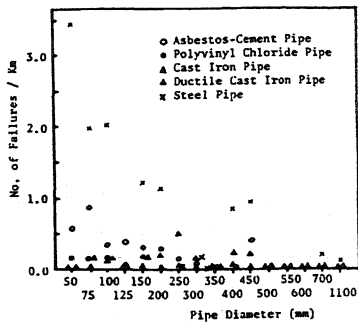
Fig. 3 Failure Ratio per km of Water Supply Pipe and Diameter ( 29 Utilities in Miyagi Prefecture ).

Since the most part of the Miyagi Prefecture experienced the JMA V intensity, 64 out of 74 cities and towns suffered damage to their water supply systems. The sizes of these systems varied from about 200 to about 600,000 (Sendai) in population. Table 4 summarizes the total numbers of failures in water supply pipes and the failure ratios for different pipe materials in 29 water utilities in the Miyagi Prefecture. Figure 3 correlates the failure ratio with the pipe diameter. It is observed that the failure ratio of asbestos-cement pipe decreases with the increase of pipe diameter, while it is almost constant for cast-iron and ductile cast-iron pipe. Note that the types of joints for steel pipelines are different according to pipe diameters. Therefore, the mode of failure as well as the vulnerability to seismic effect should be distinguished according to the type of joint.

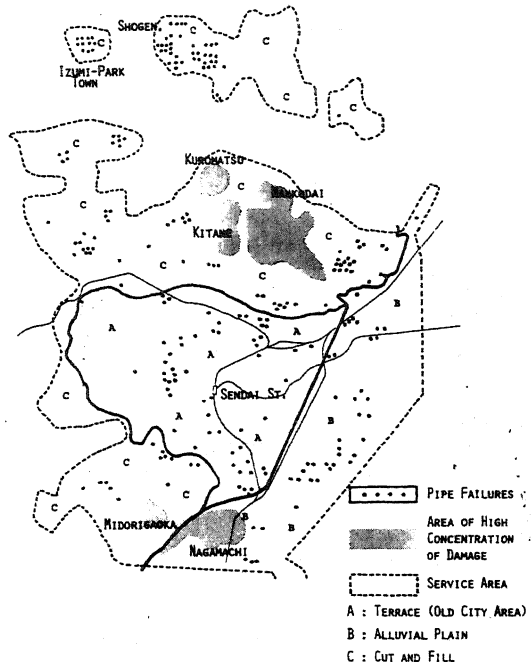
Fig. 2 Distribution of Gas Pipe Failures in the Sendai Area.

The minor distribution pipes were, however, extensively damaged and it took almost three weeks before the accumulated percentage restored became 90 % of the total number of customers. During its restoration process, a total of some 550 failures were identified and their pertinent data recorded. The distribution of damage to low-pressure pipes in Sendai area is shown in Fig. 2. The ground conditions were roughly classified into the three groups A, B and C as shown in Fig. 2 and Table 1.

Most of the damage was again restricted to minor distribution pipings, and the distribution of pipe failures in Sendai was very similar to that of city gas pipes (Fig. 2). For the total of 401 failures which occurred in the distribution mains and branches having diameters equal to or greater

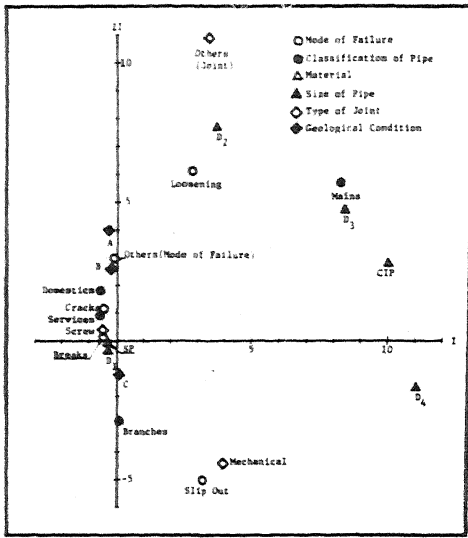
Fig. 4 Scattergram of Categories for Gas Pipe.

The damage to low-pressure gas pipes and water distribution mains was analyzed by the Quantification Theory III based on the data shown in Tables 1 and 5. Figure 4 shows the scattergram of categories for gas pipe with respect to the transformed principal axes I and II. Axis I may be considered to represent a certain quantity which reflects the combined effect of the kind of pipe and its strength property, but the meaning of axis II is not clear. The points which are close each other in Fig. 4 form a group of categories closely related among them. According to this, two primary groups seem to exist in Fig. 4. One includes Breaks, Cracks, Screw, SP (Steel Pipe), D<sub>1</sub>, Services, Branches, etc., and another includes Mains, CIP (Cast-Iron Pipe), D<sub>3</sub> and D<sub>4</sub>. These two groups seem to roughly correspond to the steel<sup>3</sup> pipe group and the cast-iron pipe group. Not so clear as these, there is an additional group with respect to axis I consisting of Mechanical, Slip Out, Loosening, D<sub>2</sub>, and Others. Although loosening and slip-out are modes of failure commonly encountered in mechanical and screw joints, this third group is located between the primary two groups because a substantial number of failures of mechanical joints were associated with steel pipes (Table 1).

From the foregoing discussions and the examination of the failure ratio matrix, the damage to low-pressure gas pipes in Sendai may be summarized as follows.

- (a) Damage were severe on the small diameter screw jointed steel pipe which were used as branches, services and domestics, and their

predominant mode of failure were mostly breaks and cracks.

(b) The second mode of failure was the loosening and slip out of mechanical jointed cast-iron and ductile cast-iron pipes, however, these modes were small as shown in Table 2.

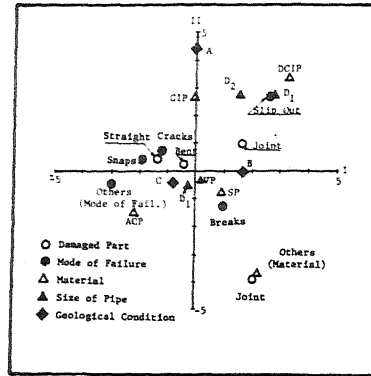
Fig. 5 Scattergram of Categories for Water Distribution Mains.

The Quantification Theory III was also applied to the damage to water distribution mains. The results are shown in Fig. 5. Two groups are also recognized, although the separation is not clear as compared with the case of gas pipes. One is the group associated with cast-iron pipe, corresponding to (a) for gas pipes, and another corresponds to (b). It is noted that the category of asbestos-cement pipe is located at a position which neither corresponds to (a) or (b).

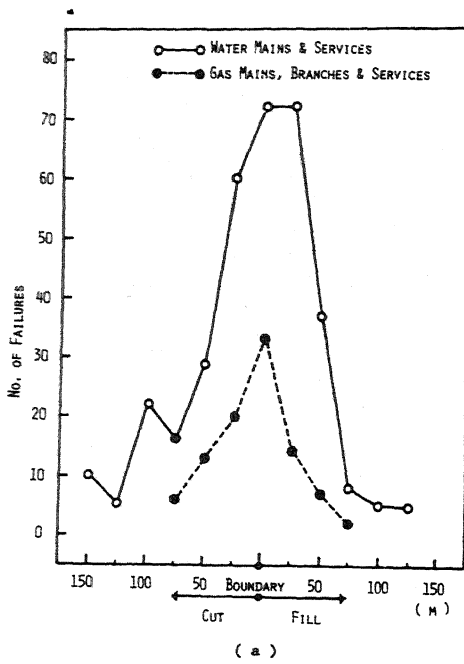
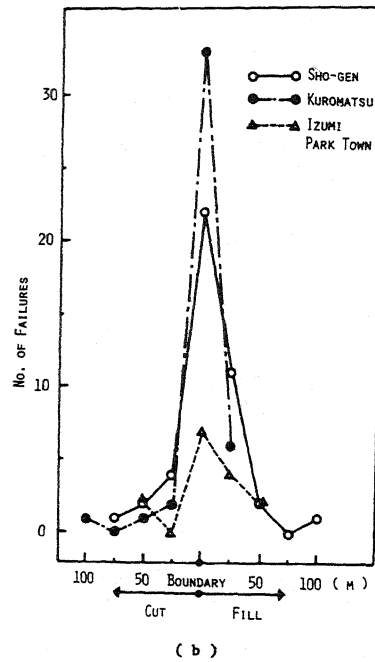
Fig. 6 Number of Failures and Distance from Cut and Fill Boundary.

One of the most important points of argument in the 1978 Miyagiken-oki earthquake has been the various damage in the newly developed residential area (Type C ground), where large scale cut and fill has extensively altered the original ground profile. A large number of pipe failures were found to have occurred near the cut and fill boundary in these districts. Because of inherent instability of artificial slopes, insufficient densification of fills, and abrupt change in subsoil properties between cut and fill, strong seismic shaking easily produced fissures, local settlement, slippage, and relative displacement over short horizontal distance.

Figure 6 correlates the number of failures of gas and water distribution pipes with the distance from the cut and fill boundary to the location of pipe failure in several newly developed residential areas. Very high correlation is found to exist between damage and distance from cut and fill boundary.
