RESTORATION OF LIFELINES IN SENDAI AFTER THE DAMAGE
CAUSED BY THE 1978 MIYAGI-KEN-OKI EARTHQUAKE

SUMMARY

The northern part of Honshu, Japan, was shaken by a strong earthquake of magnitude 7.4 at 17:14 (JST) on June 12, 1978. In the middle of the hardest-hit area was the city of Sendai with a population of 617,000. This paper briefly describes the restorations of some of the lifeline systems, mainly in Sendai, that followed the damage inflicted by the 1978 Miyagi-ken-oki earthquake.

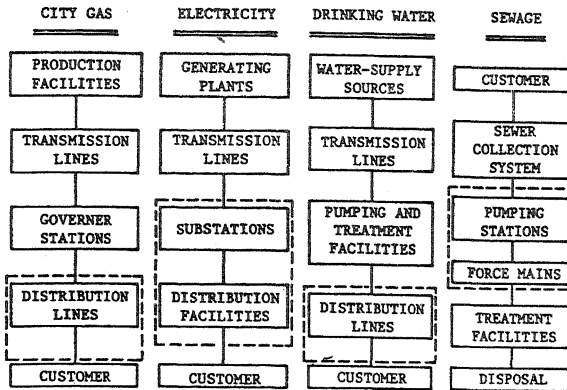
Fig.1. Schematic Flows of Utility Systems Investigated.

Figure 1 schematically shows the flows in these four systems. The portions enclosed by dotted lines indicate those most responsible for the disruptions of the systems. It is seen from Fig.1 that buried distribution pipelines in water supply and city gas systems, substations and distribution facilities in electric power system, and pumping stations and main sewers in sewerage system were accounted for the disruptions of service in this particular earthquake.

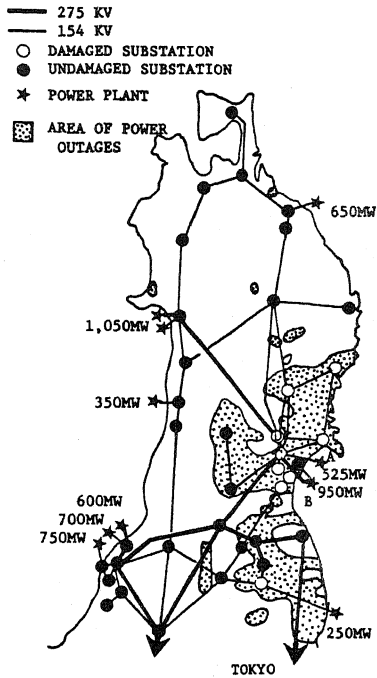
Fig.2. Transmission Network and Affected Area in the Tohoku Electric Power Company's Service Area.

part of Honshu as shown in Fig.2. An estimated 681,600 customer power services were affected by the power outages caused by seismic damage to power system facilities and by the operation of relays triggered by the earthquake. Figure 2 also shows the distribution of the areas where power outages occurred. Generating facilities generally sustained only minor damage, although two steam power plants (525 MW and 950 MW; shown as A and B in Fig.2) serving most of the customer load in the Sendai area sustained some equipment damage, which caused shortage of power supply and necessitated curtailment of customer load for several days. There was no major failure of overhead and underground transmission lines.

The primary cause for the extensive power outages in the Sendai area was severe damage to electrical equipment at two of the key bulk power substations (C and D in Fig.2) which disrupted the company's artery 275-kv transmission line. Damage was most severe at the 275-kv Sendai Substation (C in Fig.2), where three transformers including two primary 275-kv transformers, twelve circuit breakers, three disconnecting switches, thirteen porcelain-clad current transformer, three capacitance potential devices and eight lightning arresters suffered damage. Most of the equipment damage was associated with failures of porcelain components and damage due to inadequate anchorage was small.

Early restoration by 275-kv lines was judged impossible because of the damage to the Sendai Substation, and emergency service was recovered by connecting intact lower voltage (154 and 66-kv) lines. As shown in Fig.3, service was restored to about 90 percent of the customer within the same day of the earthquake occurrence, and all distribution substations in the Sendai area received power supply during the early hours of June 13. However, power outages to about 80,000 customers remained on the following morning mostly in the city of Sendai and several surrounding cities. Emergency restoration was completed within about 38 hours after the occurrence of the earthquake.

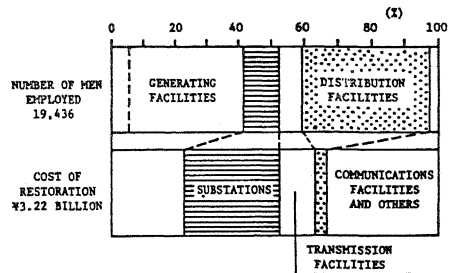
Fig.4. Breakdowns of Men Employed in and Cost of Restoration of Electric Power System.

As shown in Fig.4, it has been reported that in all restoration required some 19,400 man·day and ¥3.22 billion. It is interesting to note from Fig.4 that there are basically two types of seismic damage involved in the power supply system. In the case of the damage to substations, for example, the cost of restoration was high but the work required a relatively small amount of man power. On the contrary, the damage inflicted on distribution facilities such as poles and pole-clad transformers did not cost much in terms of money but their restorations required a large amount of man power.

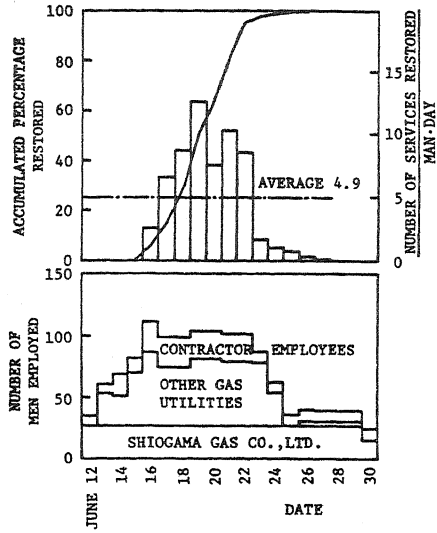
Fig.7. Progress of Restoration of City Gas in Shioyama.

Generally speaking, however, the progress of restoration seems to differ according to the size of the utility. Figure 7 shows the summary of restoration in the service area of the Shiogama Gas Company with a number of customers of approximately 6,000. Although the pipeline damage in Shiogama was heavier than that in Sendai, the restoration curve in Fig.7 is much smoother than that of Sendai. This seems to indicate that, the larger

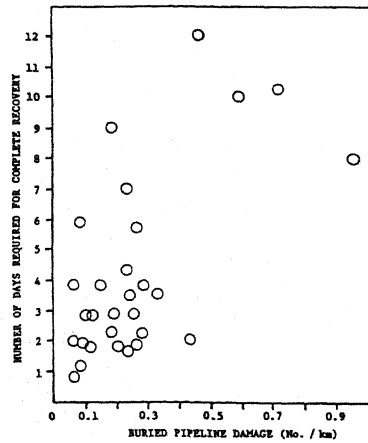
Fig.8. Number of Days Required for Complete Recovery of Water System and Extent of Damage to Buried Pipelines.

Table 1 summarizes the emergency water supply operations in four of the larger water utilities in the affected area. Figure 8 shows the relation between the number of days required before the complete recovery of the system and the extent of damage to buried distribution pipes for the 29 water utilities. The wide scatter of the data points in Fig.8 seems to indicate that the extent of pipeline damage is not the single decisive factor for the disruption of water service after an earthquake. In the case of Ishinomaki, for example, the power outage at the city's only water-supply source was responsible for the 20-hour complete suspension of supply. In Shiogama, complete suspension of water supply continued for some 61 hours because the city's major 20-km transmission line was damaged at five locations.
