VIBRATION TESTING OF AN EPOXY-REPAIRED
FULL-SCALE REINFORCED CONCRETE STRUCTURE

G. Norman Owen (I)
Roger E. Scholl (II)
Ike O. Egbuonye (III)

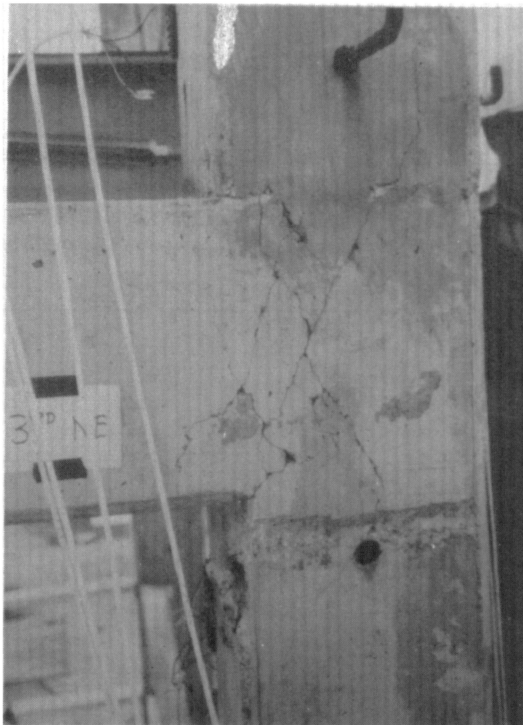
The cracking at the beam-column connections appeared to be much less severe in the 1979 destructive test than in the 1974 test. Figure 3 shows damage from the 1974 test at the northeast corner of the third floor, and Figure 4 shows damage from the 1979 test at the same location. The less severe cracking in the epoxy-repaired structure may be the result of a better bond between the reinforcing bars and the concrete in the repaired structure than the bond that existed in the original structure.

FIGURE 3 DAMAGE FROM 1974 TEST AT
NORTHEAST CORNER OF THIRD
FLOOR OF ORIGINAL STRUCTURE

In 1975, the damaged structure was repaired by the epoxy-injection technique. The repaired structure provided an excellent specimen for determining the effectiveness of epoxy-injection techniques in recovering the original physical and engineering properties of structures. In 1979, the epoxy-repaired structure was again deliberately forced into the range of inelastic response.

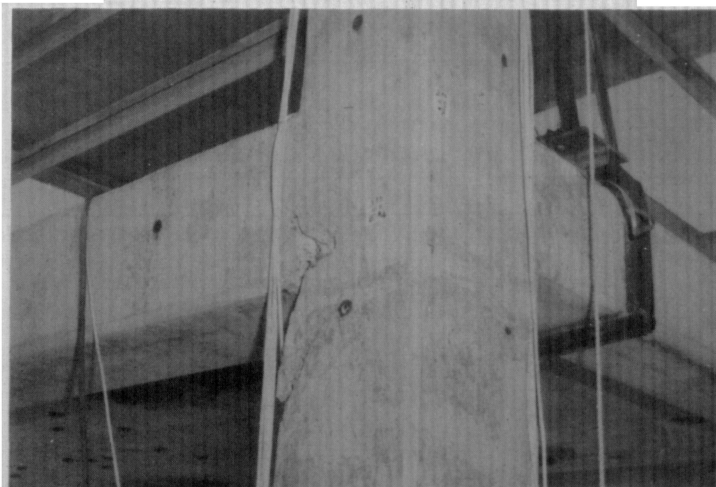
FIGURE 4 DAMAGE FROM 1979 TEST AT NORTHEAST CORNER OF
THIRD FLOOR OF EPOXY-REPAIRED STRUCTURE
