EARTHQUAKE STABILITY OF  
INTERIOR NON-BEARING HOLLOW CLAY TILE PARTITIONS

Stanley H. Mendes (I)  
Presenting Author: Stanley H. Mendes

This paper presents findings of an earthquake strengthening study for an older building. This three story reinforced concrete frame building, constructed in Santa Barbara, California, in 1924, was damaged from nearby earthquakes in 1925, 1940, 1952, and 1978. As part of the study, in-place tests to destruction were performed on panels of plastered hollow clay tile partitions with static loads of 0.82G maximum applied normal to wall surface. Studies indicate that with conventional construction, these partitions have substantial inherent earthquake resistance, deflecting 4" to 5" at collapse, and they may not require strengthening if story drift is properly controlled.

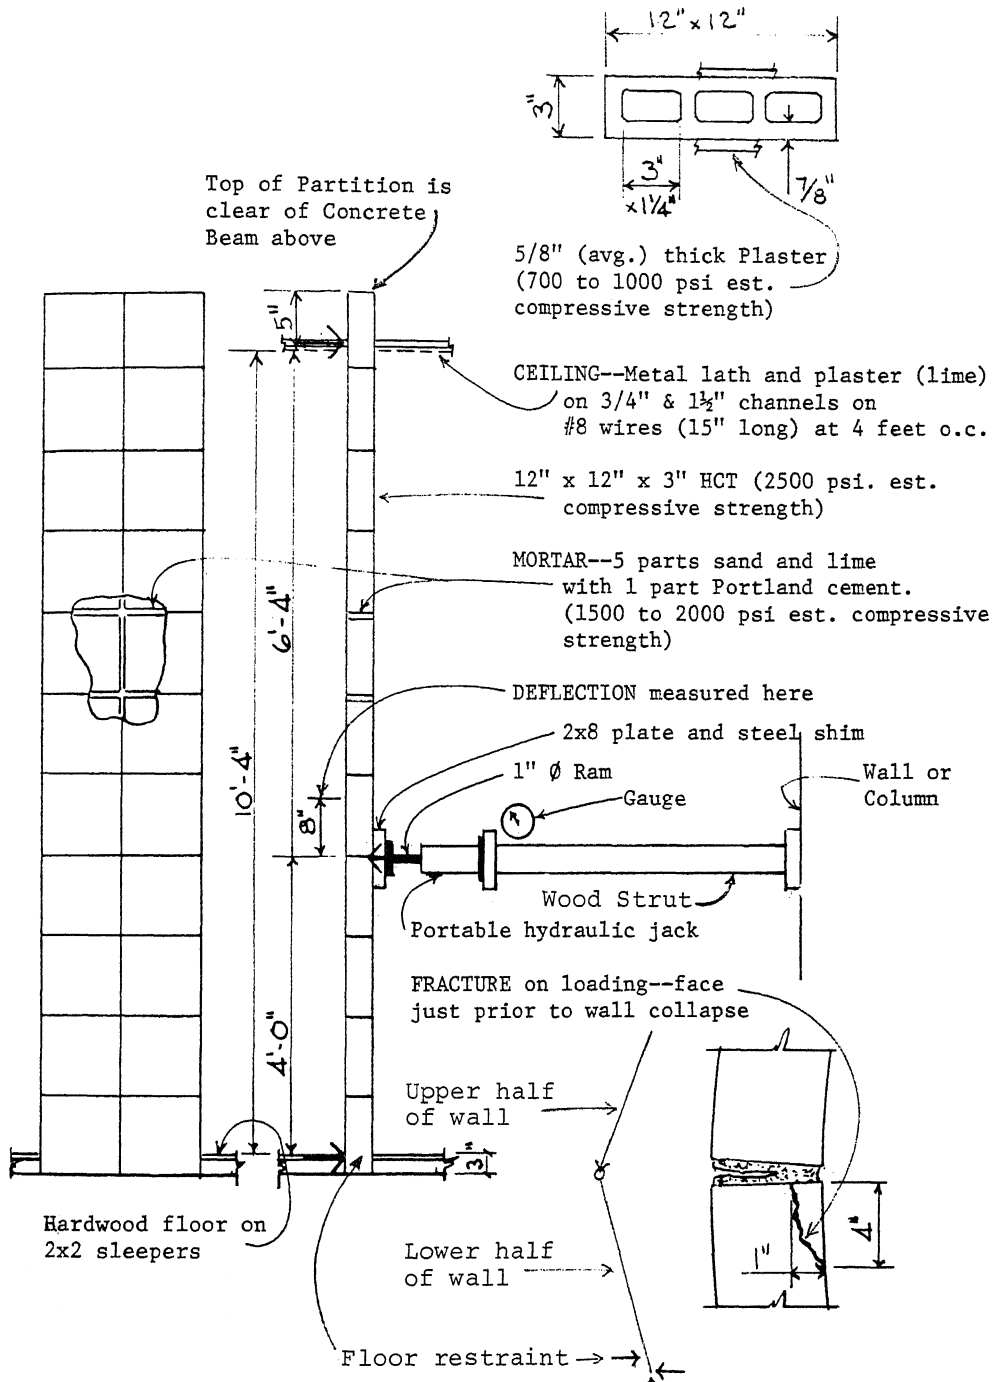
FIGURE 2 Condition at Wall Failure

No movement or crushing of ceiling plaster was observed. No movements or crushing of wood floor was observed. Just prior to failure, a vertical trending crack occurred on the loaded (compression) face of the tile as large deflections produced a rocking-like condition at the horizontal mortar joint. (See Figure 2.)

The restraint provided by the finished wood floor system was unanticipated, but welcome, because it permitted very large wall deflections before final collapse. At collapse, the wall was completely broken through at the mortar joint at point of load. It had separated into two pieces. The upper one-half of the wall "leaned" against the sides of the metal lath and plaster and could not fall out vertically until the lower half moved out from under it.

The lower half of the wall has moment restraint provided at the bottom by its "embedment" below the hardwood floor and cannot fall until it works its way out of the hole through the wood floor. The simple force diagram on Figure 2 depicts this condition.

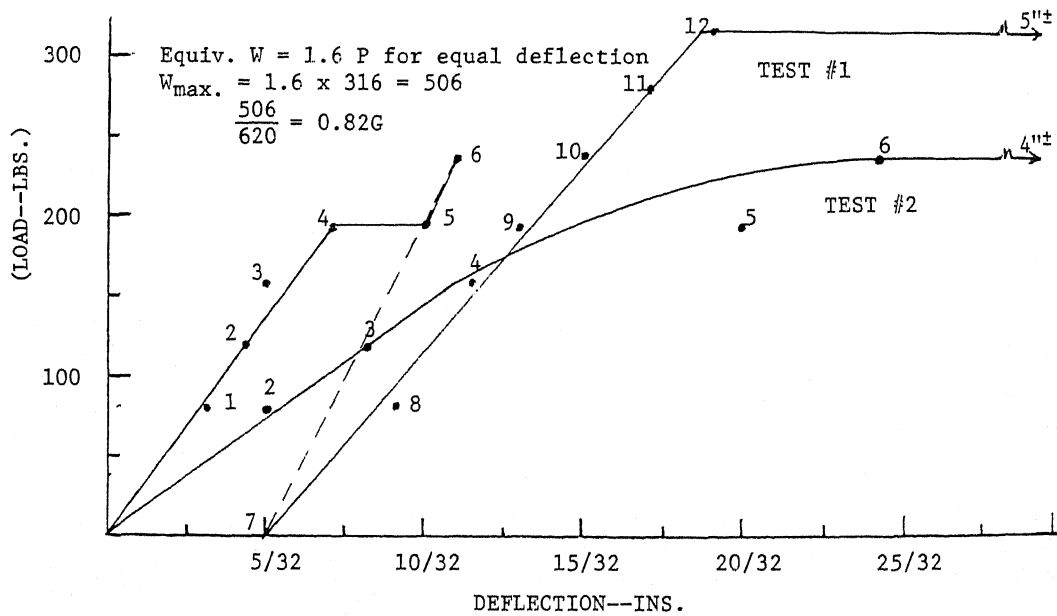
FIGURE 3

Test panel #1 with plaster each face was loaded by increments to 237 pounds. (See Figure 3.) When this load was released, a 1/8" permanent deflection was noted. Loads were then reapplied. The ultimate failure load of 316 pounds was applied for about 20 seconds as slow yielding occurred and the wall finally collapsed.

Test #1 diagram shows deflection proportional to load up to yielding at 19/32" [5/8"(-)] with a load of 316 pounds. The reason for the temporary yielding at load increments 4 and 5 is not clear.

Test #2 diagram shows larger deflections for a given load that are not directly proportional to load. Wall started final yielding @ 3/4" with a load of 237 pounds.

This difference in performance may be explained by the differences in test panels. Plaster was removed from the loading (compression) face for Test #2. This unsymmetrical cross section has a smaller moment of inertia, thus larger deflections would be anticipated. The shape of the load deflection diagram suggests that some relatively non-uniform yielding began at load increment #3 (119 pounds).
