SIMULATION ANALYSIS ON HIGH-RISE BUILDING BEHAVIOR BY THE USE OF STRONG EARTHQUAKE MOTIONS ACTUALLY OBSERVED

Y. Saito (I)
N. Uchida (II)
T. Aoyagi (III)
M. Kawamura (IV)
Presenting Author: Y. Saito

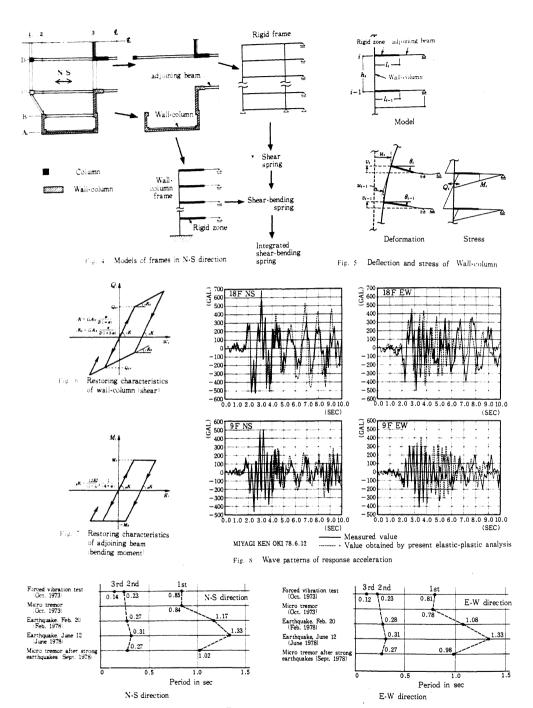
Fig. 9 Transition of natural period

The primary and secondary natural periods as obtained from the peak values of the power spectra recorded by measurement are shown in Fig. 9. In this figure, the values obtained by other forced vibration tests as well as the values obtained from the Fourier spectra found in the measurement record for the 18th story of the building during the earthquakes on February 20 and June 12 (both in 1978) are also indicated.

From these table and figure, it is found that the natural period during the February 20th earthquake was 30 % longer than that under micro tremors at the time of completion of the building. The natural period became still longer during the strong earthquake motion on June 12th which caused partial plasticization of the building structure.

After the building underwent the two strong earthquakes, its natural period was lengthened by 20 % compared with the pre-earthquake natural period.

To compare the measured values with those obtained by analysis, the values obtained from the elastic rigidity and the measured values recorded during the February 20th earthquake in which the structure is believed to have behaved within the elastic limit are indicated. These two kinds of values are in good coincidence with respect to the primary natural period.
