LOW INTENSITY EARTHQUAKES ON MULTI-STOREY R.C. BUILDINGS:  
RECORDS, IDENTIFICATION AND MODELLING

T. Sanò (I)  
E. Vitiello (II)  
Presenting Author: E. Vitiello

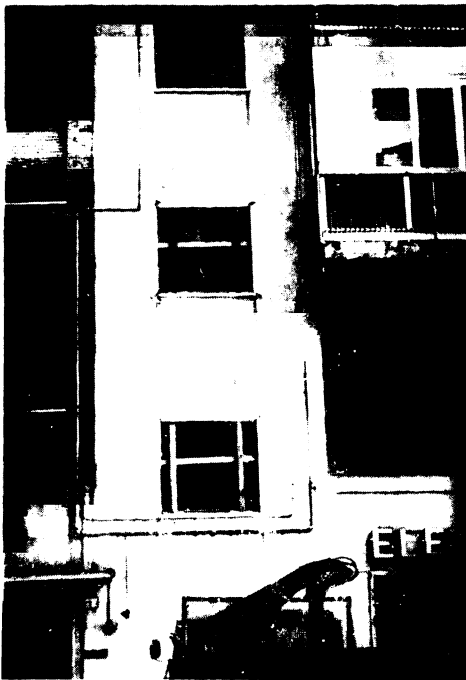
FIG. 2

The damage produced by the main shock consists of cracks in the walls, (see fig. 2), localized damage to the stair girders (see fig. 3) and small cracks in the columns at the first storey.

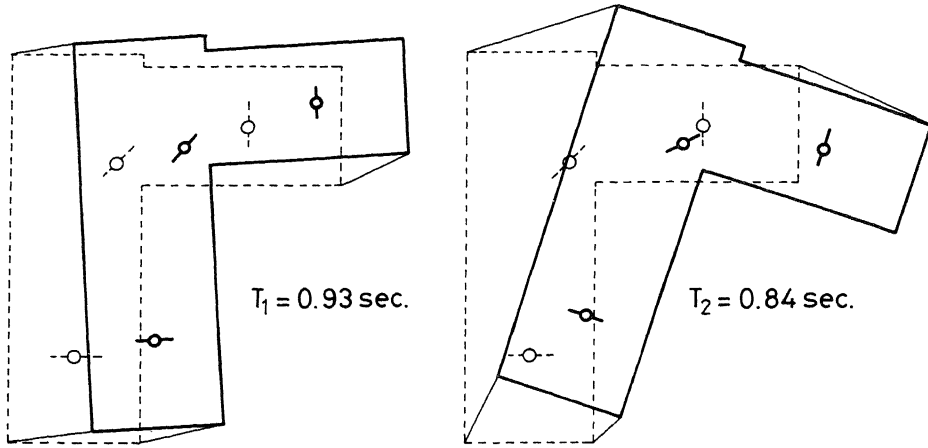
FIG. 9- MODAL SHAPES (EXPERIMENTAL)

On the basis of an examination of all the channels together and their phases at the peaks of fig. 8, an evaluation of the displacement of the roof in the first two modes is obtained, see fig. 9. Torsional effects, as expected in this kind of L-shaped building, are very evident. It is also clear that the building is less stiff in one direction (5 bay frames). This fact explains the damage in pictures 2 and 3 (see also plan 4) while the corresponding orthogonal elements (stair girders and walls) suffered no damage.
