EXPERIMENTAL AND ANALYTICAL STUDIES OF THE IMPERIAL COUNTY SERVICES BUILDING

G. C. Pardoen

R. Shepherd

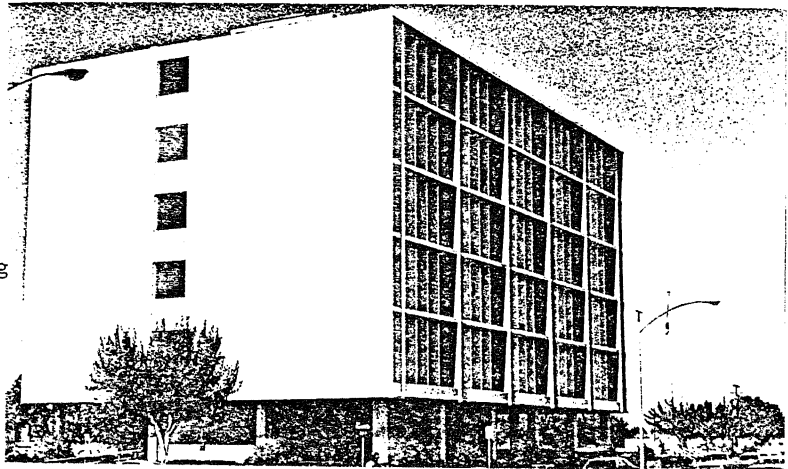
Figure 1
Imperial County
Services Building

The building was of reinforced concrete, six stories high and five bays long by three bays wide on a 25 ft. grid. See Figure 2. Each of the east and west ends consisted of an exterior shear wall extending from the second to the sixth level, leaving open ends in the first story. The end shear walls were outside the line of the exterior lower floor columns. Additionally a non-symmetrical layout of transverse shear walls existed in the central bay of the lower floor columns. These columns failed in varying degrees of severity, the ones on the eastern outer line shattering and shortening sufficiently to necessitate the subsequent demolition of the entire building.

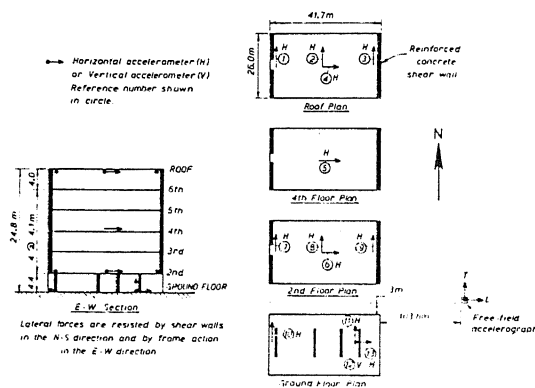
Figure 2
Strong Motion
Instrumentation

The FBA accelerometer location (Figure 2) was selected in order to provide information on overall building response as well as ground input motion. The primary purpose of the three north-south oriented accelerometers at the roof and second floor levels (accelerometers 1,2,3,7,8 and 9) was to obtain and isolate north-south translational, torsional, and in-plane floor bending response. In conjunction with the north-south oriented accelerometers at ground level (accelerometers 10 and 11), these accelerometers provided translational and torsional response, mode shape, and ground to second floor inter-story motion information. Similarly, the accelerometers at the ground floor, second floor, fourth floor, and roof levels in the more flexible east-west (frame) direction (accelerometers 4,5,6 and 13) provided east-west translational response, mode shape, and inter-story motion information. The two N-S oriented accelerometers at ground level (accelerometers 10 and 11) were intended to identify collectively the extent to which differential horizontal ground motion had occurred, and the vertical accelerometer at ground level (accelerometer 12) provided information on vertical motion at this location. There were no vertically oriented accelerometers above ground level.

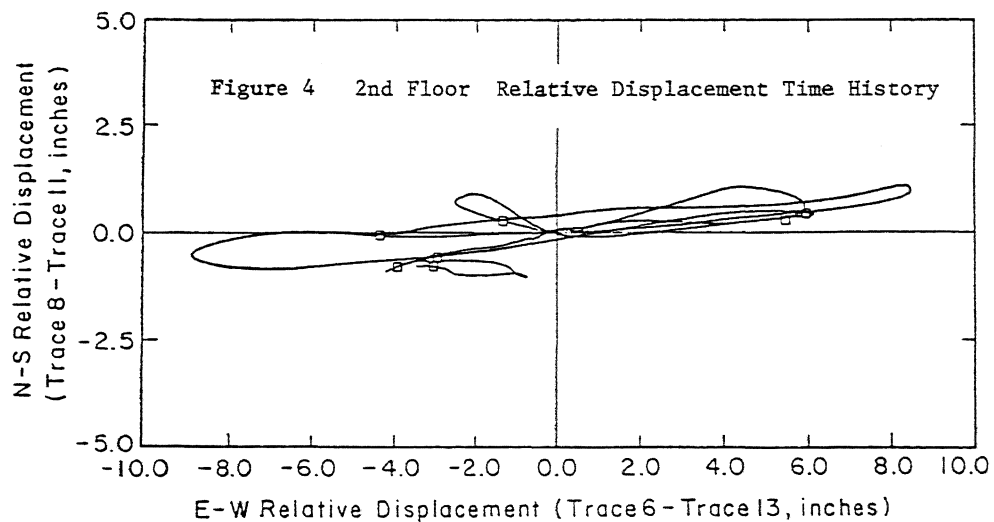
By analyzing the appropriate traces of the strong motion records, one can obtain an approximate horizontal plane movement time history such as is depicted in Figure 4. This figure represents the second floor to ground relative displacement time history during the 6-12 second duration of the earthquake. The time history curve in Figure 4 was obtained by plotting the E-W motion (the difference of traces 6 and 13) and the N-S motion (the difference of traces 8 and 11) at each time interval of the digitized earthquake response records [4]. These figures are of particular interest when one considers the relative motion of the ground level to second floor and its effect on column failure.

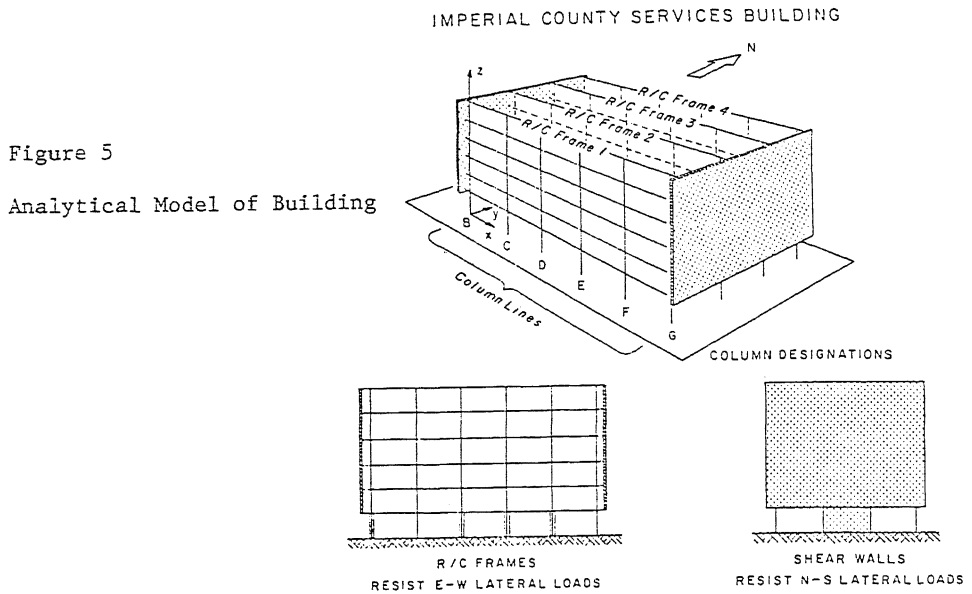
The elastic analyses' results provided a general insight into the building's macroscopic response due to the various load conditions as well as denoting those structural components which can be expected to experience inelastic behavior due to severe seismic loading. In general the internal force resultants of the beams, columns, and shear walls are of primary interest with the deformation quantities being of secondary interest. No attempt was made to tabularize the force resultants for all structural members arising from all load conditions, but attention was devoted to the significantly loaded members and, in view of the catastrophic failure of the 4 columns along column line G (see Figure 5), particularly to the ground level columns.

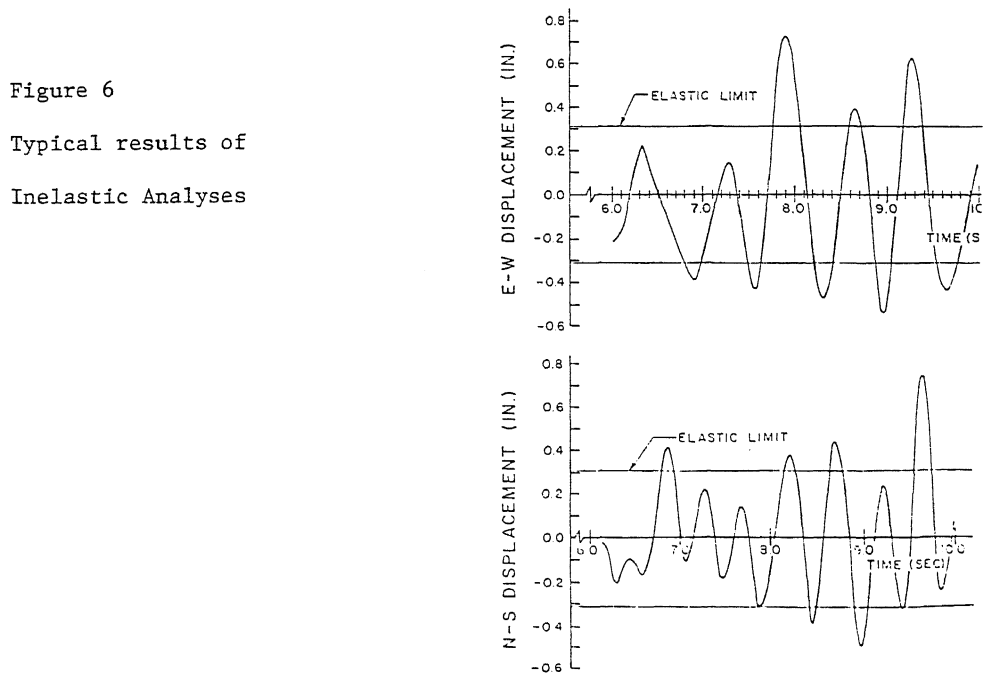
The corner column model exhibited yielding, associated with tensile load, at 6.8 sec. Neither transverse nor longitudinal frame action appeared to be responsible exclusively for the yielding. The maximum displacement ductility demands were found to be of the order of 2.4 as is shown in Figure 6.
