EVALUATION OF THE RESPONSE OF THE IMPERIAL COUNTY SERVICES BUILDING

M. E. Kreger (I)
Presenting Author: M. E. Kreger

This paper describes the Imperial County Services Building in El Centro, California, and the damage sustained by the structural system during the 15 October 1979 Imperial Valley earthquake. Recorded acceleration response of the structure and calculated base-shear and moment responses are presented and interpreted. The procedure used for determining how and when columns failed at ground level is described.

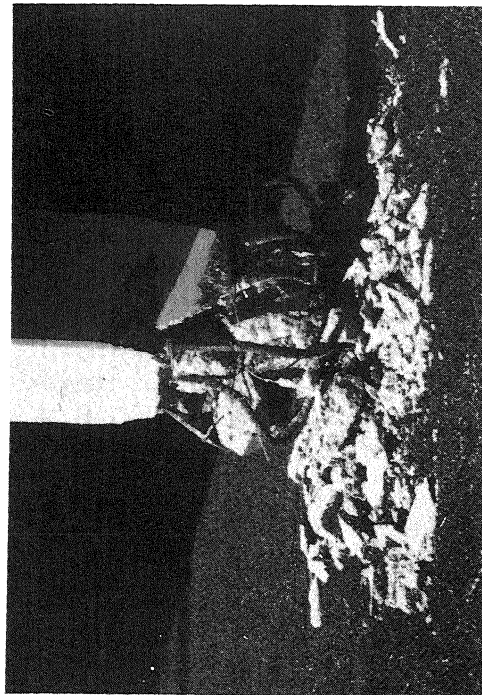
The Imperial County Services Building of El Centro, California (Fig. 1) was severely damaged during the 15 October 1979 Imperial Valley earthquake. The most significant damage sustained by the structure during the earthquake was the material failure of four east-end columns at ground level (Fig. 2). The event was unique because response of the structure as columns failed (during the earthquake) was recorded by a network of 13 strong-motion accelerographs.

Relative potential of selected pairs of forces to cause failure was evaluated by (1) the combined loading index, and (2) the horizontal position of each force pair in relation to an interaction diagram plot (Fig. 8). The set of forces which demonstrated the greatest potential for the crushing type of failure observed in the structure corresponded with a time of approximately 10.1 sec. (point 15 in Fig. 8). Failure of one corner column was concluded to have occurred at that time. Correspondence of the N-S base-moment response and response of the 1.55 Hz linear oscillator indicated that failure of another corner column was not likely to have occurred after 10.1 sec. (Fig. 6). Failure of the other corner column was then concluded to have occurred at 9.6 sec. because column forces at that time demonstrated the next highest potential for failure and the forces occurred within the same cycle of strong N-S building response.

Fig. 2 Photograph of damaged east end column

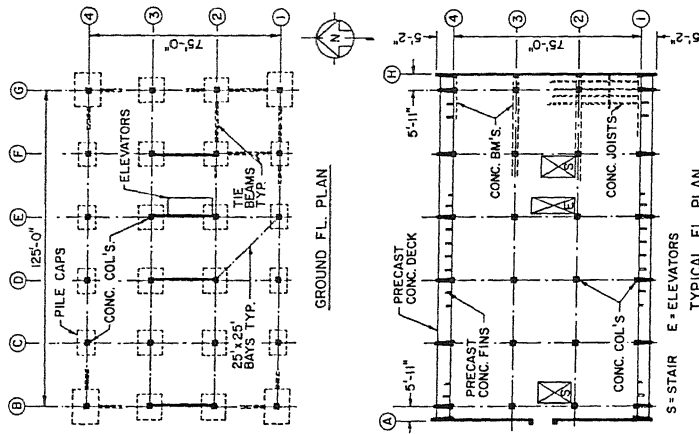
The complex of walls used to resist lateral forces in the transverse (N-S) direction comprised four first story walls located in interior bays along lines B, D, E and F (Fig. 3) and two walls rising above the first story at the east and west ends of the structure (lines A and H). Figure 3 indicates that east and west end walls were located 30 ft 11 in. (9.42 m) and 5 ft 11 in. (1.80 m) from the nearest first story walls. The resulting wall configuration contained a discontinuity at the first level in the form of a stagger in the plane of vertical stiffness. A thicker slab (5 in. instead of the typical 3 in. slab) was provided at the first level to act apparently as a diaphragm for transferring forces from end walls to first story walls. The design base shear coefficient in the transverse (N-S) direction was 0.085.

The north-south wall at the east end of the structure was discontinued at the first level to be continued to the foundation at the first interior column line located 30 ft 11 in. (9.50 m) away (Fig. 3). The stiffness discontinuity at the east end would result in overturning moment, due to N-S lateral forces, to be resisted almost entirely by axial forces in east end columns. The small scale test was conducted to investigate the nonlinear dynamic response of the complex wall system. Results of the investigation were incorporated in the evaluation procedure used to determine how and when column failures occurred. Highlights of the evaluation process are presented here.

Fig. 3 Floor plans for the Imperial County Services Building

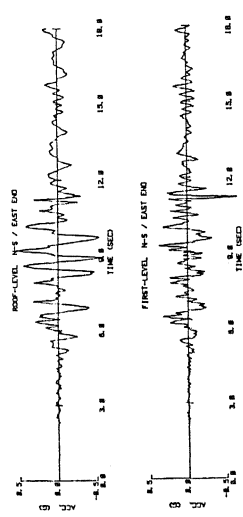
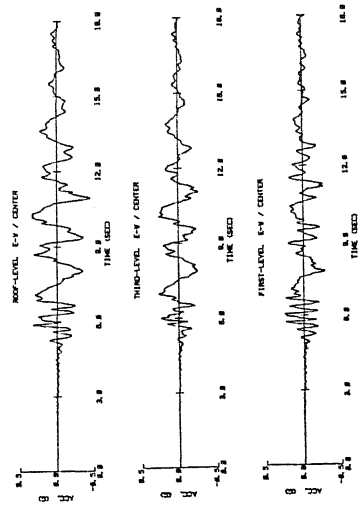
Acceleration waveforms for north-south response recorded at the east end of the structure and east-west response recorded at the center of the structure are presented in Fig. 4. North-south base-shear and base-moment response and east-west base-shear and base-moment response were estimated using measured acceleration responses and their interpolations, mass at each floor level, and mass heights as input. Base-shear and moment responses for the two principal directions of the structure are presented in Fig. 5. The base of the structure was considered to be at ground level.

Maximum top-level and base accelerations were 0.58 and 0.29 g in the transverse (N-S) direction and 0.45 and 0.33 g in the longitudinal (E-W) direction. The maximum base-shear coefficients were estimated to be 0.31 and 0.24 in the N-S and E-W directions which corresponded with 3.6 and 6.0 times the design base-shear coefficients for the two principal directions. Initial frequencies (Ref. 2) and effective frequencies following the interval of strong shaking were 2.24 and 1.65 Hz for the N-S direction, and 1.55 and 0.65 Hz for the E-W direction. Changes in response frequencies corresponded with approximately 50 and 80 percent reductions in stiffness in the N-S and E-W directions.

Interior east end columns are believed to have failed at approximately 11.2 sec. because of the increased vertical load due to failure of corner columns and the coincidence of the following: high E-W base-shear response, an observed spike at 11.27 sec. in N-S east end acceleration records (Fig. 4), and the end of correspondence of N-S base-moment response and the response of the 1.55 Hz oscillator at 11.2 sec.

Fig. 4 Acceleration response histories for the Imperial County Services Building

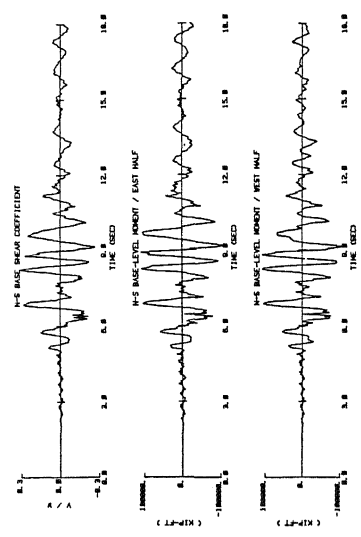
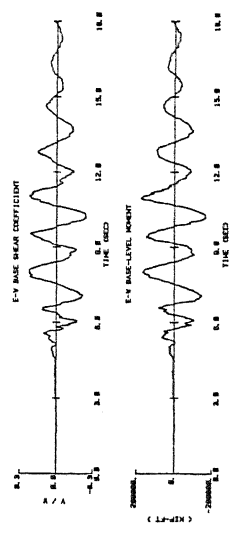
Fig. 5 Base-shear and moment response histories for the Imperial County Services Building

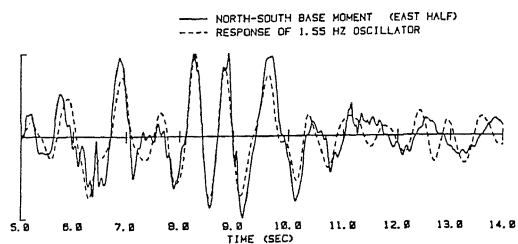
Fig. 6 Superposition of N-S base-moment response and response of a 1.55 Hz linear oscillator

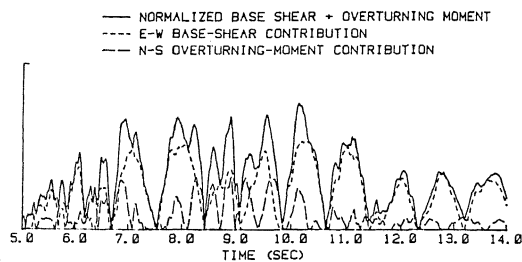
Pairs of forces deemed most significant (E-W moment and axial load) were determined for east end columns from E-W base-shear and N-S base-moment response for the east half of the structure. A method for selecting instances when forces acting on east end columns may have been critical was needed because no direct and conclusive evidence of failure was offered by measured acceleration response histories. North-south response waveforms did show a sudden decrease in response frequency at 9.2 sec. followed by a reduction in response amplitudes after 10.1 sec., both of which are common indicators of significant change in stiffness and/or strength. However, response of a 1.55 Hz linear oscillator to the N-S base acceleration record simulated this behavior (Fig. 6) indicating the sudden change in response frequency and amplitude was probably caused by the base motion. A set of 17 pairs of forces was selected for evaluation based on the relative magnitude of an index (the combined loading index) that consisted of the absolute sum of normalized E-W base-shear and N-S base-moment response (Fig. 7).

Fig. 7 Combined loading index indicating potentially critical combinations of N-S and E-W loads

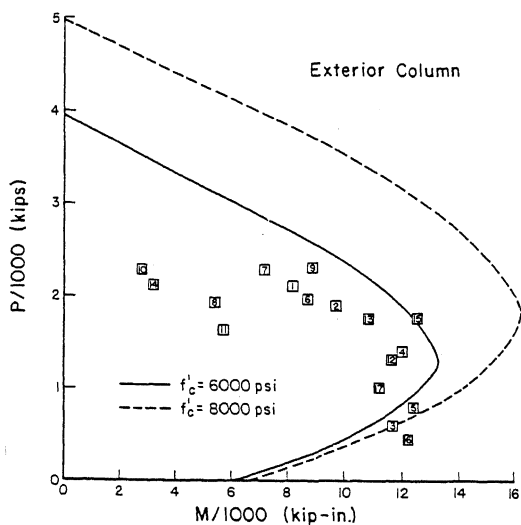
Fig. 8 Estimated column forces and load-moment interaction diagrams for east end columns
