IMPLICATIONS OF DAMAGES TO THE IMPERIAL COUNTY SERVICES
BUILDING FOR EARTHQUAKE-RESISTANT DESIGN

Christos A. Zeris (I)
Rodrigo Altmann (II)
Presenting Author: Christos A. Zeris

SUMMARY

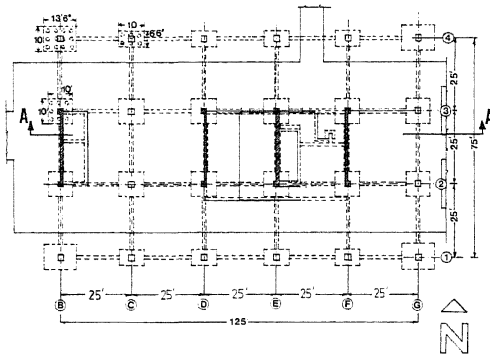
Fig. 1 ICSB Ground Level and Foundation Plan

(c) The absence of a shear wall at ground floor in G in the NS direction resulted in the one foot shortening of the East end and the formation of a yield line mechanism at F and G (Fig.1). As determined analytically, the West end columns (B, Fig.1) were equally heavily loaded axially as the columns at G; however, one of the reasons they did not suffer the extensive damage of the latter was because of the presence of the wall in the center span of bay B.

1) The use of non-continuous shear walls supported on columns, especially for columns positioned at the edges of the structure should be discouraged. If this particular system is used, well-confined columns especially by closely spaced spiral reinforcement should be employed, to ensure ductile behavior.

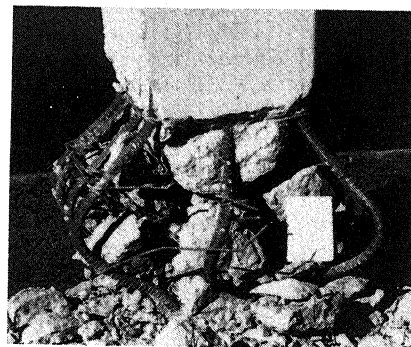
Fig. 4 Detail of Column G4 Failure

Primary damages to the structure consisted of: (a) spalling of the cover (with buckling of the longitudinal reinforcement also observed) above the base of most ground story columns, accentuated at those in line G. The crushing of these regions led to shortening of these columns by one foot (Fig.4,9). (b) Formation of yield lines along the width of the building at lines F and G (Fig.1) due to the G column shortening. (c) Flexural cracking of the exterior beams mainly in the lower floors. (d) Non-structural damage with separation of the nonstructural elements from the structure especially near lines F and G. (e) Diagonal and horizontal cracking of the walls at ground level, those at frames F and E being more heavily damaged than at B and D (Fig.1).

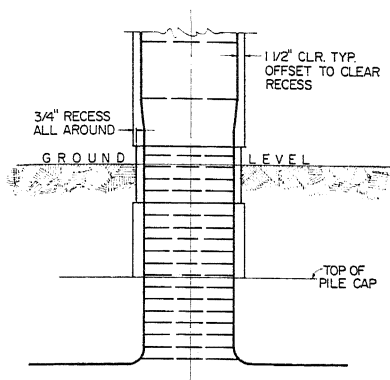
Fig. 5 Typical Ground Corner Column Detail

"nonstructural" reinforced concrete panels above the beams on the N and S facades and the bar offset detailing in the ground story columns (Fig.5). The building was founded on pile groups.

(b) Specifying offset reinforcement and a reduced confinement in the columns at ground level (Fig.5), reduced their deformability under maximum axial strength considerably. The observed localized damage at the ground story was further enhanced by: (1) significant strengthening of the second floor beams not accounted in code design, accentuated by the presence of the heavily reinforced slab; (2) the presence of the concrete ground slab between lines 2 and 3 (Fig.1) at ground level restraining the columns above the analytically assumed column bases reducing their effective clear height. On the whole, the high rigidity of the structure above the second story due to the presence of the deep nonstructural girders, and the absence of EW shear walls at ground level tended to concentrate the lateral displacements at the ground story enhancing the behavior of a soft story structure, a system that has proved inadequate in similar near-field earthquakes (Ref.12).

4) More severe restrictions on the detailing and careful field inspection during construction of reinforcement offsets and similar details are encouraged.

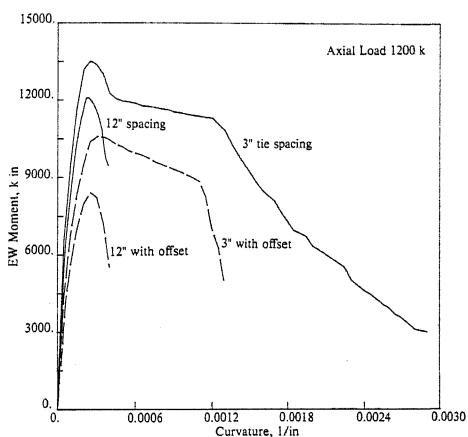
Fig. 7 Influence of Ground Column Detailing

Tests performed on steel and concrete samples removed from the building revealed that materials (particularly the concrete) were stronger than nominally specified (Table 1 and Ref.3). Based on the measured material mechanical characteristics, realistic member nonlinear characteristics and capacities were determined. Cracked flexural beam stiffnesses were about 50% of the gross section stiffnesses. However, in the case of the exterior beams, the cracked flexural stiffness was doubled if the contribution of the nonstructural elements was included; consideration also of the slab reinforcement increased significantly the beam flexural capacities (Fig.6). Motivated by the localized damage of the ground columns above the recess (Fig.4,5,9), the effect of detailing on the flexural characteristics of the columns were estimated (Ref.4) - namely the reductions in confinement (Fig.7) and in load bearing capacity of the offset reinforcing bar due to buckling (Fig. 7,8).

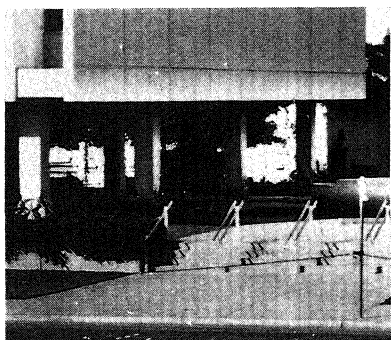
Fig. 9 Damage of G Column Line, Ground Level

The concrete strengths obtained from the tests were considerably higher than the specified especially for the lower strength concrete. The only exception being the concrete at the ground level columns on line G which was significantly weaker than the other columns' concrete. (Table 1, Ref.3,11).

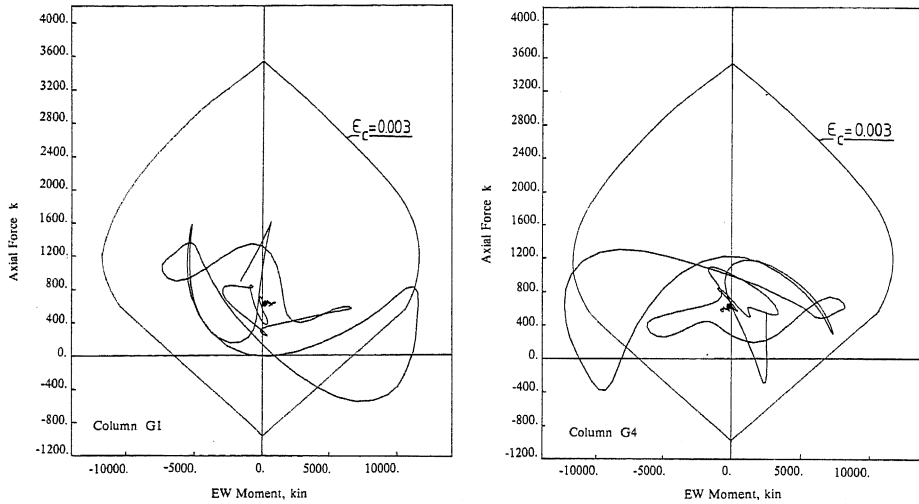
Fig. 12 Predicted Load Paths of Ground Corner Columns

As illustrated in Fig.(10), the correlation of the recorded and the predicted displacements is satisfactory until 6.20 seconds, with minor deviations until the 6.90 sec., when a change in the recorded response is observed; subsequent peaks exceed the elastically predicted ones by a factor of two. By comparing the true member capacities with the predicted demands the sequence of failure is estimated to be: (a) separation of the "nonstructural" elements from the frames around 6.0 seconds and subsequent yielding of the exterior beams in bending at the second and third floor at 6.40 seconds (Fig.10). (b) Probable yielding of the interior second floor beams, between 6.40 and 6.90 seconds. (c) Yielding of the ground level columns at their base (Fig.12) and subsequent large displacements above the second story.
