RESPONSE OF TWO REINFORCED CONCRETE
BUILDINGS IN MEXICO CITY DURING THE
PETATLAN EARTHQUAKE OF MARCH 14, 1979

JOSE LUIS TRIGOS (I)
WERNER HENTSCHEL (II)
Presenting Author: J. L. Trigos

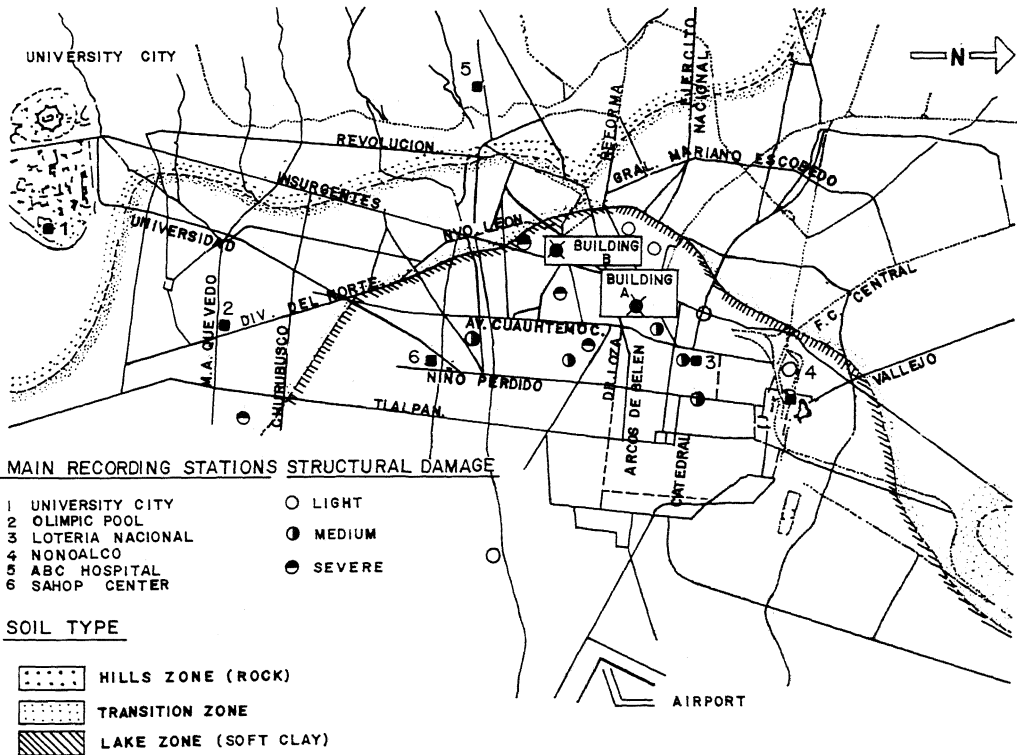
FIG. 2 STRUCTURAL DAMAGE DISTRIBUTION IN MEXICO CITY AND STUDIED BUILDINGS
(ADAPTED FROM REF 4)

The effects of this earthquake were studied on 60 buildings reported with damage in Mexico City (Ref 4). Among the most important highlights was that from 46 buildings, non-structural damage (NSD) was detected on 24 (8 light, 5 medium and 11 severe), and structural damage (SD), on 22 (10 light, 7 medium and 5 severe, of which a three level reinforced concrete structure collapsed and two had previous damage), Fig 2. This work describes the study of two structures: building A, with medium NSD and light SD; and B, with severe NSD and SD. For further details see Ref 5.

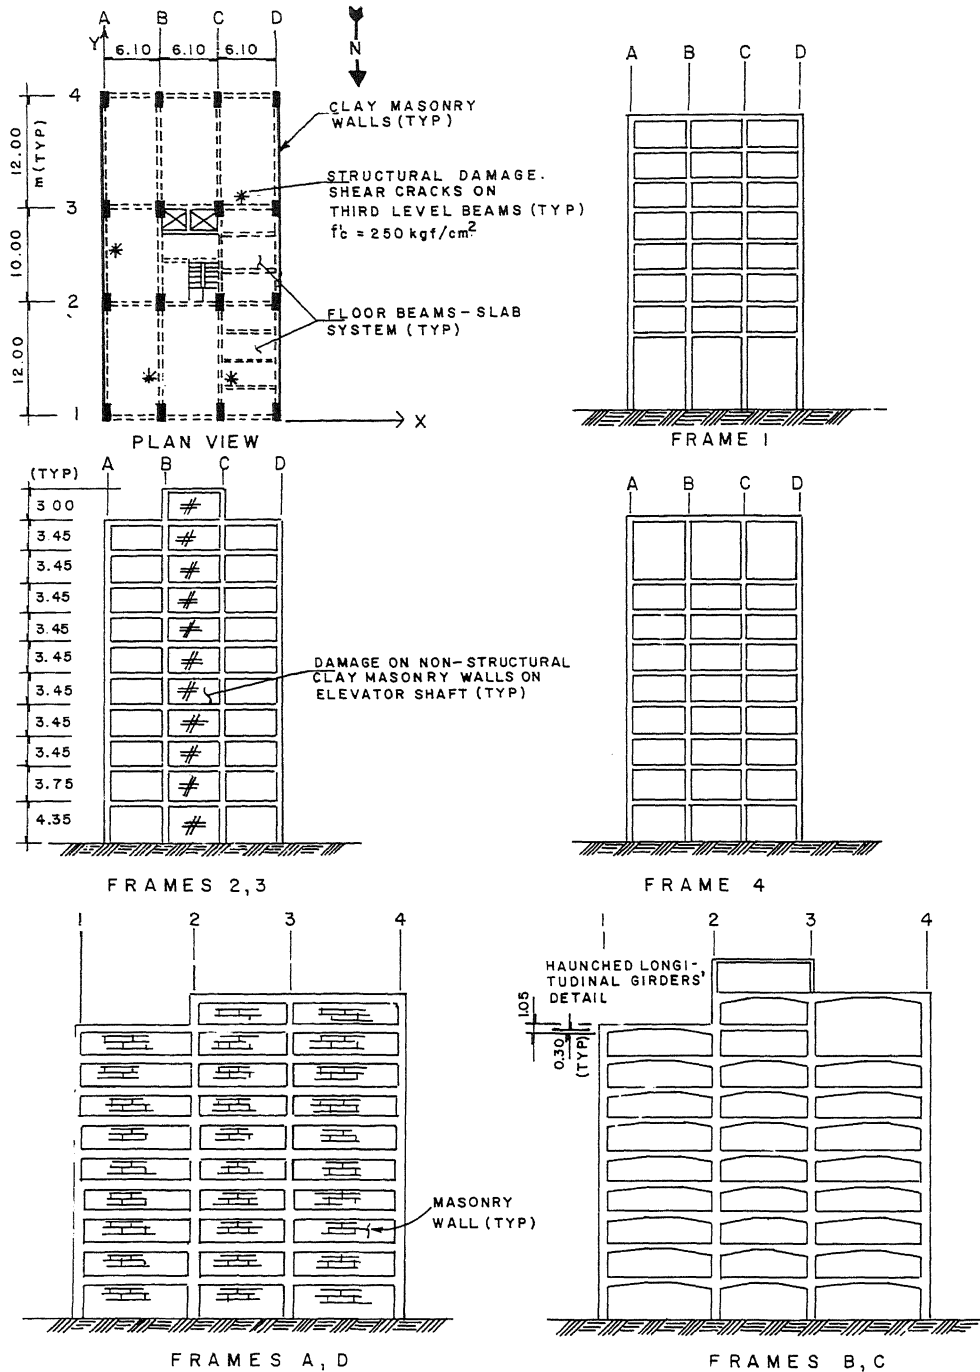
FIG 3. BUILDING A. GENERAL CHARACTERISTICS AND OBSERVED DAMAGE.

Building A consists of an eleven floor, lobby and basement reinforced concrete structure, with cast in place girders, columns and floor system formed by slabs and beams, with masonry walls on frames A and D, and in the services zone, Fig 3. The foundation mat is supported on piles resting on the City's first sand layer at a depth of 33 m. SD involved shear failure cracks on three girders of the third floor; NSD originated mainly on masonry walls in the services zone.

Concerning mechanical actions on structural elements (bending moments and shear and axial forces on columns, bending moments and shear and axial forces on girder and beams, and shear and axial forces on masonry panels), from the analyses of building A agreement was found between observed and predicted damage on girder C-D at level three of frame 3, in which shear cracks were present, and first story column A1, in which no damage was evident, as it is illustrated on the typical interaction axial force-bending moment diagram, P-M diagram, shown on Fig 6. For building B, Fig 6 shows typical interaction P-M diagrams for ground floor columns D-5 and H-1; the former did not suffer SD whereas the latter had SD, as did columns B-1, D-1, F-1, A-3, B-3, D-3, F-3, H-3, F-5, H-5 and H-7, with diminishing importance toward upper stories, fact that combined with the waffle slab damage and the NSD on all the facade walls and fenestration, led to the owners' decision of demolishing the building.

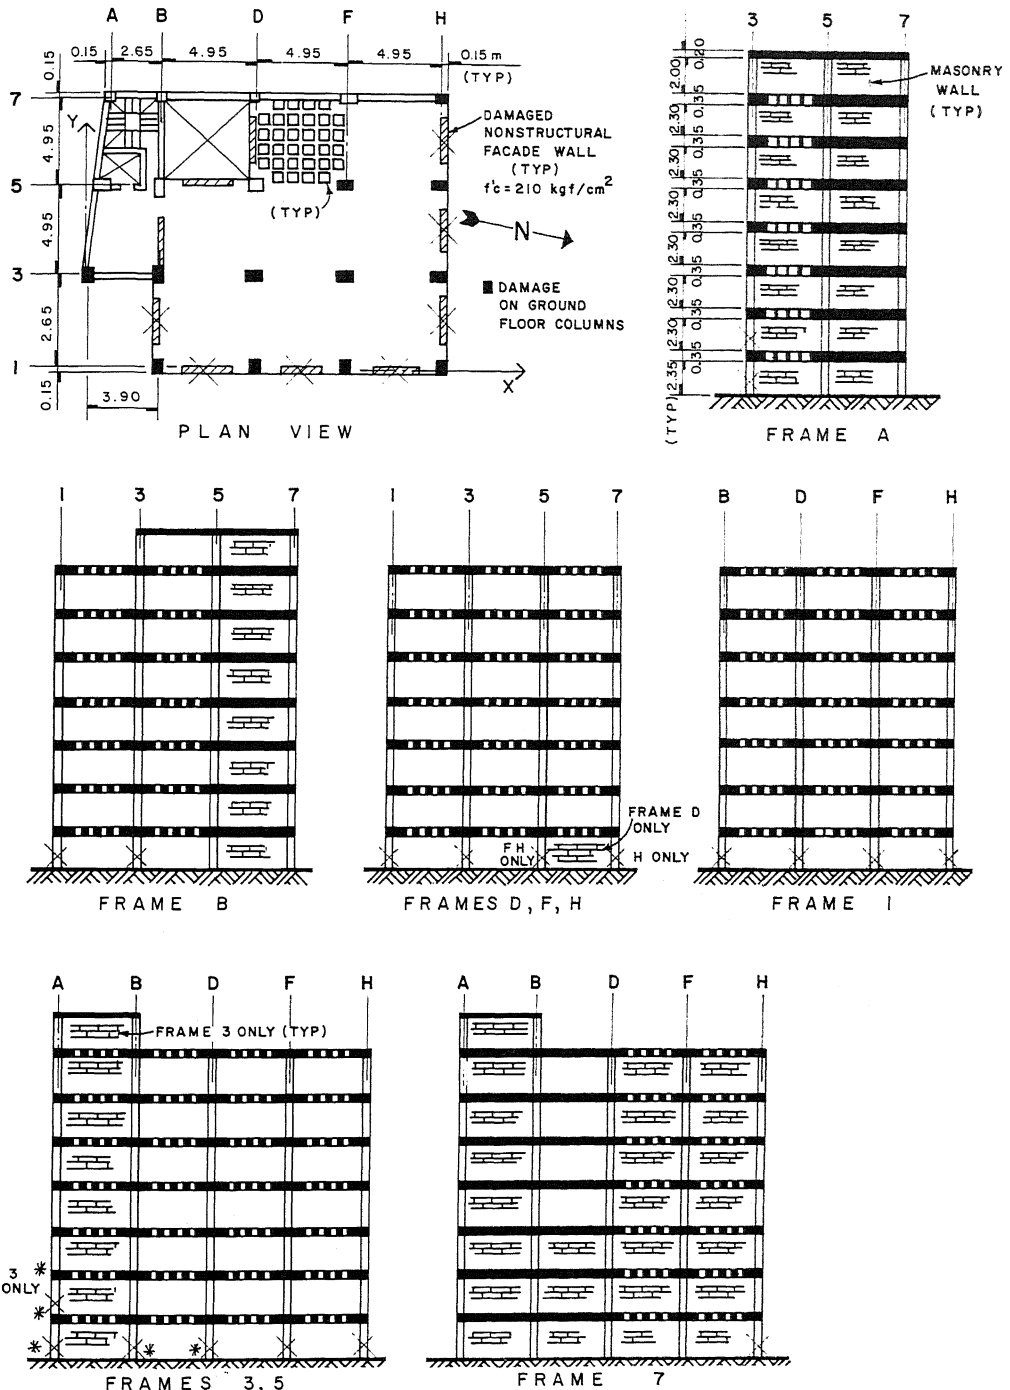
FIG. 4 BUILDING B. GENERAL CHARACTERISTICS AND OBSERVED DAMAGE.

Building B was an eight floor with lobby-garage, reinforced concrete structure with cast in place columns and floor system formed by waffle slabs, and hollow masonry walls located as shown in Fig 4. Exterior non-structural masonry walls were provided for architectural purposes. The foundation was resolved by a two way inverted beam and slab system, supported by piles resting on the sand layer at a depth of 25 m. Observed SD was concentrated mainly on the first story and consisted of the failure of columns, in some cases on the upper as well as on the lower end, and local shear failure of the flexible waffle slab, due to the torsional excentricity induced by the quake as can be inferred by inspection of Fig 4. NSD was located mainly on exterior facade masonry walls and on the adjoining windows.

The calculated interstory drifts in building A satisfied the Codes' limitations for seismic loads as well as for earthquake induced loads. In building B it was observed that a permanent drift of the first level was originated by the combined effect of the earthquake plus the excentricity between the rigidity and shear centers and the more flexible first story that had no facade non-structural walls. However, in the Codes' and earthquake analyses the maximum calculated interstory drifts were of the same order than the stipulated limit values. This fact suggests that there is a point to be reviewed in the prevailing Code.
