SEISMIC RESISTANT IMPLICATIONS
OF 1980 GUAYAQUIL, ECUADOR EARTHQUAKE

Otton Lara (I)
Presenting Author: Otton Lara

STUDY OF THE BEV BUILDING

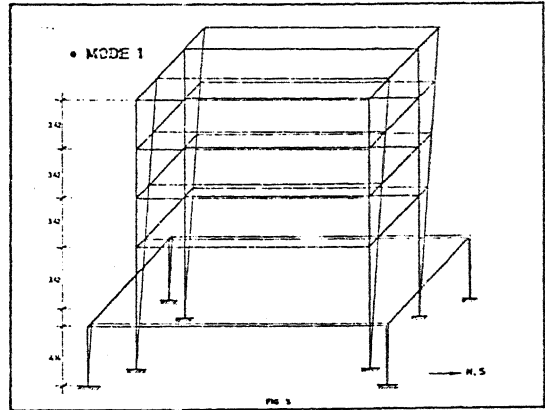
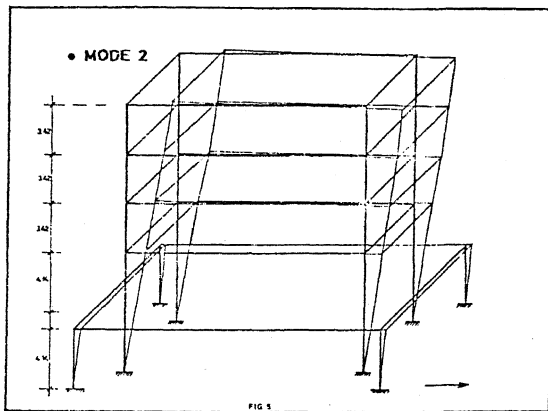
FIG. 5

The computer program ETAB (4) was utilized to determine the dynamic characteristics of this 3D model which are the periods shown in table 1 and the modes of vibration, two of which are shown in figure 5. Clearly, the torsional response would be unimportant and the building appears to be extremely flexible since its first period is 1.0 second. This flexibility is evidenced, first, by the length of the spans: 6000 mm each; second, by the height of the stories: 4140 mm the first two stories, and 3420 mm the other three stories, and third, by the presence of the masonry in all the stories above the first, while this one was completely free of partitions.

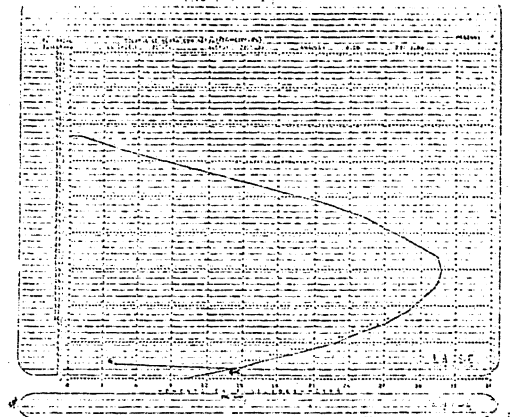
FIG. 6

Knowing the dynamic characteristics of the building, as well as, the yield surfaces of the structural members, which were calculated through the program INTERAC (5), a trial and error procedure was utilized in order to obtain the Pseudo-spectral acceleration that could reproduce the damage observed. After several iterations, the damage was reproduced for the NS and EW directions, independently, under a lateral force vector calculated through the first mode of vibration and a Pseudo-spectral acceleration of the order of 0.11 g. Only the first mode was used because, for each direction, the modal participation factors of the higher modes were insignificant. The way to check if the damage was reproduced, was determining the internal forces in the structural members of the structure subjected to the combination of the lateral force vector and the dead load. Later, these forces were plotted in the yield surface of the members and, if the forces were lower than those in the surface, the member was assumed to be elastic, while, if the forces were at or very near to the surface, yielding of the member was assumed. (Figs. 6, 7)

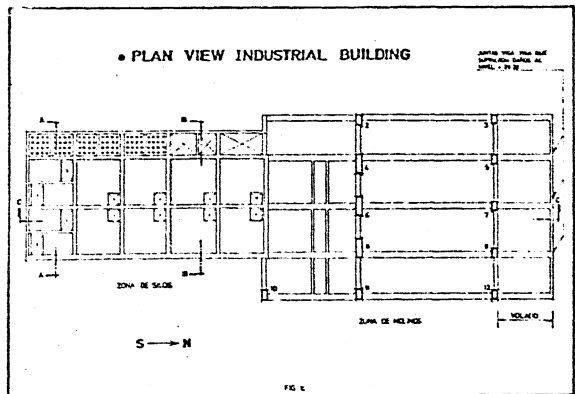
FIG. 8

The Industrial building is a high rise R/C building, 46 m. tall that was erected to satisfy two objectives: To store grains in several R/C silos in one section of it and to the process of milling those grains in another. (Fig. 8). However, the silos finish at level + 40 m., and the building continues with R/C beams and columns at levels + 43 m. and + 46 m.

This very rigid building (Table 2), whose principal Period was 0.42 seconds, suffered damage in the beams at levels + 43 m. and + 46 m. in the form of vertical cracking in regions close to the beam-column joints.
