DAMAGE TO A CONCRETE-BLOCK MASONRY HOUSE
DUE TO THE 1982 URAKAWA-OKI EARTHQUAKE

KAZUO KATO (I), MASANORI KAWAJI (II),
AKIRA MATSUMURA (III), TONEO ENDO (IV),
TAKAHIRO IGUCHI (V)

SUMMARY

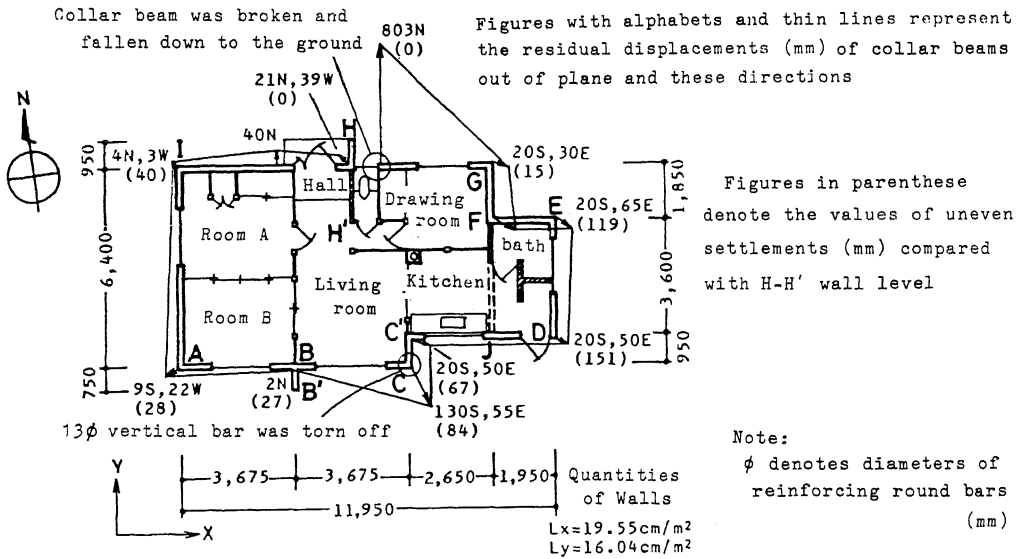
Fig.4 Plan and deformations

This house had not fallen down, but was completely damaged so that it was determined to be demolished. Longitudinal walls were heavily damaged. A point at the top of the north side longitudinal wall moved in the north direction for 80 cm. The collar beam attached to the above mentioned point dropped down about 80 cm. The maximum deflection of the south side wall out of plane was only 13 cm, but a vertical reinforcing bar of 13 mm dia. was torn off such as a testpiece after material test. Wide cracks were concentrated to the above-mentioned two walls. Most cracks were occurred along mortar joints between blocks, but several diagonal cracks were also found. The maximum uneven settlement was 151 mm. Permanent displacements at the tops of the walls and uneven settlements of the footings are shown in Fig. 4 together.

A vertical reinforcing bar was torn off at the point C in Fig. 4. This point on the elevation is shown in Fig. 8. The point did not coincide with the maximum point of bending moment assumed in structural calculation and was located at the cross point with a horizontal bar above the maximum point.

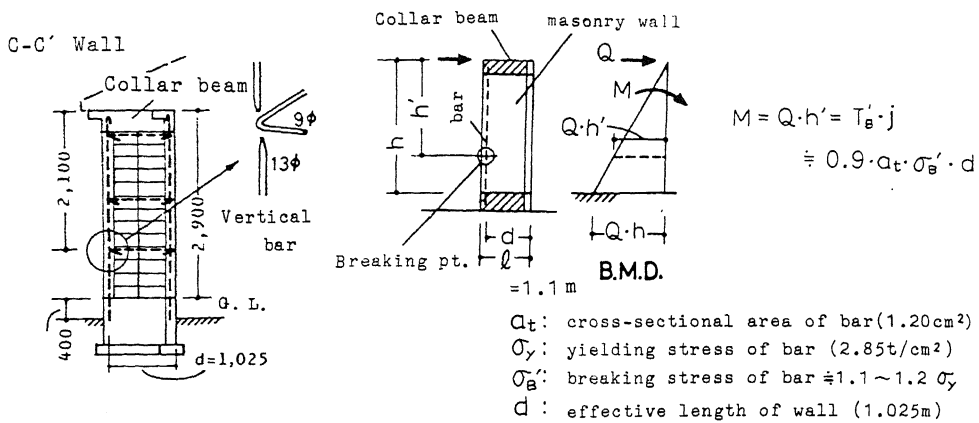
Fig.8 Situation of C-C' wall where vertical reinforcing bar was torn off and formula to estimate force applied to the wall

It is estimated that the bar was subjected to combined forces of tension and bending from large tension of the horizontal bar.

As mentioned before, the point C in the Fig. 4 did not coincide with the maximum bending moment point and was a cross point with a horizontal bar. Therefore it is estimated that the maximum tension force of the torn bar closed to the yield load T_y given by material test rather than the maximum load T_B . In this paper the maximum tension force of the bar was assumed as $T_B' = 1.1 \sim 1.2 T_y$. As a result, shear force applied to the C-C" wall was estimated about 1.7 ton.

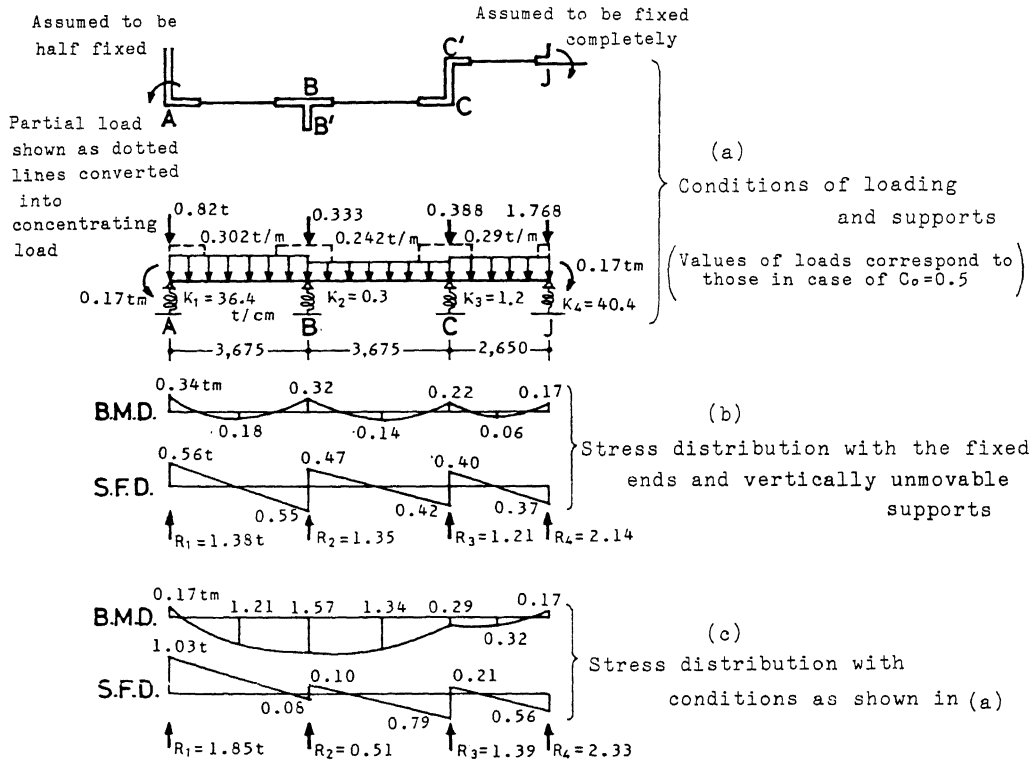
Fig.9 Stress distributions of south wall collar beam on the assumptions that it is a idealized continuous beam with and without spring supports (in case of $C_0=0.5$)

The above constances and the weights of the roof and the walls were calculated with reference to other similar field measurements. Fig. 9 (a) shows the computed spring constances and horizontal loads when the story shear coefficient; the story shear divided by the weight, was assumed 0.5.

Fig. 9 (b) shows stresses of the continuous beam computed on the common assumption that both ends were fixed. On the other hand, the stresses of the beam supported by the above mentioned springs are shown in Fig. 9 (c). Direct stiffness matrix method was used for the elastic computation. Comparing Fig. 9 (b) with Fig. 9 (c), reaction force of the wall B-B' was fairly large in the case of fixed end but it remarkably decreased in the case of spring support. The C-C' wall, however, increased its reaction and the bending moment at the point B also increased in the case of spring support. It is

estimated that the horizontal load was concentrated into the C-C' support.

The maximum story shear coefficient C_0 can be given by proportional calculation as 0.61 from the shear force 1.7 ton of the C-C' wall as mentioned before.

- b. The earthquakes with seismic intensity VIII - XI in MM scale have often occurred in Japan. The considered flat house located on a little hill was estimated to be applied large response shear force corresponding to that the story shear coefficient C_0 was 0.5 ~ 0.6. The similar reinforced concrete building shall be designed against the above mentioned shear force.
