A DESIGN ANALYSIS OF THE IMPERIAL COUNTY
SERVICES BUILDING

Slobodan Kojic (I)
James C. Anderson (II)
M. D. Trifunac (III)

SUMMARY

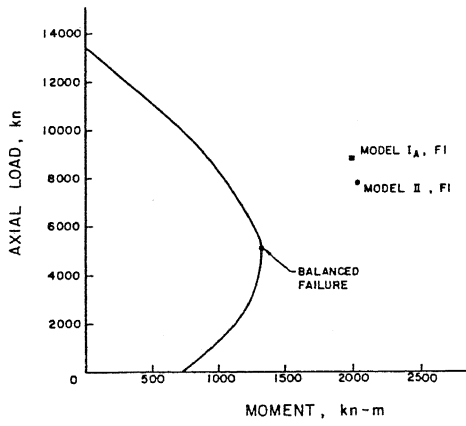
Fig. 8 Interaction Diagram Columns F1 & F4.

All columns of the ground floor were 24 inches (61 cm.) square. The exterior columns on column lines A and F were reinforced with 10 # 11 bars, whereas the other columns of the ground floor has 8 # 11 bars. The interaction diagram for the exterior columns on line F is shown in Figure 8 along with the calculated column forces due to excitation in the N-S direction. Here the capacity reduction factor, phi, has been set to unity. It can be seen that the developed forces fall well outside the interaction diagram and well above the balance point. This is indicative of an axial compression failure in the concrete which can be sudden and explosive in nature. This agrees well with the observed damage. Eyewitnesses reported that all the columns on line F tended to explode near the base. Measurements made on these columns immediately following the main shock indicated an axial shortening of some 9 inches (23 cm.). Concrete in the lower three feet of the columns was badly shattered and the reinforcing bars were severely buckled.

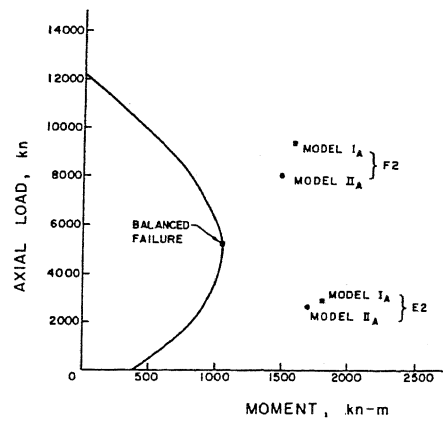
Fig. 9 Interaction Diagram Columns E2 & F2.

The interaction diagram for the interior columns on column lines E and F is shown in Figure 9. Here the difference between axial failure and flexural failure becomes readily apparent. The columns on both column lines are overstressed, however, the columns on line F are once again above the balance point indicating a brittle, compressive failure mode. Conversely the columns on column line E are below the balance point indicating a more ductile, flexural failure mode. The columns experienced cracking and spalling of the concrete cover, but no disintegration of the concrete core and no buckling of the reinforcing steel. The envelope of story shears in the two principal directions are shown in Figure 10. In both cases the story shears calculated from the response spectra are compared with those obtained using the 1967 Edition of the Uniform Building Code. In the N-S direction the shear due to the response spectrum is separated into that taken by the columns and that taken by the shear walls. As might be expected, the shear taken by the columns is almost negligible and the combined spectrum shear is almost thirteen times larger than that specified by the code. In the E-W direction, all story shear is resisted by the columns of the moment frames. Here the spectrum shear is eight times greater than the code requirements.
