BEHAVIOR OF THE LATINAMERICAN TOWER IN MEXICO CITY

Adolfo Zeevaert C. E.*
Presenting Author: Adolfo Zeevaert

This paper presents the main observations of the behavior of the Latinamerican Tower in the last 27 years since the completion.

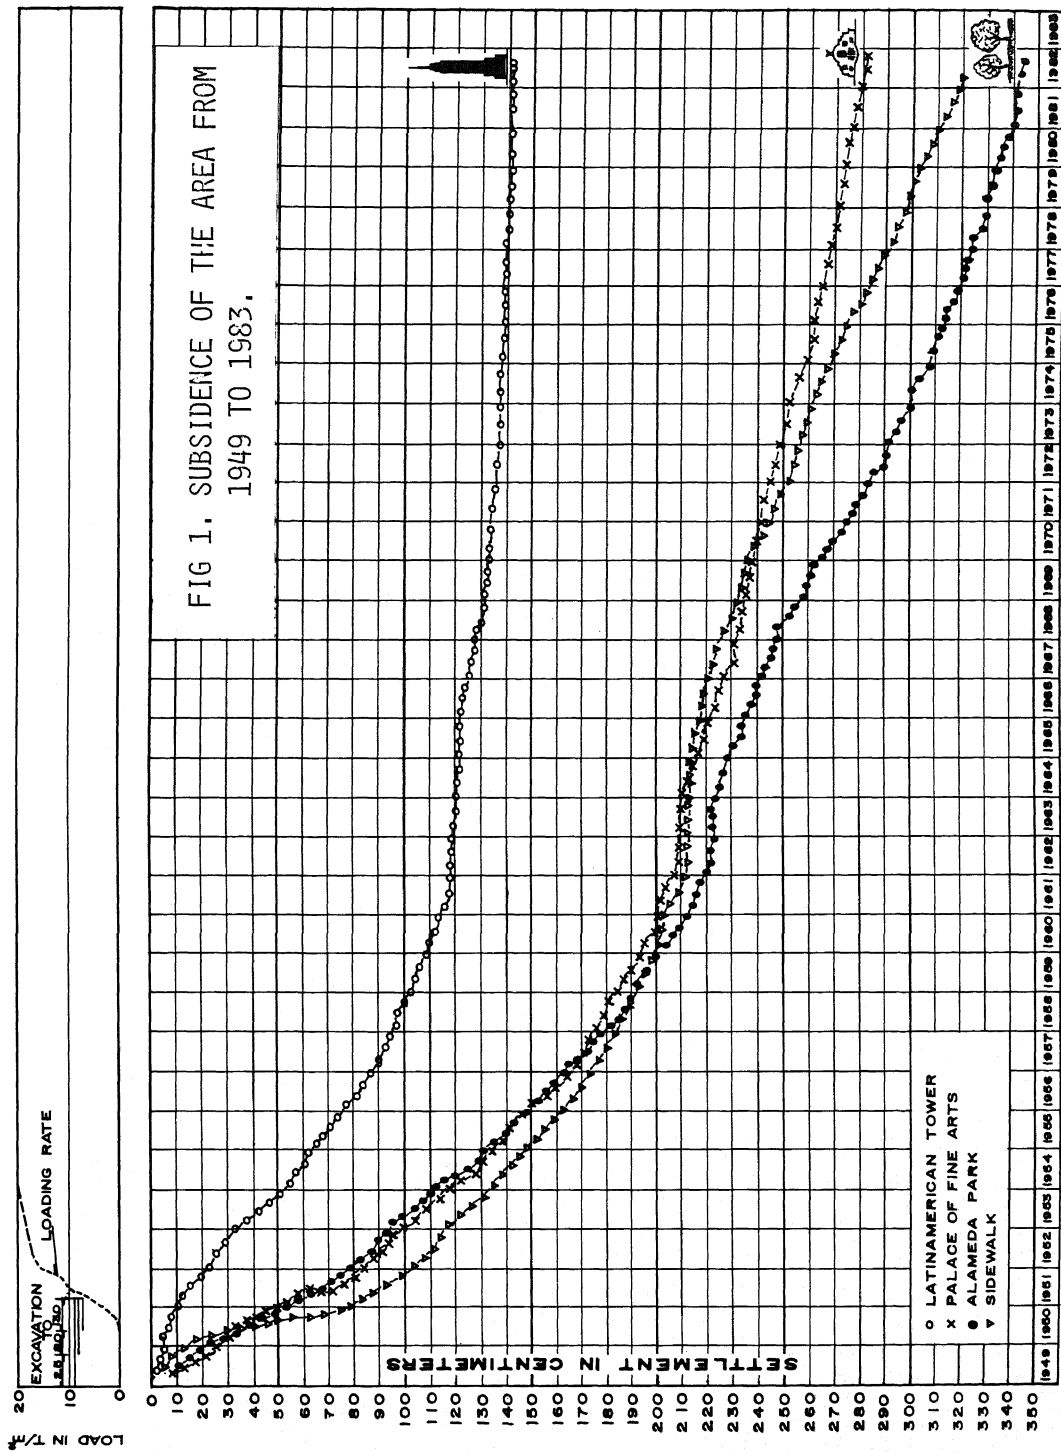
foundation, since then the observations have been continued are as follows (see figure 1):

Total subsidence from 1949 to 1983:

Alameda Park	3.50 meters
Palace of Fine Arts (across the Latinamerican Tower)	2.82 meters
Latinamerican Tower	1.45 meters
The side walk (in front of the Latinamerican Tower)	1.70 meters

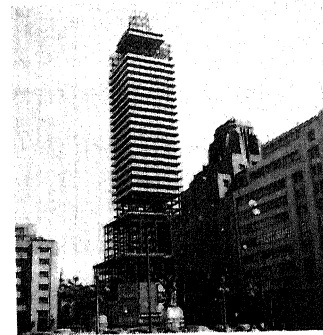
Photo 2. Construction detail
showing the concrete slabs -
from the 14th to the 36th --
floor for preloading the --
center columns of the -- --
building.

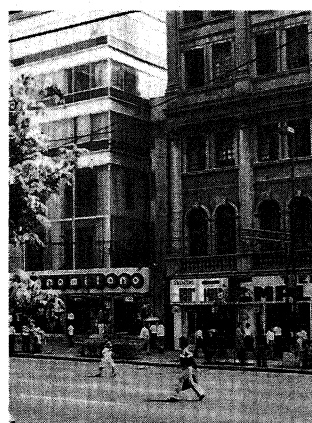
Photo 4. Rule Building 1983

No damage in this adjacent building.

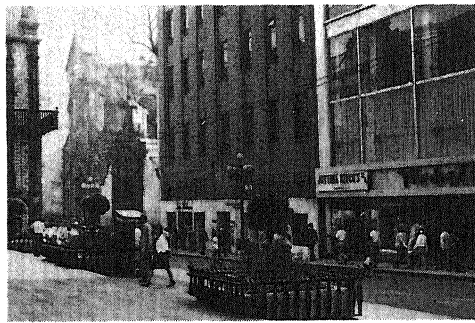
Photo 6. Guardiola Hotel 1983.
No damage in this adjacent building

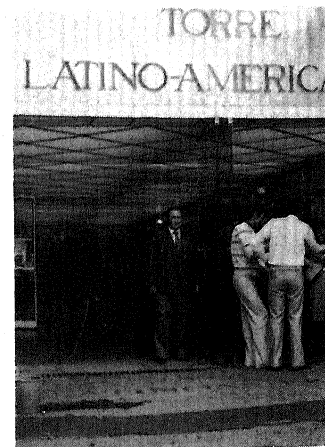
These observations are less than the estimations in the project (Ref. 3) - it was necessary to build only one step at the entrance of the building -- until now, it was estimated that four steps would be necessary in 20 years. The water pressure below the foundation slab of 12 Ton/m² has been - - - maintained all the time automatically with a water tank, with a supply and 50 lts/month of water is necessary to keep the pressure. With respect to - the vertical of the building the report is as follows: the initial measure^ument after the building was constructed reported 3 centimeters out of - -- plumb, after 26 years the measurement indicate 12 centimeters out of plumb, an inclination of 12/18100 = 1/1508, not noticeable.

Photo 7. Notice one
step. Building at -
the entrance in - -
26 years.
