U.S.-JAPAN COOPERATIVE RESEARCH ON R/C FULL-SCALE BUILDING TEST

PART 3 INSTALLATION ON NONSTRUCTURAL ELEMENTS  
AND REPAIR WORKS, DAMAGE ASPECTS AND  
HYSTERESIS PROPERTIES AFTER REPAIR

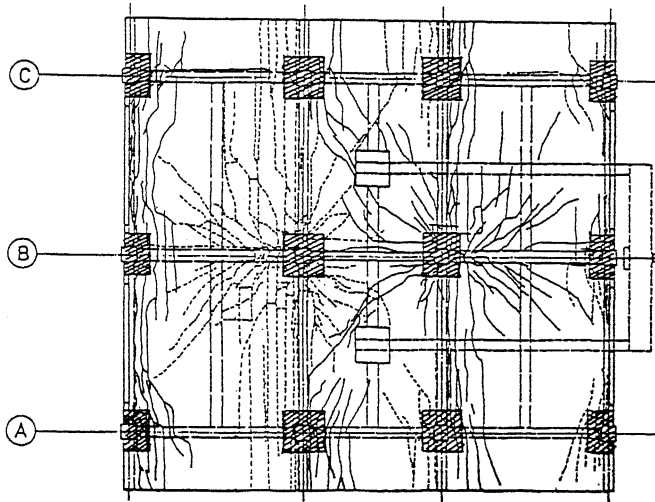
Fig.2.1 Repair Portion by Epoxy Resin

After a series of tests on the bare frame, wide cracks were observed at the beam ends, especially in those beams framing into the wall, and in the first three stories of the wall. Epoxy resin was injected into the cracks in the wall and at the ends of beams as shown in Fig.2.1.

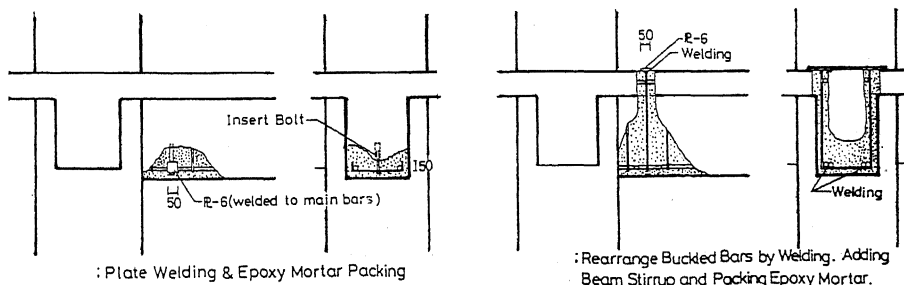
Fig.2.2 Typical Repair at Beam Ends

Spalled concrete at the ends of beams framing into the wall was replaced by epoxy mortar. Buckled longitudinal reinforcing bars were cut and replaced by parallel bars welded at the cut point. Additional U-shaped stirrups were provided for the slightly bucked bars. Typical repair works at beam ends are shown in Fig. 2.2.

At the four places of the total fourteen beam ends adjacent to the shear wall, the bottom longitudinal reinforcing bars were buckled in SPD-4. Two types of repair were applied to these portions. The crushing of concrete at the repaired portions was not observed throughout the after-repair test series, which means these repairs were considered to be effective for preventing an immature failure of the structure.

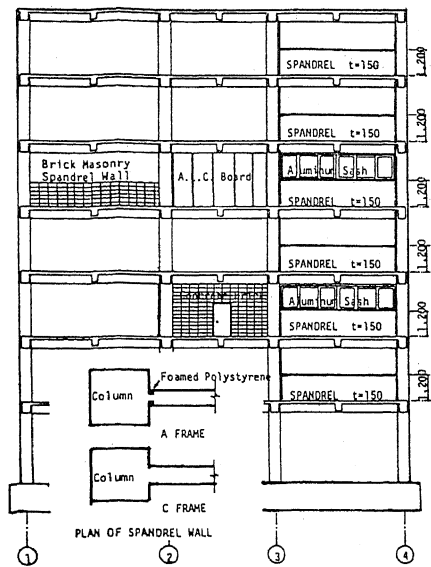
Fig.2.3 Spandrel Installation

In parallel with the repair work, reinforced concrete spandrel walls were set at one span of the A and C frames from the second floor to the top floor level as shown in Fig. 2.3. On the second and the third floors,

the reinforcing bars of the spandrel walls were anchored to the columns and floor slab by inserting anchor bolts. At other stories, those anchors had been set in advance. As shown in the lower left hand side in Fig.2.3, the connection of the spandrel wall with the column in frame-C is different from that used in frame-A which had a narrow thickness (6cm).

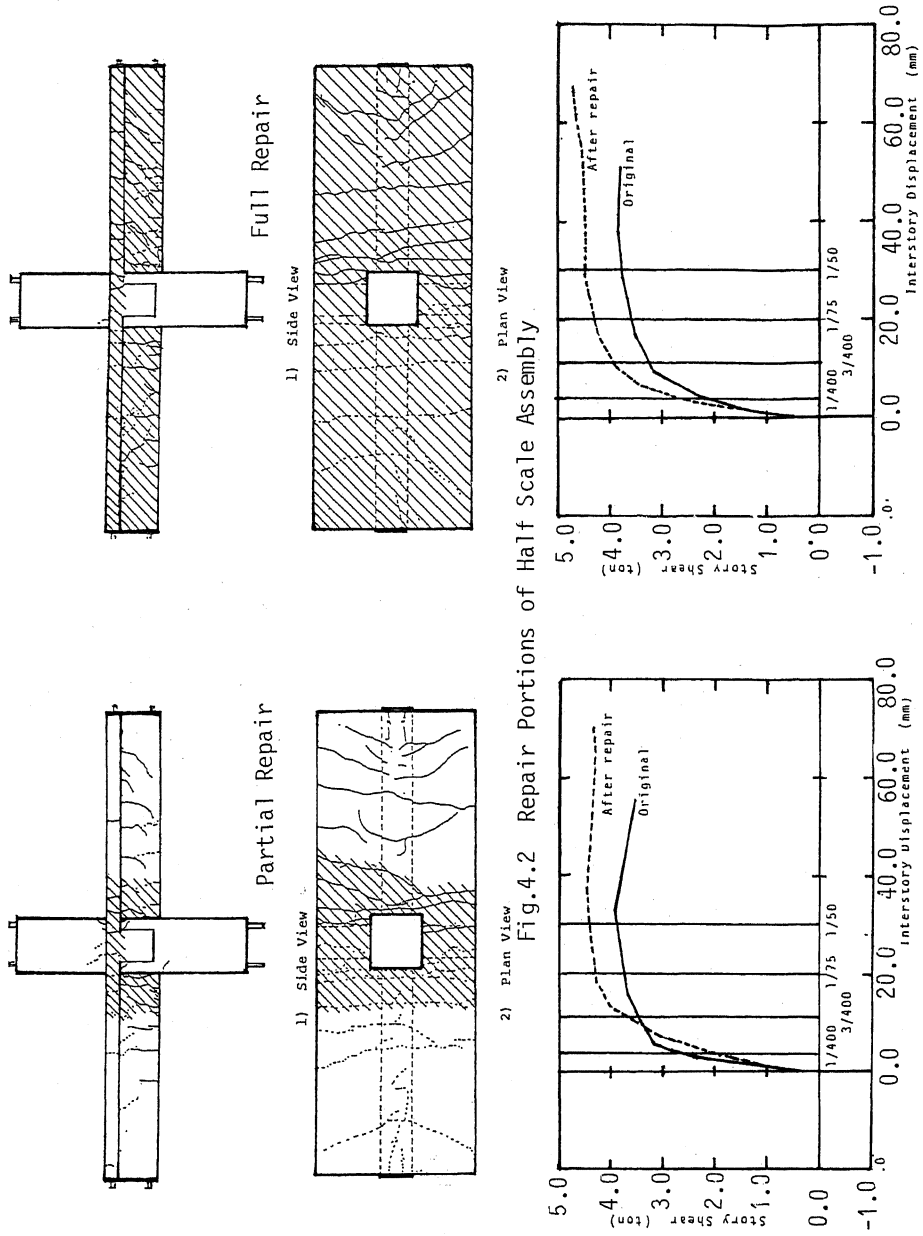
Fig.4.2 Repair Portions of Half Scale Assembly

Epoxy resin injection into the cracks of floor slabs and beams was done within the area of 1.0 D distance from the surface of columns. In order to examine the difference of effect between full repair and partial repair of epoxy resin, the following support tests were done. The shape of the test specimen and repaired portion (hatched part) are shown in Fig. 4.2. These test specimens are just half scale model of full scale beam column joint assembly. The dimension of slab width is equal to the regulated effective width which is almost same in both U.S. Code and Japanese Code. According to these test results, the recovery of stiffness and strength showed differently between full repair and partial repair for these two specimens as shown in Fig. 4.3. A full-repair specimen recovered almost same stiffness as that before repair and showed higher strength than the virgin strength. It was estimated that epoxy resin injection into cracks was effective for structural recovery as long as its works were carefully done. The physical origin of repair effects are now being surveyed by the basic tests. Such a cause of effects are analyzed in each case of failure mode; flexural failure, shear flexural failure, shear failure and bond splitting failure.
