COLLAPSE OF LUAN RIVER BRIDGE DURING TANGSHAN EARTHQUAKE
— A CASE-HISTORY STUDY

He, Du-xin (I)

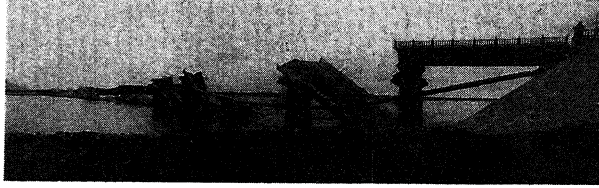
The superstructures of the 2nd to 24th span from west collapsed during the earthquake, the west ends of the beams fell to the river, but the east ends moved distinctly on the piers eastward with a max. value of 0.5^m . The supports were inclined or overturned to the east. The other 11 spans in the east also moved eastward and touched to each other, while the last span to the chest wall of the abutment. In the collapsed spans 12 piers were broken to the east, and the others inclined eastward about 3%. Span length was not changed distinctly, the total length (distance between the two abutments) was decreased not more than 0.5^m .

Field investigations indicated that the foundation and the bank slope were stable, no liquefaction track was found. Although some piers were broken, but their caps fell onto the decks of the collapsed span. It indicated that the piers did not break until the beams fell down at first. Because the beam spans moved towards a same direction, and it was 0.5^m wide from the support to the boundary of pier top, there must be a relative displacement of at least 0.5^m before the collapse. Such a large displacement could not be explained as the nonlinearity of materials or the time difference of earthquake motion.

The collapsed Luan River Bridge

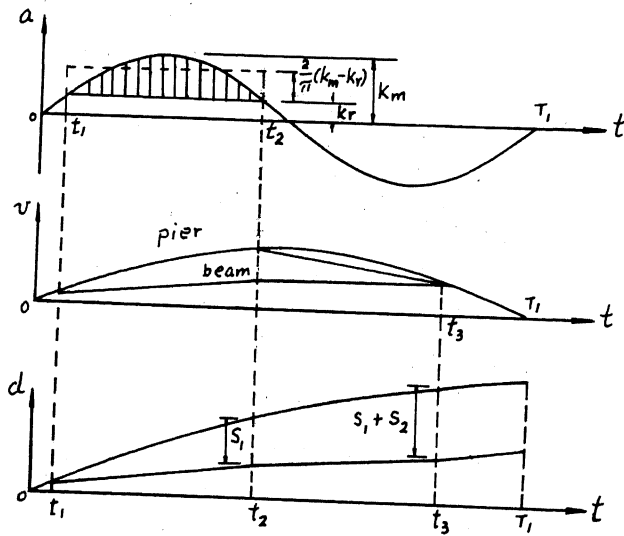
In this paper, an analysis is based on Newmark's (1965) idea about soil slope stability. The critical friction coefficient of the steel plate supports is supposed as $k_r = 0.15$. We consider a simple harmonic vibration as shown in fig. 1 (with period T_1 , acceleration amplitude $K_m g$, $K_m > K_r$). an overload pulse ($t_1 < t < t_2$) would cause a relative displacement as approximately

Although the accel. of the pier top decreased to K_r again when $t = t_2$, but the beam and the pier still didn't return to equivalent motion. It is because they had got different velocities, of which the difference was the area of shadowy part of fig 1, i.e. $\frac{2}{\pi} (K_m - K_r) g (t_2 - t_1)$. Till $t = t_3$ while the velocities became equal, the both returned to coincidence again. During the time interval $t_2 < t < t_3$ a relative displacement was approximately

It is important that the beam and the pier still retain relative motion during $t = t_2 - t_3$, and the opposite pulse ($t > \frac{T}{2}$ in fig.1) after the former positive pulse must be mainly missed. Hence, for a simple harmonic process the odd pulses with same direction would be accumulated, while the even pulses with opposite direction couldn't take place, and it led to a motion of several slides with same direction. Although it could be more complex for an earthquake, but the above mentioned character of relative motion still would be a main reason of collapse towards a same direction.

Fig. 1. Slide of beams on pier

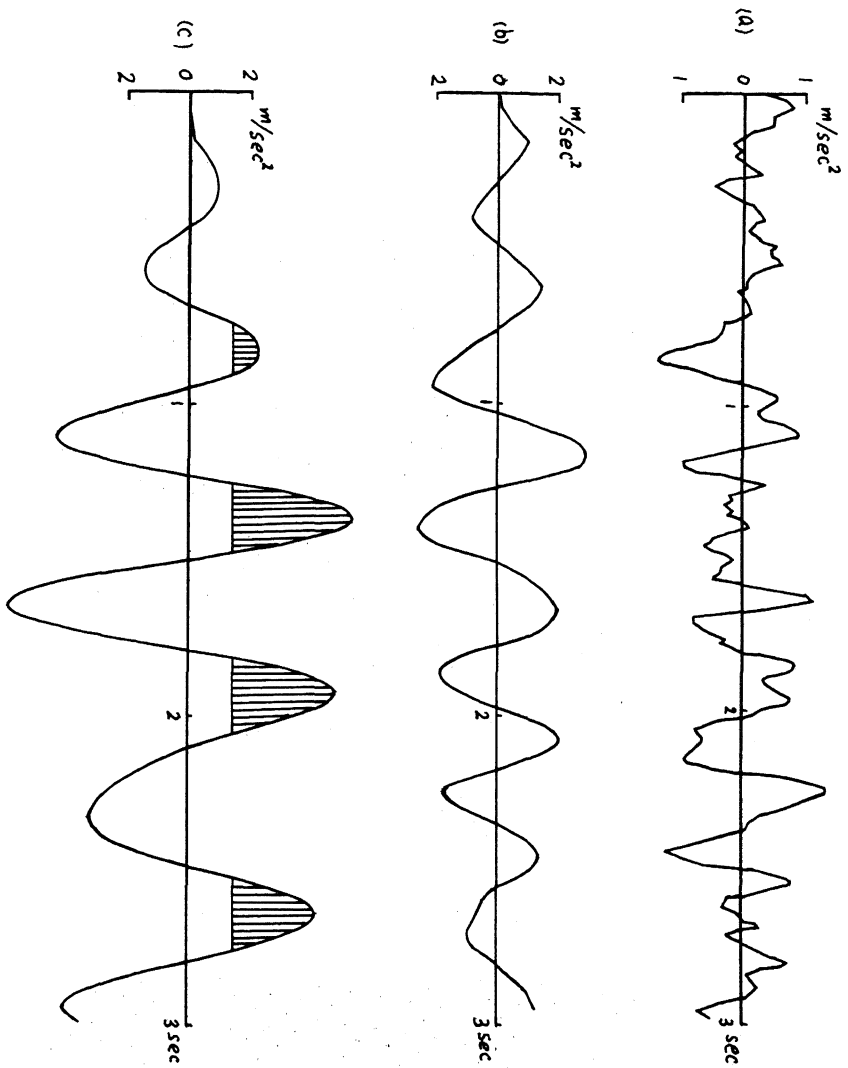
Take the ground motion record of an aftershock of the Tangshan earthquake received on a bed rock on an end of the Luan river bridge in Qian-an County (about 30 km upstream from Luan County) as an input as shown in fig. 2 (a). The soil layer of the river bed was assumed as 18^m in depth. For the soil $G = 5000 \text{ t/m}$, $\nu = 0.4$, $\gamma = 2 \text{ t/m}^3$, $\mu = 0.07$. The EQ response of the river bed surface was evaluated as shown in fig. 2 (b). Then the acceleration response of the pier top was defined as in fig. 2 (c). Some relative displacements were obtained as follows:

summing up all the positive values, a total relative displacement could amount to 33.7 cm.

Fig. 2. Response of Juan River Bridge
 (a) base input (b) surface response of 18^m layer
 (c) response of pier top
