## DYNAMIC RESPONSE OF THE NAMIOKA TOWN HOSPITAL BUILDING DAMAGED DURING THE 1983 NIHONKAI-CHUBU EARTHQUAKE

Masaomi TESHIGAWARA<sup>1</sup>, Masaya HIROSAWA<sup>2</sup>,  
Yoshikazu KITAGAWA<sup>3</sup>, and Yutaka YAMAZAKI<sup>4</sup>

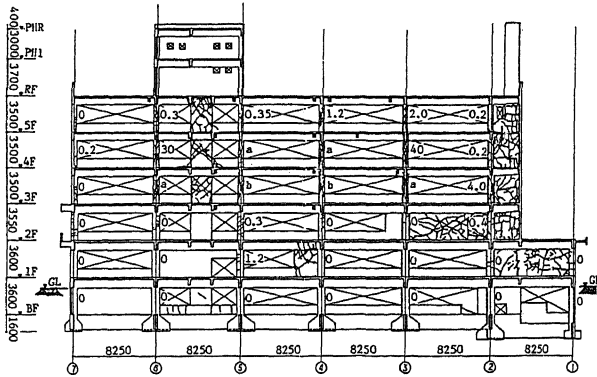
Fig. 4 Cracking Pattern of J-Frame

Outline of Structural Damage Observed cracking pattern of J-Frame as an example is illustrated in Fig. 4. Actual damage level of G- and J-Frames are denoted in Fig. 5. The outline of the structural damage of this building is as follows ;

- a) Most of the third to fifth story interior columns in the exterior bay which have spandrel walls sustained severe shear failure. Among those columns, those having a large amount of longitudinal reinforcement also suffered from bond splitting failure.
- b) Shear cracking occurred in the second to fifth story walls that were not counted in the design, and some of those walls exhibited shear failure.
- c) A reinforced concrete chimney on the roof and parapets were inclined.
- d) Local failure was observed in slabs of staircases.

note  
 numbers : max. residual  
 crack width in mm  
 a : max. residual crack  
 width is about 30mm  
 b : core concrete failure

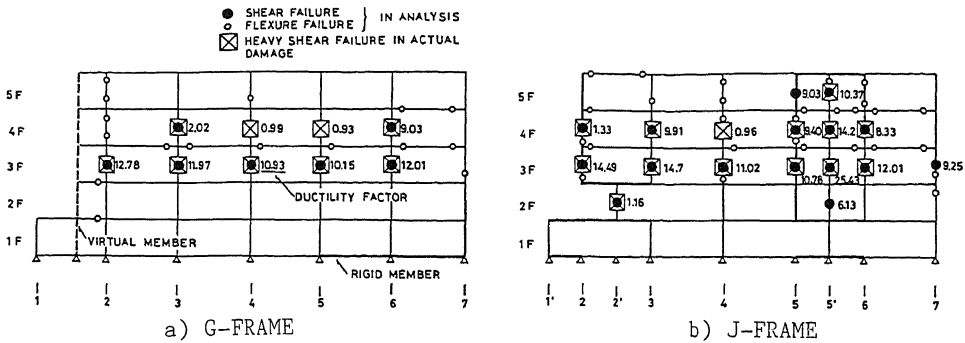
Fig. 5 Failure Mode :  
 Strength-Degrading Model, NAMIOKA NS 225gal

Structure Model Every column, beam and wall of A- to J-Frames are represented by beam models having rigid zones at both ends. Figures 5 a) and 5 b) show the frame models corresponding to G- and J-Frames. In these figure, actual damage level and results of analysis are also denoted. The following is taken into consideration for the idealization of the building.

The final state on G-, and J-Frames of response of the Strength-Degrading Model is shown in Fig. 5. Almost all vertical elements at the third story of G- and J-Frames and about half of those at the fourth story sustain shear failure (denoted with the symbol●). Flexure failure (denoted with the symbol○) occurs at many fourth story horizontal elements of G- and J-Frames. In contrast with the analytical results, actual damage produced on vertical elements is also indicated in Fig. 5 with the symbol☒. The figures in Fig. 5 denote analytically obtained ductility factors in shear deformation characteristics (standardized by displacement corresponding to its ultimate strength). Very good agreement between the analytical results and the actual damage is observed in these figures.

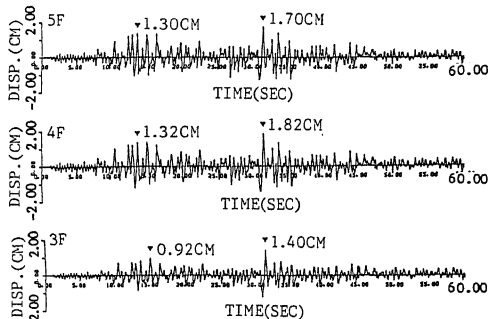
Fig. 8 Story Displacement Response of Origin-Oriented Model : NAMIOKA NS 225gal

Figures 8 and 9 show story displacement response time histories of the Origin-Oriented and the Strength-Degrading Models, respectively. Comparing both time histories, it is recognized that the response of both models at all stories except the third one is quite similar to each other, while there exists a big

difference at the third story. The maximum displacements of the former model are 0.92 and 1.40cm for the first and the latter halves respectively in the entire duration time, whereas those values of the latter model are 1.20 and 2.70cm for those two halves respectively. The Strength-Degrading Model gives 30% and 93% larger story displacements at the third story for the first and the latter half parts respectively in the entire duration time compared with the Origin-Orient Model.

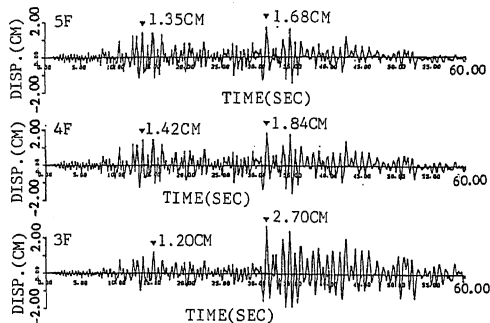
Fig. 9 Story Displacement Response of Strength-Degrading Model : NAMIOKA NS 225gal

As described above, the Strength-Degrading Model gives larger story displacements at the third story, particularly for the latter 35 seconds compared with the Origin-Oriented Model. This fact indicates that the duration time span greatly affects the response of a structure mainly composed of strength-degrading-type resisting elements. Based on the results discussed above, it is estimated that damage of the Namioka Town Hospital building would have remarkably decreased in comparison with the actual damage, if the 1983 Nihonkai-Chubu Earthquake were a single-shock-type earthquake.

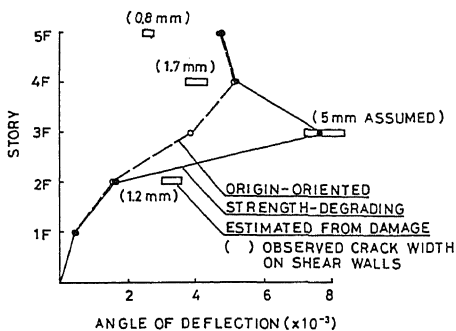
Fig. 10 Maximum Angle of Deflection NAMIOKA NS 225gal

As shown in Fig. 10, these maximum story displacement analytically obtained for the Strength-Degrading Model also gives quite good correspondence with the distribution of the maximum story displacements along the height of the building which were estimated from the observed maximum residual crack width on shear walls in the building.

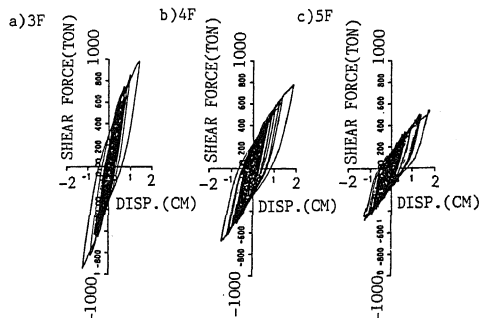
Fig. 11 Shear Force vs. Story Displacement Origin-Oriented Model : NAMIOKA NS 225gal

Figures 11 and 12 show story shear force vs. story displacement curves at the third to fifth stories obtained from the both models. In these figures, it is seen that stiffness at the third story of the Strength-Degrading Model compared with the one of the Origin-Oriented Model greatly decreases in the last part of the duration time due to the negative slope after reaching ultimate strength. This coincides with the fact that the vibration period of the third story response oscillation shown in Fig. 9 is initially 0.5 second approximately at small amplitude response in the first part of the whole duration time, and becomes about 0.9 second in the last part.
