A STATISTICAL EVALUATION OF DAMAGE TO BUILDINGS IN THE THESSALONIKI, GREECE EARTHQUAKE OF JUNE 20, 1978

G. PENELIS¹, D. SARIGIANNIS², E. STAVRAKAKIS¹, K. STYLIANIDIS¹

¹Department of Civil Engineering, University of Thessaloniki,
Thessaloniki, Greece

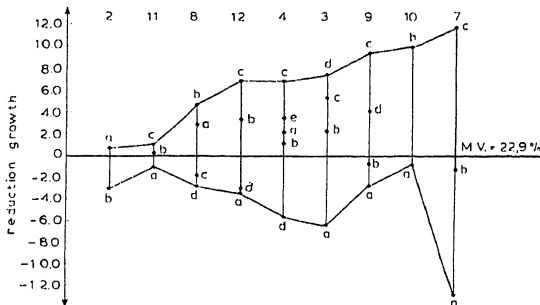
Fig. 2 Divergence from the mean value in regard with the parameters investigated (Symbols in table 1)

Correlation between structural characteristics and damage Table 1 shows the influence of the structural characteristics on the variation of the percentage of the damaged buildings. In all cases, the buildings with normal structural layout were less affected by the earthquake. Higher reduction corresponds (in an order of minor significance) to buildings which were low-rise, stiff, had normal plan configuration, no appentages, normal stiffness distribution in elevation and were free in the block. Short columns, stiffness eccentricities in plan and basements did not affect the damage percentage (Fig. 2). It can be concluded that, although some exceptions exist, standard provisions of current seismic codes concerning normal structural layout proved to be effective in seismic hazard reduction. An almost linear reduction of the percentage of the damaged buildings versus construction period was found (Fig. 3). The Code for Aseismic Design (1959) had no significant effect on the hazard reduction. Local maxima correspond to peaks in building construction activity.

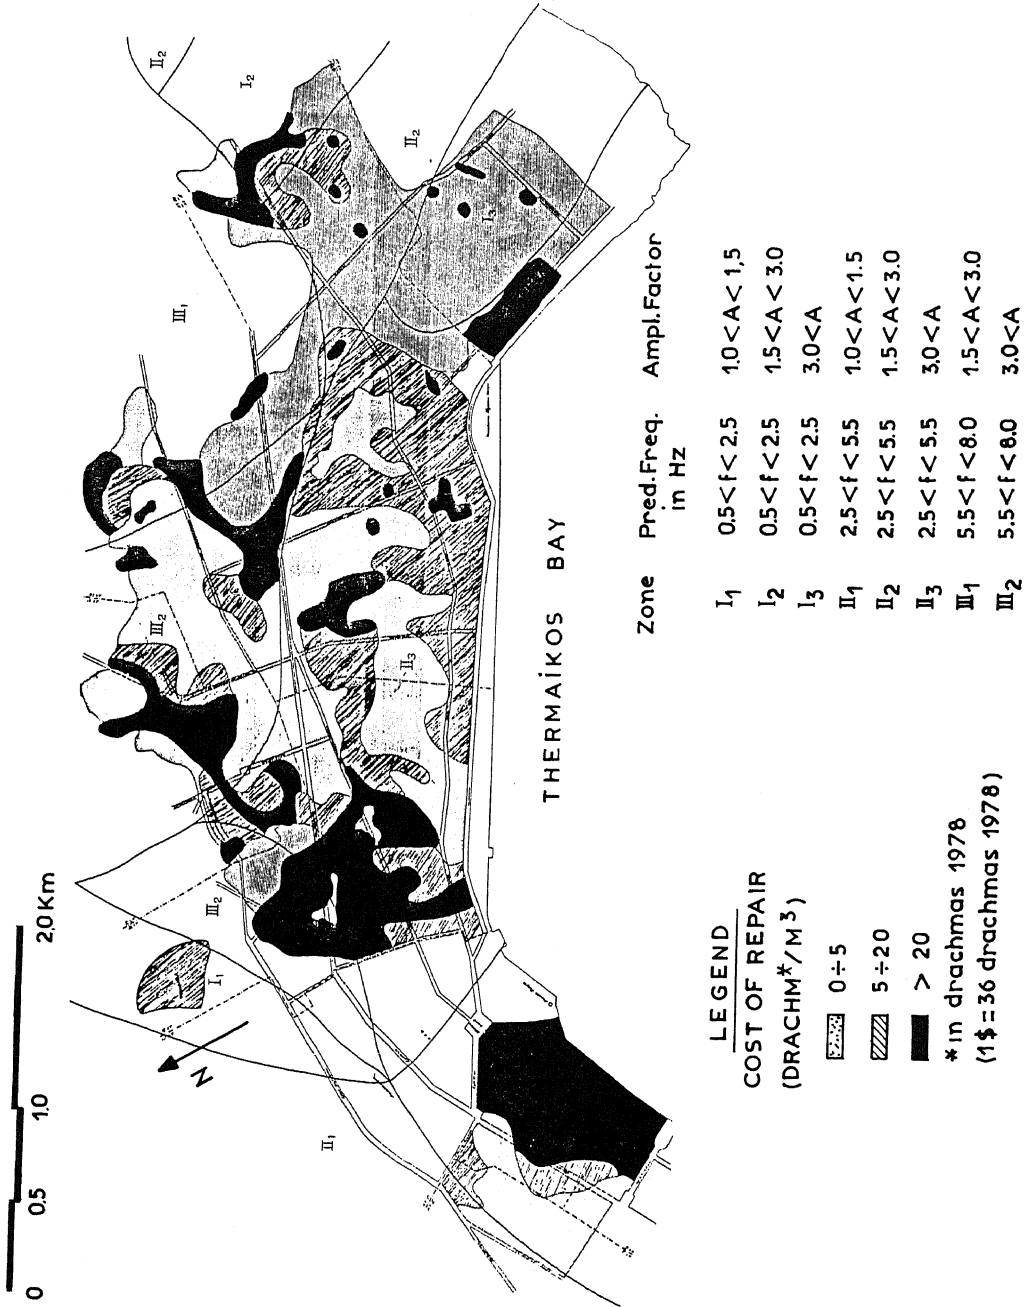
Fig. 4 Correlation between microzonation maps and damage distribution

Correlation between microzonation maps and damage distribution To examine the damage distribution in the research area, the map shown in Fig. 4 was drawn. In this map, zones of relatively low, moderate and high cost of repair are shown. In the same map, zones of predominant frequencies and site amplification factors (after Sherif, 1973) (Ref. 1) are also drawn. The correlation between damage and microzonation maps is not bad, although damage concentration zones, not traced by the latter, appeared in some cases. It appears that the characteristics of the buildings, not affecting the microzonation maps, have equally affected the damage distribution. In any case, more research is needed in the direction of the city microzonation.
