## 12-2-2

### SEISMIC CAPACITY OF REINFORCED CONCRETE BUILDINGS WHICH SUFFERED 1985. 9. 19-20 MEXICO EARTHQUAKE

Seismic capacity of twelve reinforced concrete buildings suffered 1985.9.19-20 Mexico Earthquake were estimated by the Japanese Standard for Evaluation of Seismic Capacity of Existing Reinforced Concrete Buildings, and correlation between the estimated capacity and the degree of damage were examined. An applicability of the Japanese Evaluation Standard to Mexican buildings was confirmed.

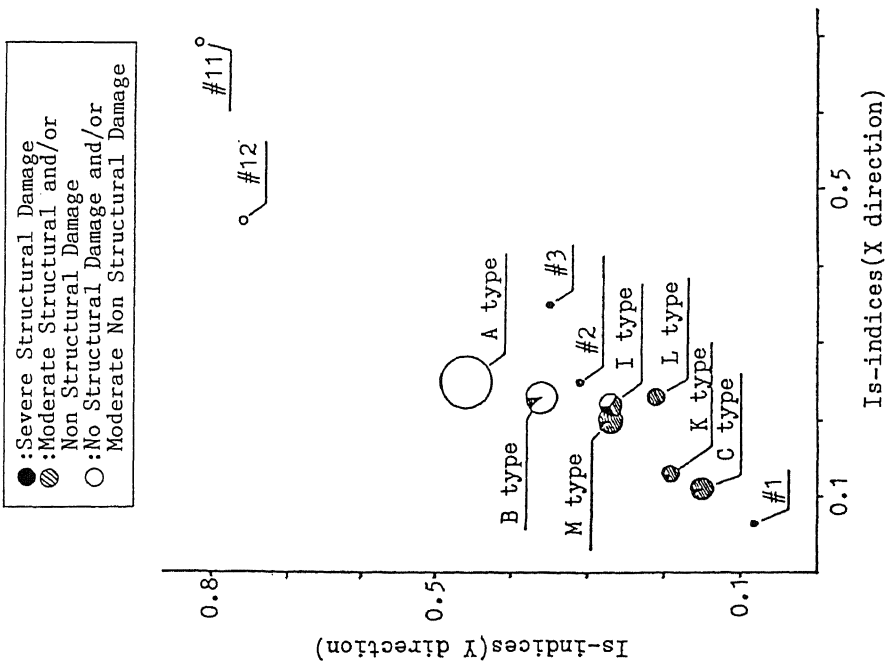
Fig. 2 Is-indices by Second Level Screening Procedures vs. Earthquake damage in Mexico [Ref.(2)]

Relationship between the estimated seismic capacity and the degree of damage is illustrated in Fig. 2. The Is-index of the east-to-west direction is plotted in the abscissa and that of the north-to-south direction is in the ordinate for each building. The mark of ● indicates severe damage and the mark of o small or slight or no-damage. The size of the mark shows the number of buildings and shaded and hatched portions show the ratio of severe damage, and medium damage, respectively. According to decrease of the Is-indices, the number of damaged buildings increase and the Is-index of around 0.4 is a border between damage and no-damage.

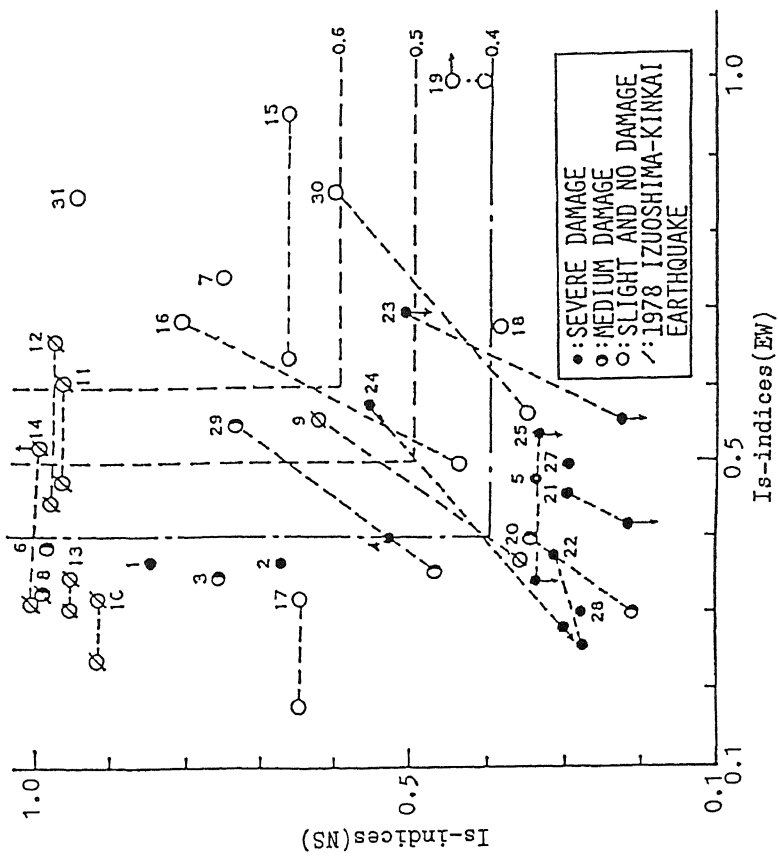
Fig. 3 Is-indices by Second Level Screening Procedures vs. Earthquake damage in Japan [Ref.(5)]

Fig. 3 demonstrates the similar characteristics of Japanese buildings experienced 1968 Tokachi-Oki Earthquake, 1978 Izuoshima- Kinkai Earthquake and 1978 Miyagiken Earthquake. The border of the damage and no-damage is about 0.6 in Is-index.
