SEISMIC CAPACITY AND RESPONSE OF A REINFORCED CONCRETE SCHOOL BUILDING IN MEXICO CITY WHICH SUFFERED THE EARTHQUAKE OF 1985

Shunsuke SUGANO ¹ Hiroaki ETO ²
Toshiyuki NOJI ³ and Kazuo TAMURA ⁴

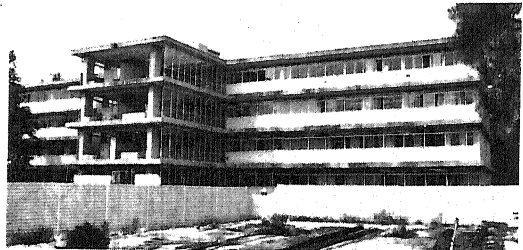
Photo 1 South View of Block E (1985.10)

The 4-story reinforced concrete building (Photo 1, Fig.1), suffered moderate damage to structures and moderate or severe damage to nonstructural elements during the earthquake of September 19, 1985. One month after the earthquake, this building was inspected by the authors' team with respect to the features of damage, properties of materials and vibrational characteristics of the building and the ground. The inspection was made as one of the activities of the technical mission which was sent to the Department of Federal District of Mexico (DDF) by Japanese Government through Japan International Cooperation Agency (JICA), in accordance with the cooperative program.

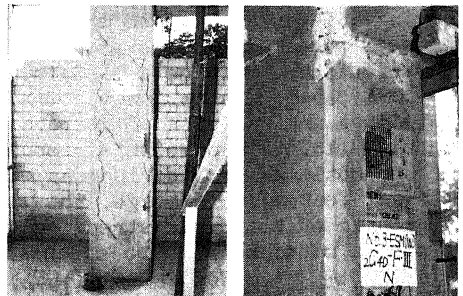
(a) Block E (b) Block W
Photo 2 Damage to Columns

Different types of damage to columns were observed between two blocks. Typical damage in Block E was caused by the bond-splitting as shown in Photo 2(a) and Fig.5, while that in block W was caused by the flexural compression (Photo 2(b)). The buckling of reinforcement, however, was not observed in any columns. No significant damage appeared on the Losa Plana except a few minor cracks on the floors. Nonstructural walls of hollow bricks suffered very severe shear cracks, fell down and/or turned over in the staircase and on the adjacent frames. Tilting and settlement were not observed. The observed damage levels of columns (Ref.4) are shown in Fig.6. The damage rank of a total building (Ref.4) was classified into "moderate damage", therefore, the strengthening by appropriate methods along with repair was recommended(Fig.7)(Ref.2).
