SEISMIC PERFORMANCE OF STRENGTHENED BUILDINGS IN 1985 ZIGONG, SICHUAN EARTHQUAKE

Niu Zezhen¹ and Li Dinggen²

SUMMARY

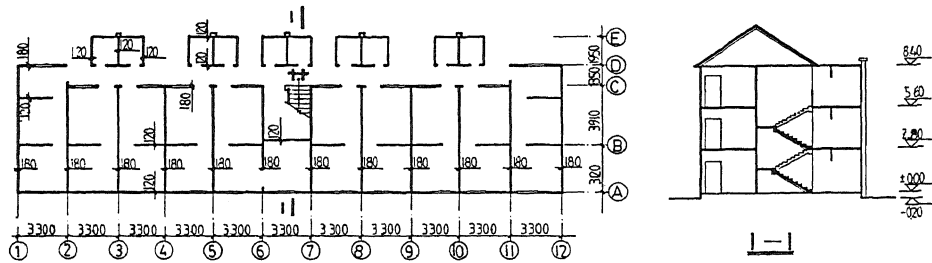
Fig.6 Typical three story brick housing with corridor exposure

It was built in early 1970's. The grade of mortar is 25#. The roof structure supporting on gable bearing walls consists of tiles, rafters, and purlins. The floor structure is formed by precast R/C slabs. Cast-in-situ R/C ring beams are laid on exterior walls at the floor level for each story. Two $\phi 4$ tie steel bars are laid on wall intersections each 600mm along the height. The plan and elevation are shown in Fig.6. The building was evaluated by current seismic evaluation criterion(Refs 5). It follows that the earthquake resistance of transversal walls coincides in criterion's requirements. The longitudinal walls, however, are small for their earthquake resistance. The safety factors of earthquake resistance for longitudinal walls are shown in Fig.8 with dot and dash line. The building was strengthened in 1984. The rear longitudinal wall(A axis) and exteriorly longitudinal walls of kitchen(E axis) were strengthened by adding cement mortar coating with thickness of 30mm on exterior surface of the wall(Fig.2a). Reinforced cement mortar coating ring beam(Fig.3c) and R/C ring beams(Fig.3b) were placed at the top level of interiorly transversal walls in first, second stories and third story respectively.

Thanks to strengthening before the event, the two exemplified buildings mentioned above were intact and showed good performance during the earthquake.

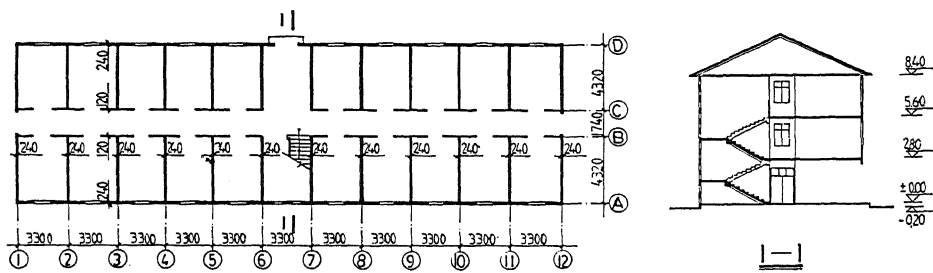
Fig.7 Plan and elevation of office building of Zigong Third Radio Plant

Building 2 Office building of Zigong Third Radio Plant It is also three story brick building with interior corridor as shown in Fig.7. The brick walls was laid by normal brick and 10# grade mortar with cavity except staircase walls in first and second story and all of the interiorly longitudinal walls. Those walls are solid brick walls and their thickness are 240mm and 120mm respectively. The thickness of cavernous brick walls is 240mm. The roof structure is the same with Bldg.1. The floors were made of precast R/C slabs. The cast-in-situ R/C ring beams are placed on the top of the brick wall at the eaves level. The building was evaluated by current criterion(Refs.5). It shows that the seismic strengths of transversal walls conformed to the requirements specified in the criterion. The safety factors of seismic strengths of longitudinal walls are shown in Fig.8 with solid lines. The building was strengthened in 1984. The exteriorly longitudinal walls and intersections of interior and exterior walls were strengthened by vertical reinforced cement mortar coating belts(Fig.4b). R/C ring beams(Fig.3a,b) and steel tie rods (Fig.4a) were placed at the top level of each story's walls.

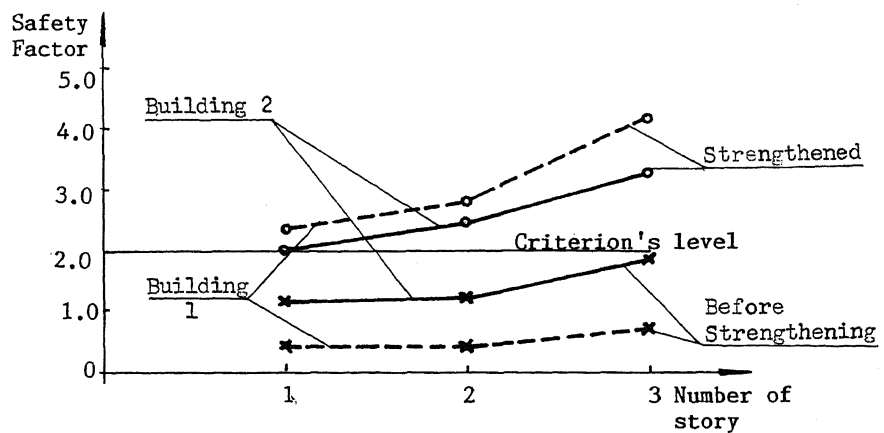
Fig.8 Safety factors comparison between original and strengthened longitudinal walls

Evaluation The safety factors of seismic strength of the wall(K) can be calculated by the following formula:

$$K = [A/F]_R / [A/F]_{\min}$$

Where, $[A/F]_R$ denotes the real ratio of wall to floor area of the wall considered, $[A/F]_{\min}$, the minimum ratio of wall to floor area of the floor concerned.
