SEISMIC STRENGTHENING OF PALO ALTO CIVIC CENTER

Roland SHARPE¹ and Edgar UGARTE²

SUMMARY

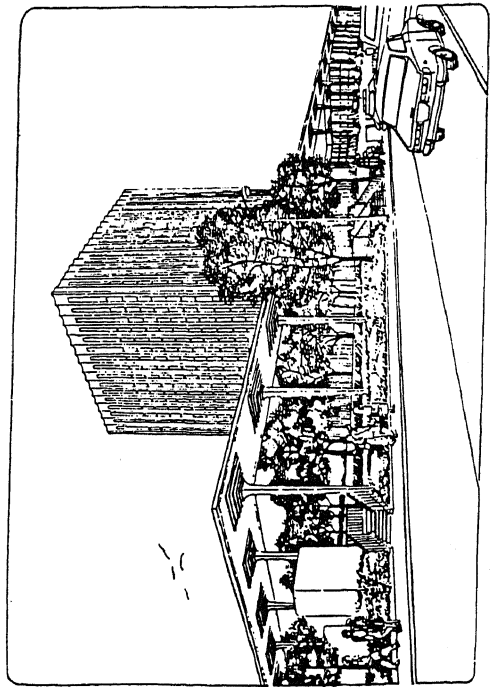
FIGURE 2. PALO ALTO CIVIC CENTER BEFORE / AFTER RETROFIT

The initial design and construction for the building was in general accordance with the 1961 Uniform Building Code. The building consists of an 85-foot square eight-floor tower supported on a three-story below-grade parking garage 242 by 272 ft. in plan (see Fig. 2 and 3), with elevators serving all floors. The tower is constructed with reinforced cast in place concrete columns and walls, and post-stressed slabs and girders. The garage is constructed with reinforced concrete columns and exterior walls with post-stressed concrete slabs and girders. An expansion/contraction joint divides the garage into two parts.

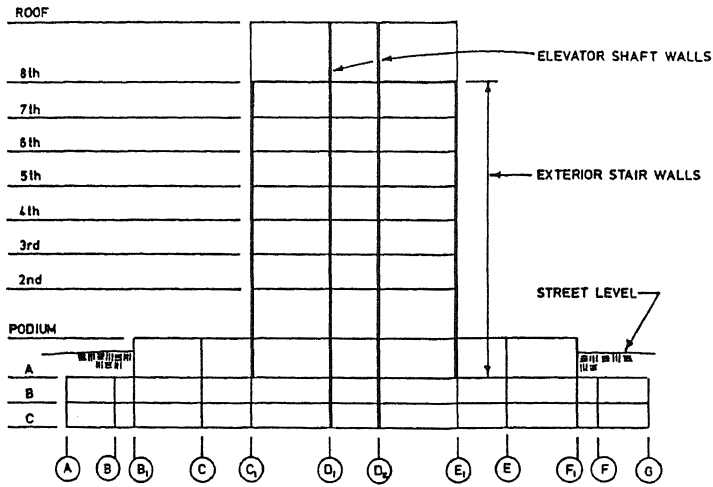
FIGURE 4. SCHEMATIC SECTION LOOKING NORTH

The tower's exterior cladding is precast concrete facade columns with window walls in between. Tower story heights are 12 feet except for 23 high for the first and the eighth stories (see Fig. 4). The parking story heights vary from 10.00 ft to 13.75 ft. Lateral force resistance was provided by the walls of the elevator shaft and the exit stairways, and the rear wall of the restroom areas

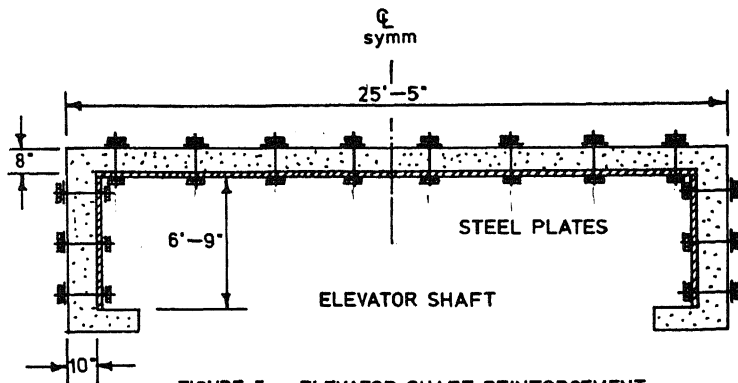
FIGURE 5. ELEVATOR SHAFT REINFORCEMENT

The 1982 seismic risk study showed that the lateral force resisting system for the tower was inadequate. Shear walls were missing from the eighth story and in the garage levels below the tower, shear resistance of walls on other floors was inadequate, concrete columns supporting the perimeter walls were overstressed in the lower levels, and connections of the precast facade columns to the structure were overstressed.

Initially it was planned to thicken the concrete walls of the elevator shaft on the exterior. However, careful inspection of running clearances in the shaft revealed that there was enough clear space (2.5") to install steel plates against the concrete walls. It was decided to strengthen the walls with 0.5" and 0.63" thick steel plates anchored with bolts through the walls and epoxy injected between the plates and the wall (see Fig. 5). This solution minimized impact on

adjacent office spaces and did not reduce usable office space which was at a premium.
