12-4-9

## SEISMIC RETROFIT OF A RC BUILDING: A CASE STUDY

A twelve-story reinforced concrete frame building located in Mexico City was repaired and strengthened after suffering extensive damage during a moderate earthquake that shook the city in 1979. The building suffered no damage during the great Michoacan Earthquake that rocked Mexico City on 19 September 1985, even though the shaking was much greater than that in 1979. Forced vibration tests and analytical studies were conducted on the building to determine why the building behaved so well during this earthquake. Results indicate that the steel braced frames that were attached to the building strengthened it, and they stiffened the structure, moving its natural period away from the predominant ground period of 2.0 sec.

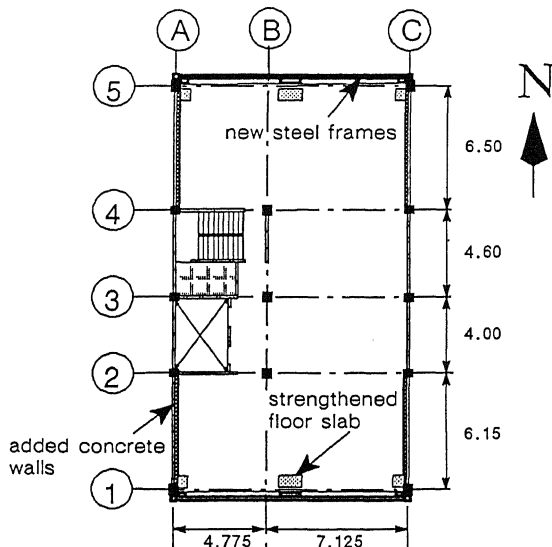
Fig. 1 Typical Floor Plan

Building Description The Durango building is a twelve-story reinforced concrete building that measures 11.9 x 21.3m in plan and stands 36.4m above the foundation level, excluding the penthouse. A typical floor plan is shown in Fig. 1. Lateral forces in the original structure were resisted by Frames 1-5 in the E-W direction and by frames A and C in the N-S direction. Frames 2 through 4 are identical and are characterized by haunched beams as shown in Fig. 2. Frame 1 and Frame 5 have only two columns each, and are identical except that the first story beam was omitted from Frame 1 to provide access for a driveway. However, deep spandrel beams were provided in Frames 1 and 5 as part of the facade. An elevation view of Frame 5 is shown in Fig. 3. This figure also depicts the location where damage occurred during the 1979 earthquake. Notice that extreme columns of Frames 1-5 are tapered continuously from bottom to top due to architectural reasons; central columns of Frames 2-4 are reduced in steps in several floors in order to save material. Frames A and C were identical, but the floor system was not connected to the columns on Frame B to form a seismic frame. Masonry infill walls were provided in Frames A and C to enclose the building and to provide minimum insulation. These infill walls were "non-structural" and were not assumed to participate with the frames in resisting seismic forces. A gap filled with celotex was provided to isolate them from the structure, as the masonry material is very stiff but weak.

New reinforced concrete infill walls were provided to strengthen the building in the N-S direction. The walls were placed in the 1-2 and 4-5 bays of Frames A and C for the full height of the building. Nails were inserted into the existing masonry walls. Reinforcing mats were attached to the nails, and the concrete was placed by trowels; the celotex plates that filled the gap between walls and structure were removed and the gap was filled with mortar. All of the new strengthening elements are shown in the shaded areas in Fig. 1.

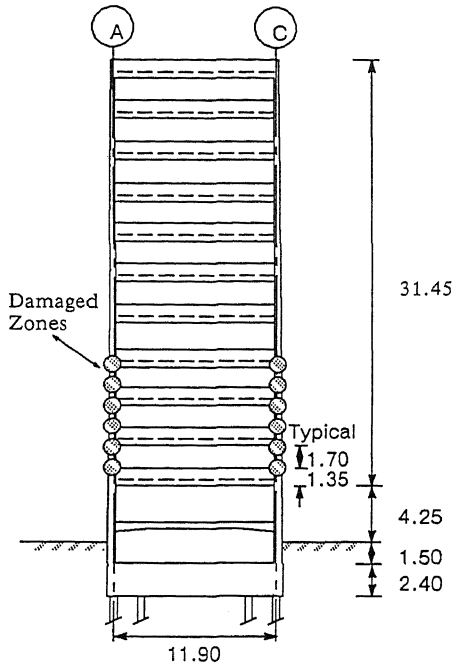
Repair and Strengthening A moderate earthquake shook Mexico City in 1979 and caused considerable damage to the Durango building as a result of shaking in the E-W (transverse) direction. The damage was restricted to the first four stories as shown in Fig. 3. The spandrel beams and columns in Frames 1 and 5 experienced diagonal cracking over much of their length in the first floors. In addition, the beam-column joints of these frames suffered severe cracking and spalling. The middle column in the fourth story of Frame 3 suffered cracking and crushing.

Fig. 3 Elevation View of Frame 5 Showing Damage that Occurred During the 1979 Earthquake

The cracked beams and columns were repaired with epoxy injection. The columns of Frames 1 and 5 were encased in steel through the fourth story level. Braced steel frames were attached to Frames 1 and 5 on the outside of the building to increase the strength and stiffness of the structure in the E-W direction. An elevation view showing the braced frames is shown in Fig. 4. The columns of the frames and diagonal bracing at the first level were fabricated steel boxes. The other bracing members were made from 2 channels placed toe-to-toe with gusset plates between them. New footings and piles were placed under the columns of the new frames and were attached to the original foundation to ensure monolithic action. A 1.3m wide section of the floor slab was strengthened at each location where the new steel frame was attached to existing structure.

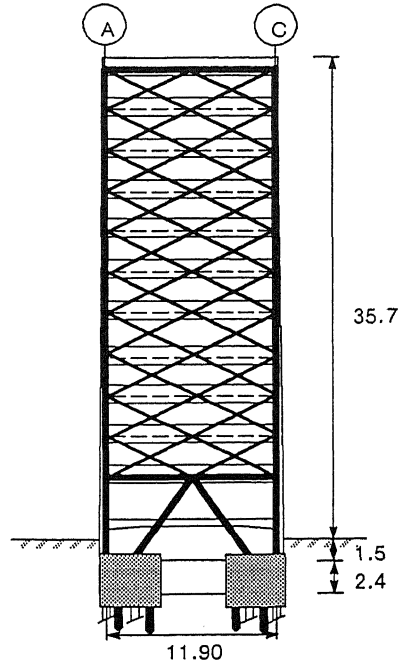
Fig. 4 Elevation View of Frame 4 Showing New Steel Frame
