FORCED VIBRATION STUDIES OF AN RC BUILDING RETROFIT WITH STEEL BRACING

Keith D. HJELMSTAD¹, Douglas A. FOUTCH¹,
Enrique DEL VALLE², Ruth E. DOWNS¹

¹Department of Civil Engineering, University of Illinois, Urbana, Illinois, USA

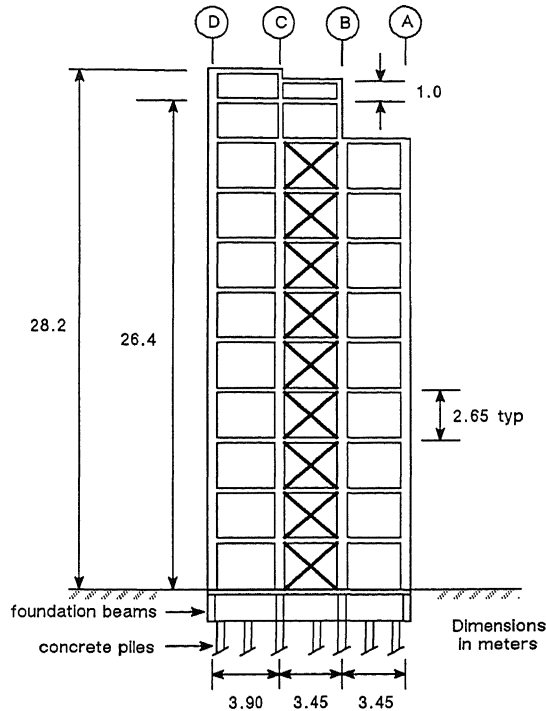
Fig. 2 N-S Elevation of Building

Repair and Strengthening. The building was severely damaged during the 14 March 1979 Mexico earthquake ($M_s = 7.6$). One of the fourth story columns failed as a result of pounding against an adjacent four-story building located approximately 5 cm north of the Park España building. Because the floor systems of the two buildings were at a different levels, the pounding effects were aggravated and greater damage was incurred by the Park España building. The Park España building also experienced large interstory deforma-

tions of its frame, reflecting the very flexible nature of its structural system. Because no gaps were provided between the exterior wall infills and the building frames, these deformations resulted in damage to the exterior walls (both longitudinal and transverse). In addition, the longitudinal and transverse partition walls were badly cracked at several levels. No indications of foundation failure were observed.

After the 1979 earthquake, diagonal steel cross-bracing was added to the central bay of frames 1, 2 and 3 to increase the strength and stiffness in the transverse direction (Figs. 1 and 2). The cross-braces were

fabricated by continuously welding two angles together toe-to-toe to form a structural box. The columns of the three braced bays were encased in a steel lattice composed of angles at the corners and diagonal flat plates. This encasement provided the additional strength necessary to carry the increased axial forces anticipated in the columns of the braced bays. These forces result from the additional overturning moment attracted to the braced bays. Special steel collars were fabricated and placed at the top and bottom of each column to facilitate the attachment of the steel cross-braces. These collars were grouted and bolted to both the original concrete column and the adjoining slab to smooth out the transfer of forces between stories.

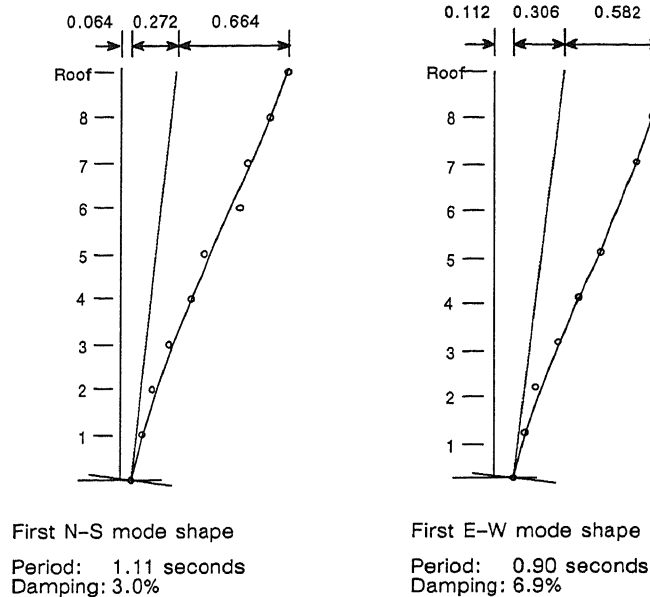
Fig. 4 Measured Mode Shapes of the Building

because the floor plan was asymmetrical and the centers of mass and rigidity did not coincide. The first five measured natural frequencies and the first two damping ratios of the building are given in Table 2. The first two mode shapes are shown in Fig. 4. This figure shows the contribution of roof displacement from base translation, foundation rocking, and structure distortion. The large influence of foundation flexibility is evident from these results.

Results indicate coupled translational and rotational response due to the asymmetry of the structural configuration. The close spacing of the two lowest vibration frequencies reflects the modal interference found to exist for the structure.

One surprising result of the vibration tests is the large amount of foundation compliance observed in the building. Figure 4 shows that over 34% of the roof motion in the N-S direction and 42% of the roof motion in the E-W direction was the result of translation and rotation of the base. The large foundation contribution to motion results from the combination of very soft soil and a stiff building.
