BEHAVIOR OF REINFORCED MASONRY CONSTRUCTION IN THE CHILEAN EARTHQUAKE OF MARCH 3, 1985

Ricardo VILLABLANCA F.¹, Richard E. KLINGNER²,
and Bjorn I. SVEINSSON³

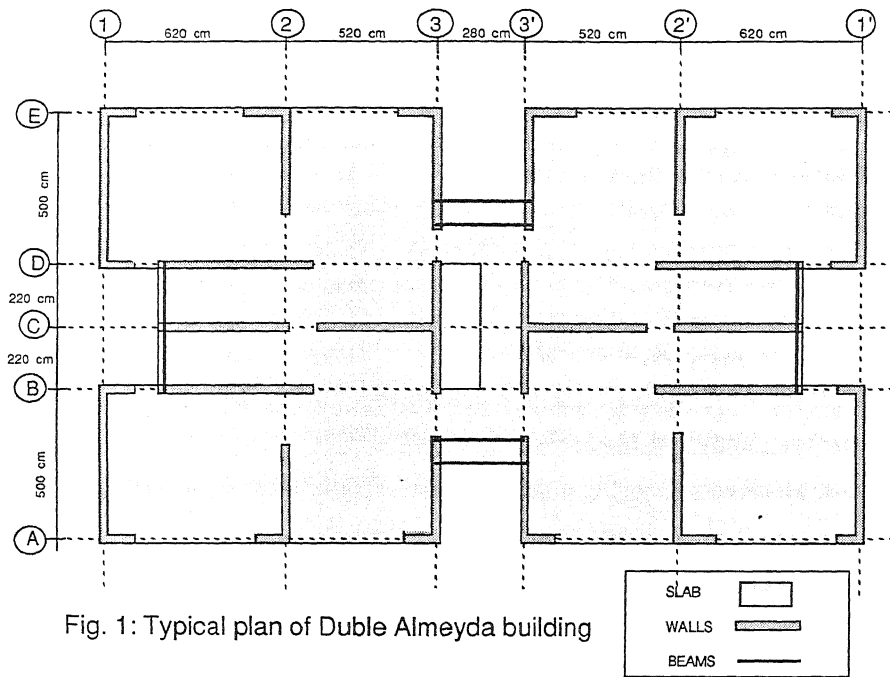
Fig. 1: Typical plan of Doble Almeyda building

The Doble Almeyda building, located in the Chilean capital of Santiago, is a 4-story apartment building of fully grouted, 20-cm concrete block walls. Its plan symmetry is evident in Fig. 1. Its wall area ratio is about 6%, evenly divided in each direction. Its floor system consists of a 13-cm, cast-in-place concrete slab. The steel used has a yield strength of 2800 kgf/cm², and the masonry compressive strength is estimated at 120 kgf/cm². The building was designed consistently with the 1985 Uniform Building Code (UBC) (Ref. 1). The horizontal reinforcement percentage for the walls is typically 0.13%, more than the minimum 1985 UBC requirement of 0.07%. The vertical reinforcement percentage is typically 0.33%. About one-third of the vertical steel is placed at each end of the wall, and the rest is distributed uniformly. Total horizontal and vertical steel percentages are 0.46%, considerably higher than the UBC minimum of 0.20%. This building resisted the earthquake of March 3, 1985 with only one minor crack. This implies essentially elastic performance, surprising given the severity of the earthquake.
