## REPAIR AND STRENGTHENING OF DAMAGED STONE HOUSES AFTER DHAMAR EARTHQUAKE OF DEC. 1982

Anand S. ARYA<sup>1</sup>

The paper presents a scheme of repair and seismic strengthening, as recommended by the author, for about 13500 stone buildings damaged during Dec. 1982 earthquake in Dhamar Province of Yemen Arab Republic. The main causes of damage are outlined and the essential elements necessary for earthquake resistance are explained with practical details. The cost of total repairs was estimated less than 20% of reconstruction cost. One post office building was strengthened as field illustration.

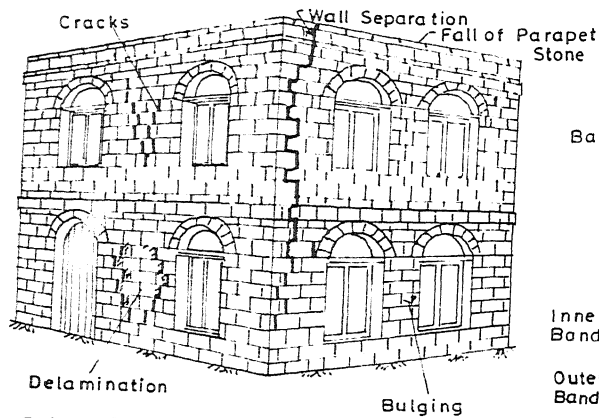
- (a) Vertical or slightly inclined cracks near outer corners indicating separation between the perpendicular walls, usually wider at top and finer towards base.
- (b) Bulging of outer wythe of masonry in walls indicating its delamination and falling away of outer wythe stones in certain parts of the walls.
- (c) Random cracks near the corners of openings, and disturbed parapet stones.

FIG. 1 - DAMAGED YEMENI HOME

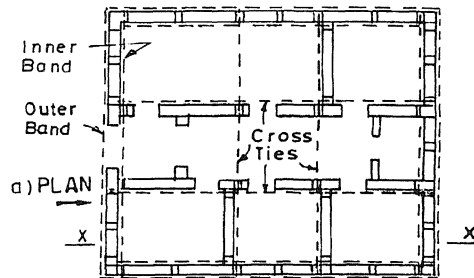
FIG. 4 - BAND AND CROSS-TIES

as in new constructions. But the strengthening work of the existing house can be simplified by using cross-ties instead, running by the sides of the internal walls reaching to outside of the external walls to hold the opposite external walls together. The cross-ties will also reduce the horizontal span of the bands on the external walls, thus ensuring integral box like action of all the walls. Fig. 4 shows the proposal schemetically.

(d) Installing Reinforced Concrete Band : This will involve the following steps (see Fig. 4 and 6).

(i) Making through hole in the walls, one stone in size, just below the roof or floor, one each at the ends of spans at a spacing not more than 5m, through which the cross-ties may be installed. Additional holes will be made at centre of these spans for providing additional shear-connection between outer and inner bands.

(ii) Installation of cross ties through the holes and filling all holes in internal walls with concrete 1:2:4. The cross ties are placed at two points in each direction dividing the length or width of the building in three parts, each less than about 5m in length. The ties consist of two high-strength-deformed bars 10mm dia.

(iii) Installation of band steel on outside and inside faces of the external walls. This will consist of two bars 10mm dia on each face which can be placed in position by driving concrete nails in the stones at about 0.9m apart at the correct level, supporting the bars on the nails and tying with them by wire.

(iv) Inserting U-shaped stirrups, 8mm dia, two from outside and two from inside in each hole so as to go round the 10mm dia longitudinal bars and be tied to them.

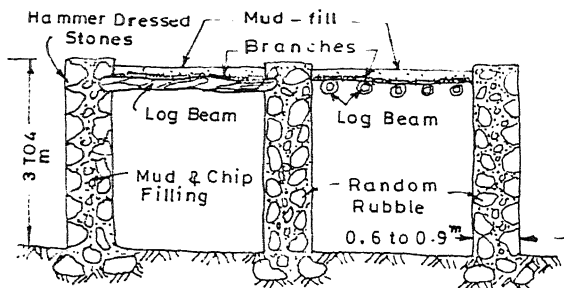
The stone wall thickness usually varies from 50 to 75cm, but may even be 90cm. Larger stones, from 20 to 30cm in width and height are provided to make the outer and inner wythes of a wall, and the space in between is filled with loosely broken stone chips along with clay mud. In some old homes the mud is washed out by rain.

FIG. 2 - TYPICAL CROSS SECTION

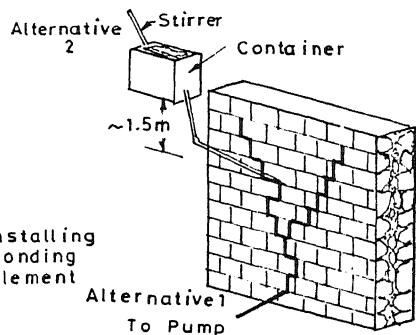
FIG. 5 - GROUTING OF CRACKS

(a) Grouting in cracks : For fine cracks, the grout should be gypsum-water fluid like mixture or neat cement and water in the ratio about 1:1. For wide cracks, it may consist of cement and fine sand in the ratio of 1:1 or 1:2 depending upon the crack width and water added to obtain free flowing consistency. For grouting operation, a low pressure mobile grouting pump run on diesel will be suitable. But it could be carried out by using a container kept about 1.5 to 2m higher than the cracked area and grout allowed to flow freely through a plastic pipe into the cracks. The cracks to be grouted will be sealed with mortar first along their length leaving a few ports open to receive the nozzle of the grout pipe. The grouting is to be done starting with the lowest part and proceeding upwards after the lower part of the crack gets filled up, see Fig.5. It may be mentioned that it will be too expensive to fill the normal joints in dry masonry walls by this procedure, and should not be attempted.

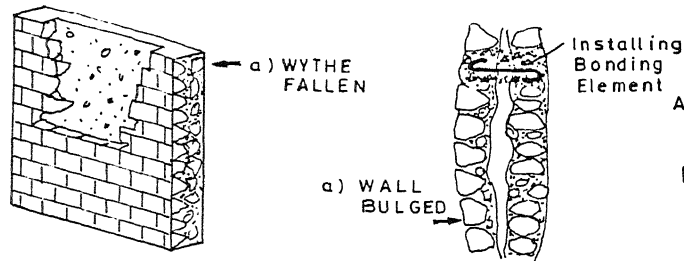
- (b) The tensile and shearing strength is very small, almost zero for masonry in mud mortar, thus incapable of resisting such imposed stresses during earthquakes. Also no 'through' or 'bond' stones are used in the walls which could have provided inter-connection of the outer and inner wythes. Thus they are free to separate out during shaking. This may be called 'delamination' of the wythes (see Fig.3). The half cut stones generally become pyramidal in space, their stability under the vertical load depending on the filler stone pieces used to keep their outer face vertical and once they become loose during shaking, the stability of the outer wythe gets disturbed. The vertical load then tends to buckle the outer wythe outwards.

FIG. 3 - DELAMINATED WALLS

(b) Stitching oof Stone wythes : For new constructions, the 'through' stones or 'bonding' elements are recommended to be provided at the rate of one per  $m^2$  area of the wall. For restoration work, however, it is considered adequate that stitching elements may be provided at one level in each storey at about mid-height between the floor and the reinforced concrete band, that is, about 1.2m above the floor and a horizontal distance of not more than about 2m. For installing the bonding element, a hole will be made through the wall by removing one external stone and one opposite internal stone. After cleaning the hole, it is to be filled with concrete while embedding a 8mm dia bar hooked at both ends in it transverse to the wall length. The length of this bar will be kept 5cm less than the wall thickness (see Fig.3). These may be omitted where cross walls exist at right angles to the external walls.

(c) Treating Bulged Walls : The grouting of the hollow will be done after installation of bonding elements whose number could be increased locally if the bulge area is large. The grouting mortar could in this case be cement-fine sand in the ratio of 1:3. Fallen masonry should be reconstructed using 1:6 cement sand mortar and installing 'through' stones or bonding element, as the reconstruction proceeds. See Fig. 3.

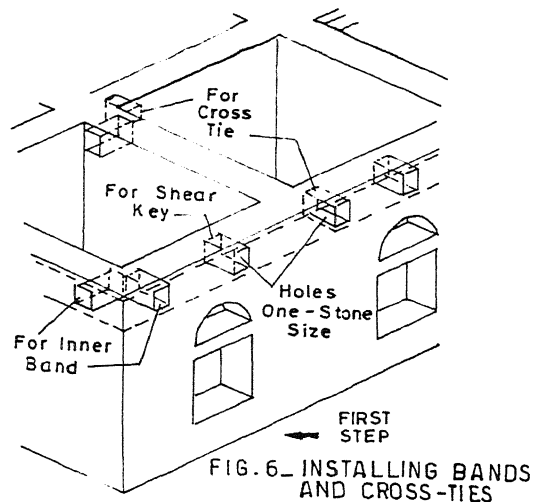
FIG. 6 - INSTALLING BANDS AND CROSS-TIES

(v) Tying of galvanized wire mesh (wire 1mm dia, mesh 25mm x 25mm) to the main bars in between the holes.

(vi) Nailing of wooden strips 4cm thick and 7.5cm wide into the joints of the stone wall to form the edges of band-concrete so as to achieve 30cm wide band.

(vii) Filling of all holes in external walls with 1:2:4 concrete, and applying cement concrete 1:2:4, using aggregate passing 10mm size, by trowels like plaster to form the concrete plate. The mesh will hold the concrete and prevent its shrinkage cracking.
