EARTHQUAKE DAMAGE BY LIQUEFACTION-INDUCED PERMANENT GROUND DISPLACEMENT

Masanori HAMADA¹, Kimimasa SAITO²,
Susumu YASUDA³, and Ryoji ISOYAMA⁴.

The damage to bridges, foundation piles and buried pipes caused by the 1964 Niigata earthquake was re-investigated from the viewpoint of liquefaction-induced permanent ground displacement, which were measured by using aerial photographs taken before and after the earthquake. A close casual relationship between the damage and permanent ground displacement was found, and it was concluded that most of the damages by the earthquake were caused by permanent ground deformation rather than inertia force of structures.

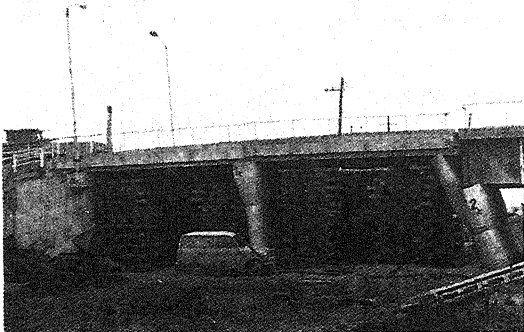
As have already been pointed out in the Introduction, a large magnitude of permanent ground displacement occurred along the Shinano River area toward the River. Photo 1. shows the damage to the pier of Yachiyo Bridge on the left bank. As indicated in Fig. 1, it is completely broken at the middle of the pier. According to the investigation conducted immediately after the earthquake, ground displacement had been caused toward the River displacing the foundation of the pier. It was then estimated that the steel girder restrained the pier from the deforming at the top of the pier and caused a large bending moment at the middle of the pier. Fig. 2 shows horizontal displacements measured near the left bank side of Yachiyo Bridge. It should be noted that the ground on the left bank side moved by 4 - 5m toward the River. It can, therefore, be concluded that these ground displacements were the direct cause of the damage done to the pier of the Bridge.

Photo 1.
Damage to Pier of Yachiyo Bridge

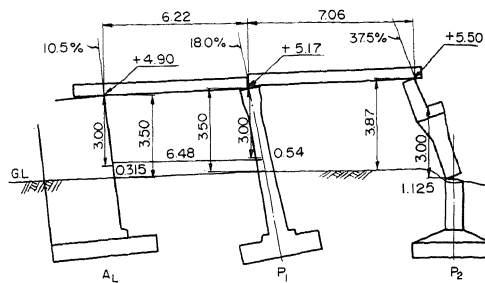
Fig. 1
Damaged Pier of Yachiyo Bridge

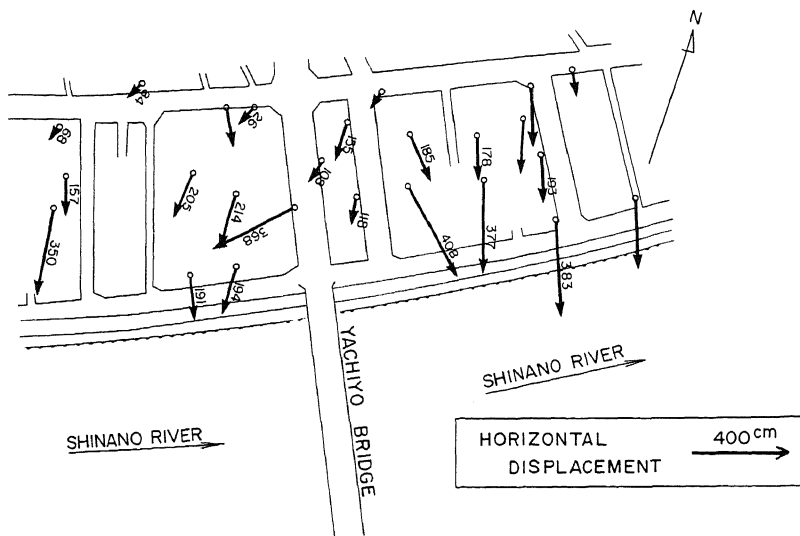
Fig. 2
Permanent Ground Displacement in the Neighborhood of the Damaged Pier

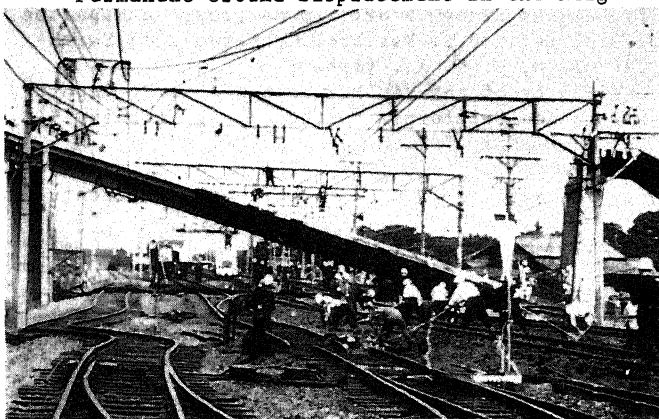
In case of the Niigata earthquake, two bridges fell down during earthquake. One of them was the East Over-Railway Bridge as seen in Photo 2. This Bridge was constructed with a simply supported steel girder with a span of 10m. The girder on the side of movable shoe slid off the pier and fell down, crushing a train running right beneath it. The foundations of the Bridge pier consisted of reinforced concrete piles of 30cm in diameter. Fig. 3 shows one of the damaged piles extracted from the ground after the earthquake. Following special features were found about the damage to the piles: firstly, a large number of cracks were seen only on the one side of the pile, and secondly, the cracks were caused in the lower portion of the pile as well as in the upper portion. These features indicate a fact that the piles were not damaged by repeated inertia force, but rather by some static external force.

The above-mentioned damage inspection and ground displacements lead to the conclusion that the cause of the fall-off of the bridges was the liquefaction-induced permanent ground displacement.

Photo 2.
Collapse of East Over-Railway Bridge

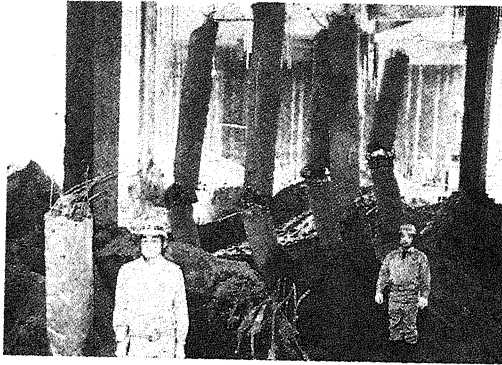
In the neighborhood of Niigata Railroad Station, damage to foundation piles are reported to have been found in two buildings. Photo 3. shows damage of piles of a three-story RC building (N Building). This damage was found by Kawamura and others twenty years after the earthquake had occurred(Ref. 5). All the piles were completely broken at two elevations: one in the upper portion and the other in the lower portion. Deformation of the piles are illustrated in Fig. 5. The horizontal deformation of the piles were estimated as 1.0 - 1.2m as shown in the Figure. Fig. 6 indicates displacement vectors in the area nearby N Building. Horizontal displacement of ground surface was about 1.5m, which agrees mostly with the horizontal deformation of the piles. In addition, the direction of deformation of the piles were heading southeast, which are almost the same as the illustrated vectors of horizontal displacement.

Photo 3.
Broken RC Piles
(ref. 5, Kawamura, S.)

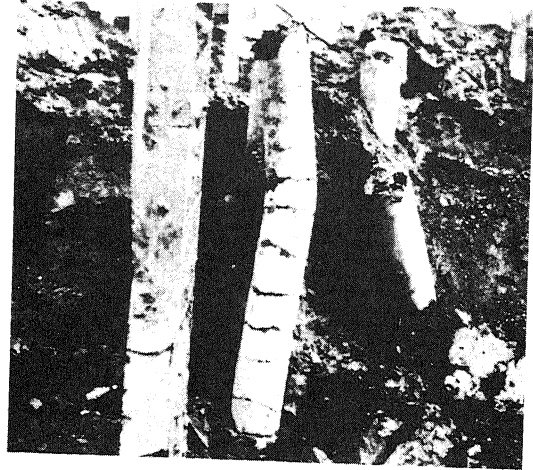
Photo 4. shows another example of damage occurred to reinforced concrete

pile, which was found during the reconstruction of a hotel building of five stories as shown in Fig. 6 (H Building). The foundation piles were totally broken and permanent displacement in the neighborhood of this Building reached over 5m.

Photo 4.
Broken RC Piles (H Bldg.)

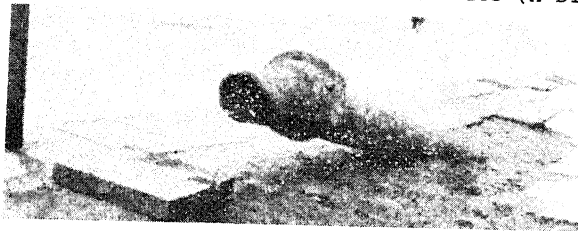
Photo 5. indicates a cast-iron gas pipeline pushed out to ground surface. This was found near Niigata Railroad Station, and horizontal permanent ground displacement in this area is shown in Fig. 7. The Figure shows strain of the ground on horizontal plane, which was calculated from the measured permanent ground displacement within the area indicated by the dotted line. A compressive strain with a magnitude of 0.3×10^{-2} was caused in the direction of the pipe axis. It is presumed that the pipe was forced out to ground surface by the compressive ground strain which triggered the buckling of the pipe, coupled with the decreased resistance of the ground in lateral direction, which was induced by liquefaction.

Photo 5.
Pushed-out Buried Gas Pipe

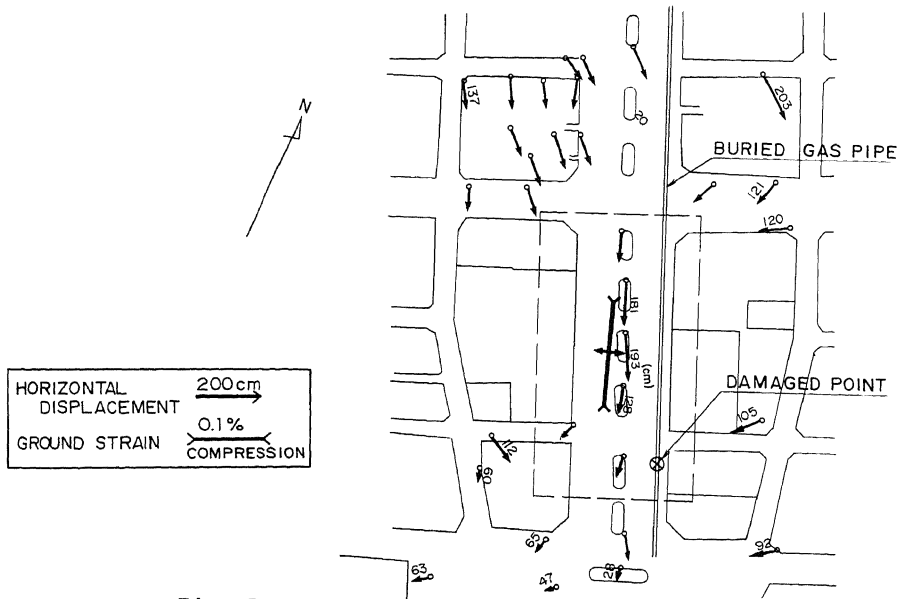
Fig. 7
Permanent Ground Displacement and Strain
in the Neighborhood of Damaged Gas Pipe
