SEISMIC TESTING ON SMALL SCALE MODELS OF ADOBE HOUSES

E. Leroy Tolles¹ and Helmut Krawinkler²

SUMMARY

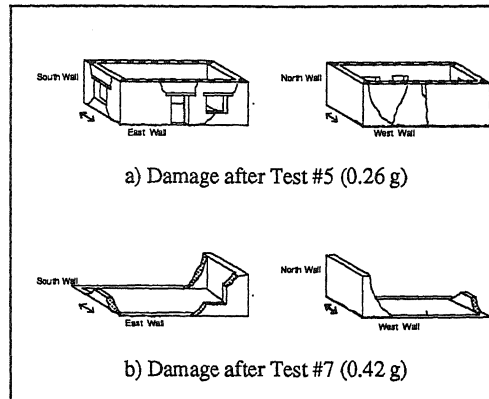
The damage to structure #1 began on Test #4 (0.23 g) with a very small crack over the doorway. The damage after Test #5 (0.26 g) is shown in Figure 6(a). During test #7 (0.42g) three of the four walls collapsed. The collapse of Structure #2 also occurred on Test #7 (0.42 g) although no previous damage had been observed. The west wall overturned and the east wall nearly collapsed.

Figure 6: Damage to Structure #1

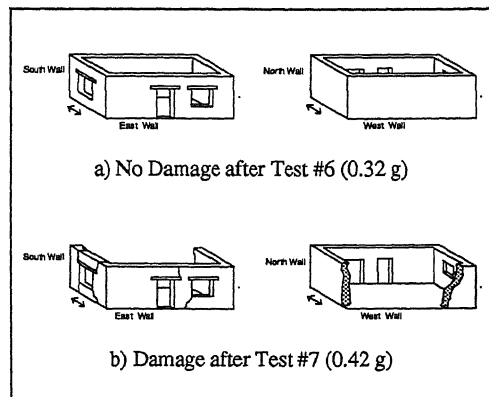
Figure 7: Damage to Structure #2

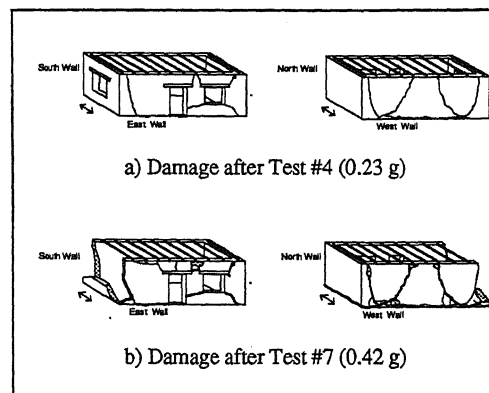
Figure 8: Damage to Structure #3

Structure #3 developed substantial damage after Test #4 (0.23 g) as shown in Figure 8(a). The damage was only slightly worse after the following two tests. After test #7 (0.42 g), the two long walls were still standing but the south wall collapsed perpendicular to the table motion. Structure #4, with the bond beam, developed cracking after Test #5(0.26 g). Because of the bond beam, relatively small cracks occurred in the long walls. The load was forced into the end walls causing greater cracking in the short wall with openings. The building was first to survive Test #7 (0.42 g) and continued standing through Test #8 (0.49 g). Test #9 (0.54 g) caused complete collapse.

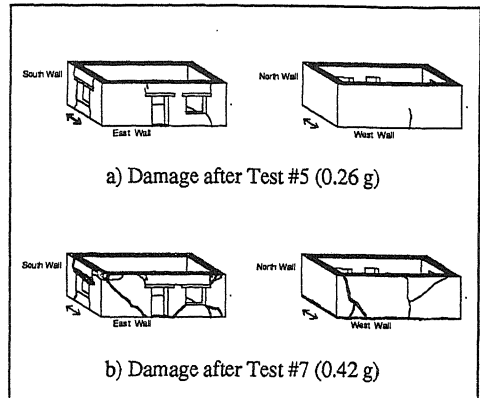
Figure 9: Damage to Structure #4

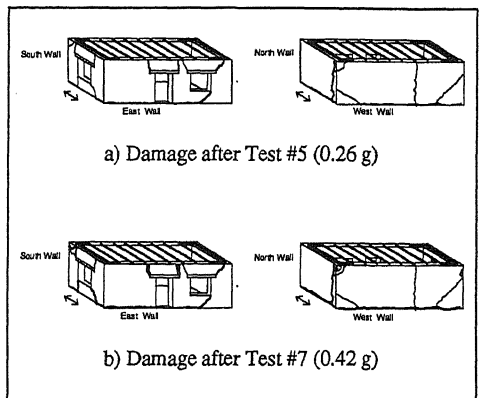
The repairs to Structure #5 proved very effective. Cracking developed early along the same lines as the pre-existing damage. This was the second model to withstand Test #7 (0.42 g) and continued until collapse in Test #9 (0.54 g). The anchored roof beams provided surprisingly good resistance to overturning of the long walls and the ties across the corners provided sufficient continuity to prevent collapse of the short transverse walls, as observed in Structure #3. Although Structure #6 was tested in the longitudinal direction, this model nearly collapsed after Test #7 (0.42 g). It did collapse at the beginning of the following test.

Figure 10: Damage to Structure #5

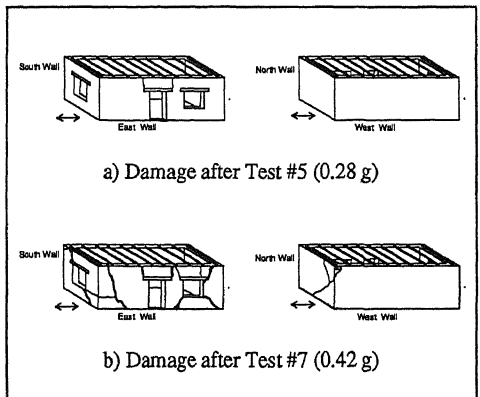
Figure 11: Damage to Structure #6

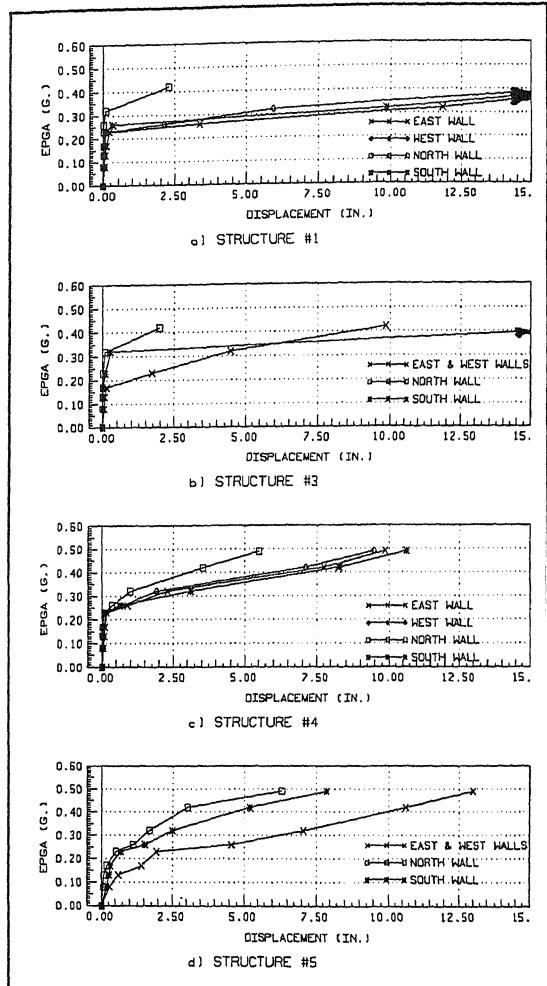
The drawings in Figure 12 and 13 summarize some of the results of the test. Figure 12 has plots of the EPGA versus the peak displacement. The lines with arrows indicated which walls have collapsed. The plots show the failure of three of the four walls in Structure #1 while only the south wall failed in Structure #3 during the test of the same severity. The plots show that both Structure #4 and #5 were able to withstand larger displacements without collapsing during more severe tests. The improvements to the latter buildings provided them with some amount of 'ductility.'

Figure 12: EPGA vs. Maximum Displacement (Arrows indicate a collapsed wall)

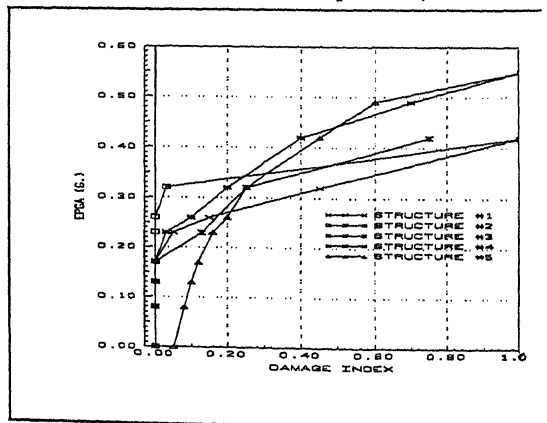
Figure 13 is a plot of the EPGA versus a subjectively evaluated Damage Index. The plot shows that Structures #1 and #3 cracked earlier but collapsed during the same test as Structure #2. Both Structure #4 and #5 were able to withstand larger ground motions without failure.

Figure 13: EPGA vs. Damage Index
