DAMAGE FEATURE OF SEWAGE PIPES CAUSED BY THE NIHON-KAI-CHUBU EARTHQUAKE OF 1983

Kazuhiko KAWASHIMA, Naomi OBINATA and Takashi KANOH

Earthquake Engineering Division, Earthquake Disaster Prevention
Department, Ministry of Construction, Tsukuba Science City, Japan

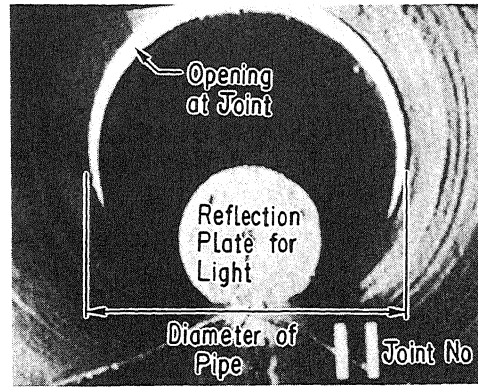
Fig. 2 Dislodgement Detected by TV Camera

direction. Fig.2 shows an example of damage detected by TV camera. Damage of pipes and joints can fully be surveyed. One more advantage of the inspection by TV camera, which had never been achieved, is a measurement on precise amount of dislodgement of joint. Because diameter of pipe and distance between the lens and the point of interest are known, an amount of dislodgement can be estimated geometrically.

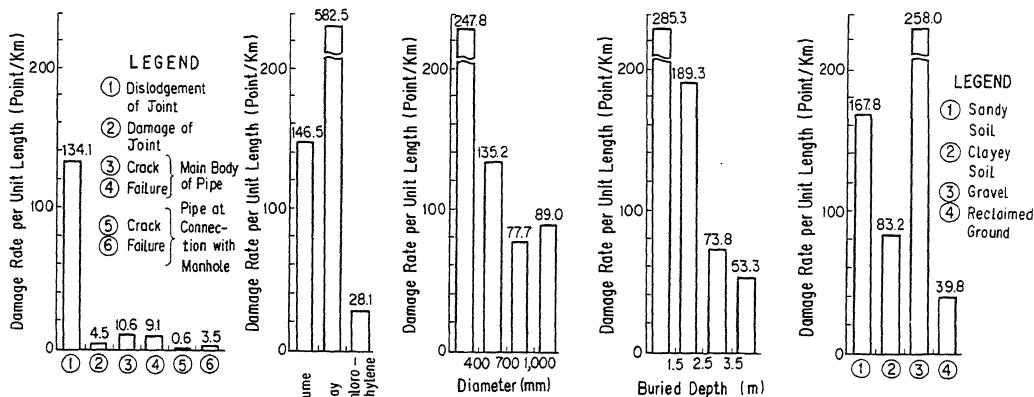
Fig. 4 Damage Rate per Unit Length

1) Damage rate of dislodgement at joint is 134.1 point/km, which is much pronounced than the pipe damage, i.e., damage rate of failure and crack of pipe is 9.1 point/km and 10.6 point/km, respectively. Summing up these damage rate as well as the damage rate of pipe at connection with manhole, total damage rate of pipe becomes 23.8 point/km, which implies that the pipe in the Akita city suffered one damage at about 40 m interval.

2) Damage rate of clay pipe, which is of earthware, is much pronounced than that of hume pipe and chloroethylene pipe.

3) Damage rate decreases as either the diameter or the buried depth increases.

4) Damage rate takes the highest value at the gravel site followed by sandy soils. It should be noted that estimation of the soil condition may have some error. Because boring data were limited, it was estimated based on informations either from city officials or surface geological map. It should be also noted here that the "gravel" defined in Fig.4 should mostly be regarded as sandy soils with gravel. High damage rate at the gravel and sandy soil sites may be attributed to liquefaction and soil movement due to liquefaction (Ref.2), which was developed widely in the city.

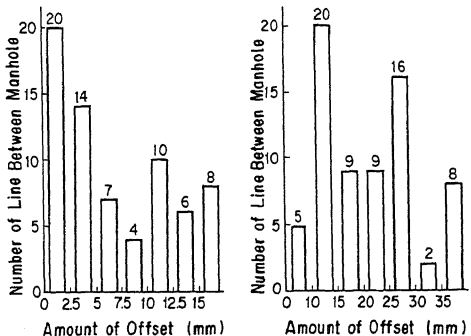
Fig. 5 Mean and Maximum Offsets Developed in Each Line

Although there are considerable scatters depending on the line, the maximum dislodgement is 30 - 35 mm (offset), 60 - 70 mm (opening) and 60 - 70 mm (pulling-out). Because such dislodgement at joint was most likely developed due to deformation of subsoils, a finite ground strain(Ref.3) may be estimated as $\Delta l / l$, in which l and Δl represent one pipe length (equals 2.4 m for hume pipe) and amount of dislodgement. From the maximum offset and pulling-out, one can compute the maximum finite shear strain of ground of $(1.3 \sim 1.5) \times 10^{-2}$ and the maximum finite axial strain of $(2.5 \sim 2.9) \times 10^{-2}$. Development of 1 ~ 2 % of ground strain is required to be considered for design of sewage pipe installed near the ground surface.

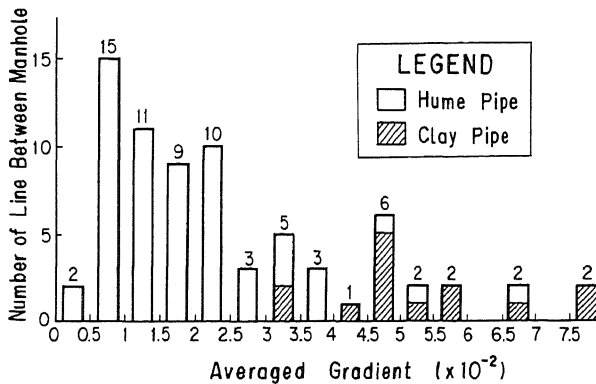
Fig. 8 Averaged Gradient of Pipe Determined from Levelling

Fig.8 shows gradients of each pipe determined from a difference of levelling at both pipe ends. Such inclination was most likely developed by the ground settlement. The gradient of as large as 8 % was developed. This corresponds to a difference of levelling of about 20 cm between both ends for hume pipe with length of 2.4 m.

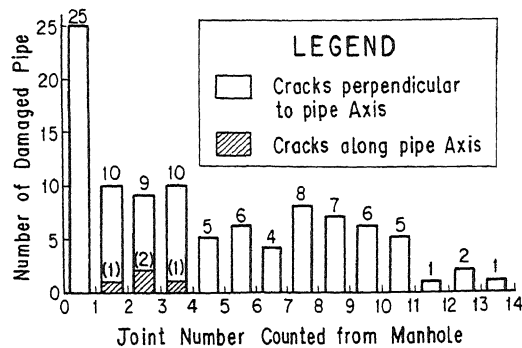
Fig. 9 Joint Where Damages Were Developed

Pipe Damage It was found from the inspection by TV camera that most of the pipe damage was cracks and/or failure in circumferential direction, and there were few cracks and/or failure along pipe axis. Fig.9 shows where pipe damage was developed, in which joint number is counted from manhole. It is obvious that the pipe damage concentrates at the first joint, i.e., at the connection with manhole. Different structural response between pipe and manhole resulted in large relative displacement at the connection.

4) Pipe damage concentrated at the connection with manhole where significant difference of structural response between pipe and manhole was developed.
