## COMPARISON OF DAMAGE DUE TO TWO RECENT EARTHQUAKES SAN SALVADOR AND KALAMATA (GREECE)

Amr S. ELNASHAI<sup>1</sup>, Kypros PILAKOUTAS<sup>1</sup>, Julian BOMMER<sup>1</sup>  
and Stephen LEDBETTER<sup>2</sup>

<sup>1</sup> Department of Civil Engineering, Imperial College,  
University of London, London, U.K.

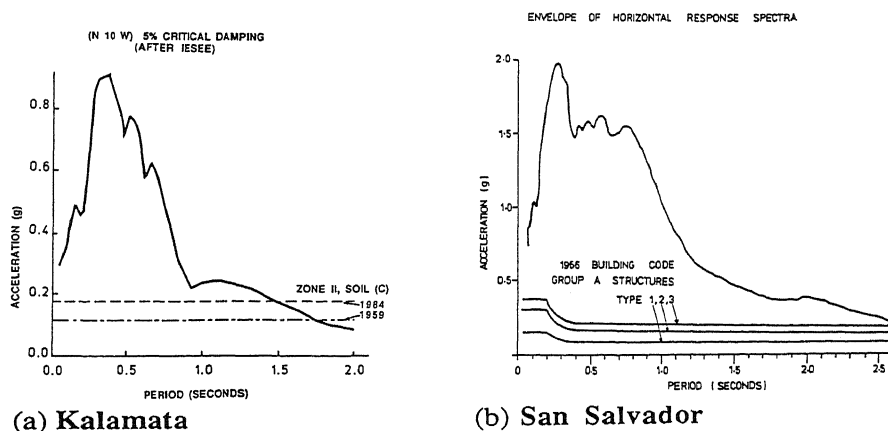
Figure 1. Comparison between Response Spectra and Design Codes

**Code provisions** Code provisions for earthquake-resistant design were first issued in Greece in 1958, and were updated in 1984. The code does not take into account the dynamic characteristics of the building; the base shear coefficient is a function of zone and soil condition only. A code for aseismic construction in El Salvador was introduced in 1946, but was not enforced. Another code was introduced soon after the 1965 earthquake, but it also is reported not to have been implemented. This code specified a base shear coefficient which unlike the Greek code was dependent on zone and dynamic characteristics, but not soil type, as shown in Figure 1.a and 1.b.

In addition to the above deficiencies, in both cases damage was aggravated by the frequency content of the earthquakes, as shown in Figure 1.a and 1.b, where the earthquake 5% damping elastic response spectra are compared to the relevant design spectra. The horizontal component exhibited high peaks corresponding to a period of 0.2 to 0.6 seconds, coincident with the natural period of 2 to 6 storey buildings. Furthermore, the vertical component peaked around periods of 0.08 to 0.2 seconds, close to the period of axial vibration of some buildings. This vertical component in some records exhibited peak acceleration of about 80% of the peak horizontal value.

- As demonstrated in Figures 1.a and 1.b, the correlation between design base shear coefficients and earthquake resistance is very weak. Ductility and energy absorption capacity may be much more relevant. It is hence important to note that increasing base shear coefficients does not necessarily lead to higher earthquake resistance.

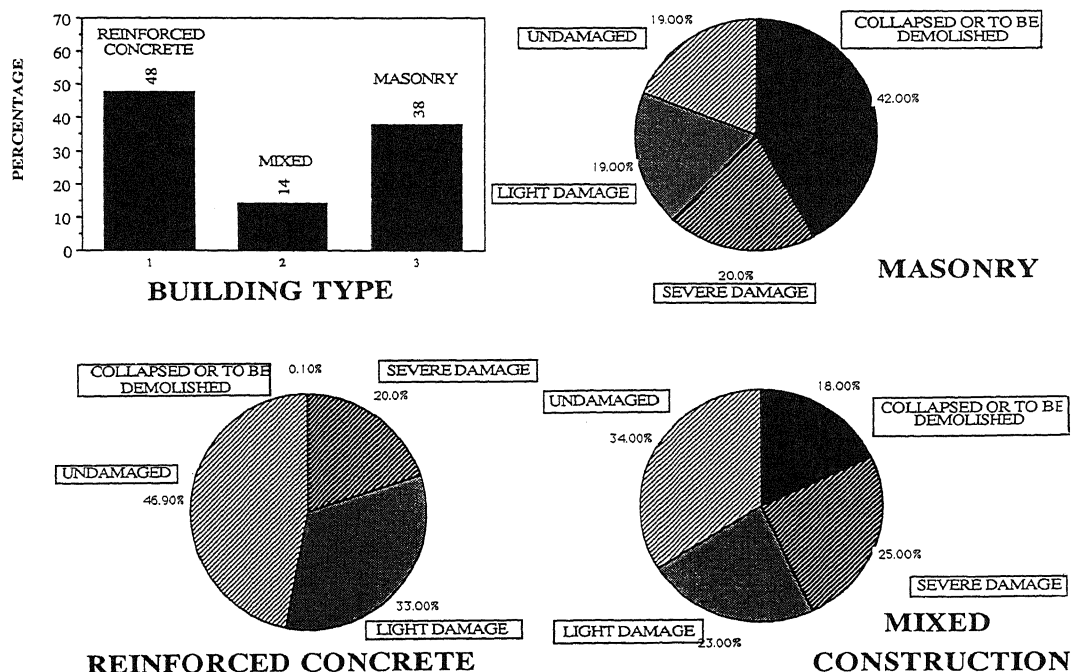
Figure 2: Damage statistics for Kalamata as reported by the Greek organization for seismic protection (O.A.S.P.).

In Kalamata, the Greek organization for seismic protection (O.A.S.P) has undertaken structural inspections of all buildings in the affected area immediately after the mainshock. The damage distribution within the three categories of buildings as reported by O.A.S.P. are shown in Figure 2 below. As can be seen, a large number of traditional buildings suffered severe damage, thus raising very substantially the cost of repair and reconstruction. The modes of failure covered a very wide range, such as out-of-plane panel failure, total collapse of roofs, severe cracking of piers and separation of walls at corners. A list of likely causes of this high degree of damage is given below. The amount of damage in San Salvador was much higher since the population density was higher in the affected area. The first estimates were that 23,000 dwellings have been destroyed and 30,000 were badly damaged and to the knowledge of the authors no detailed survey of the damage has been reported.
