# The Mw=9.0 Tohoku Japan Earthquake (March 11, 2011) Tsunami Impact on Structures and Infrastructure

E. Lekkas, E. Andreidakis, V. Alexoudi, E. Kapourani and I. Kostaki

National and Kapodistrian University of Athens, Greece

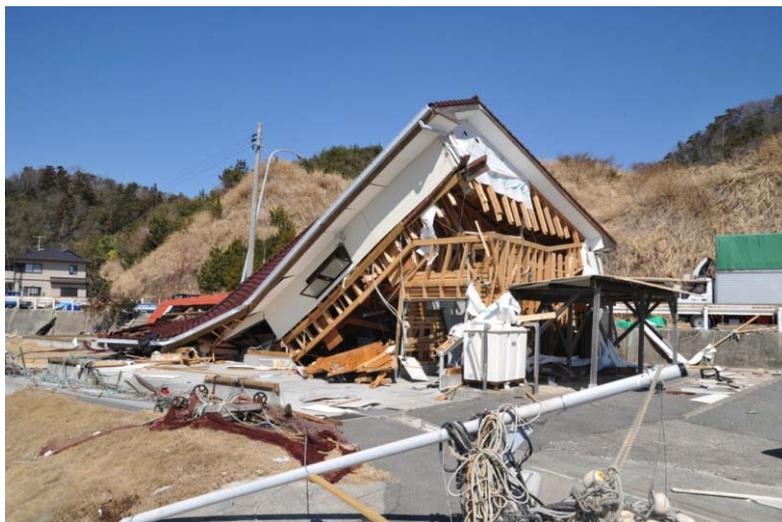
**Figure 2.** Collapse of a wood frame house in Iwaki area. Tsunami height of about 5 m.

On the contrary, the tsunami impact was devastating. More specifically, they were totally swept by the wave forces and by the impact of objects carried by the water. They were broken to small pieces of debris, which were deposited in the inundated areas, or were carried to the coast-line or the open sea, when the water receded. A great number of this particular type of constructions were swept by their footings and were carried, practically unchanged, to great distances (Figs. 2, 3, 4).

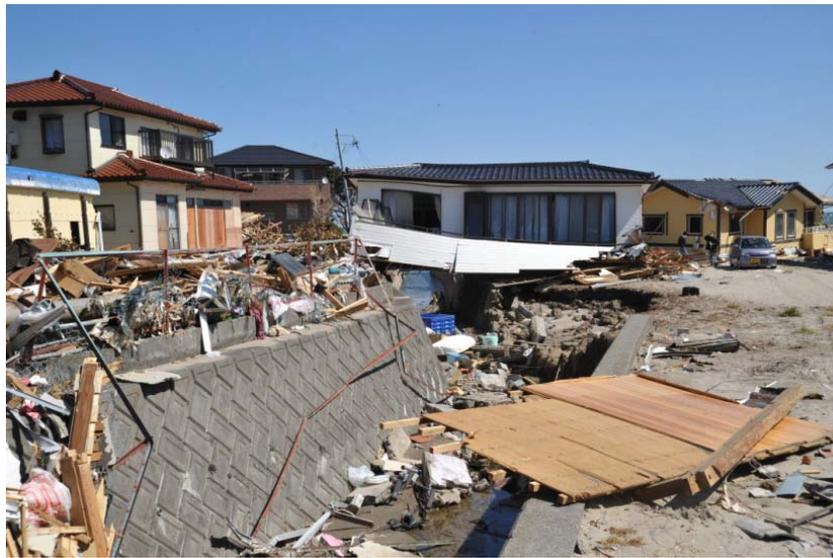
**Figure 3.** View of a wood frame residential construction and collapse of others, in Iwaki area

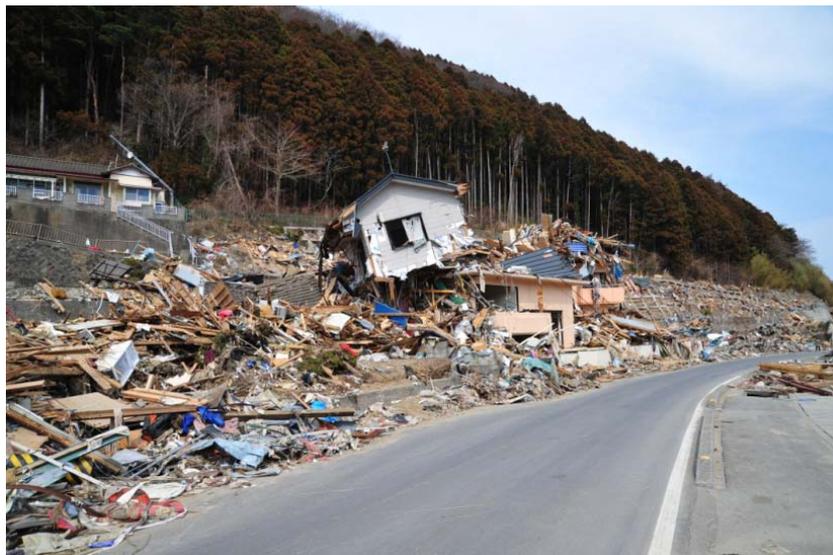
**Figure 4.** Transport and collapse of wood frame constructions in Onagawa city

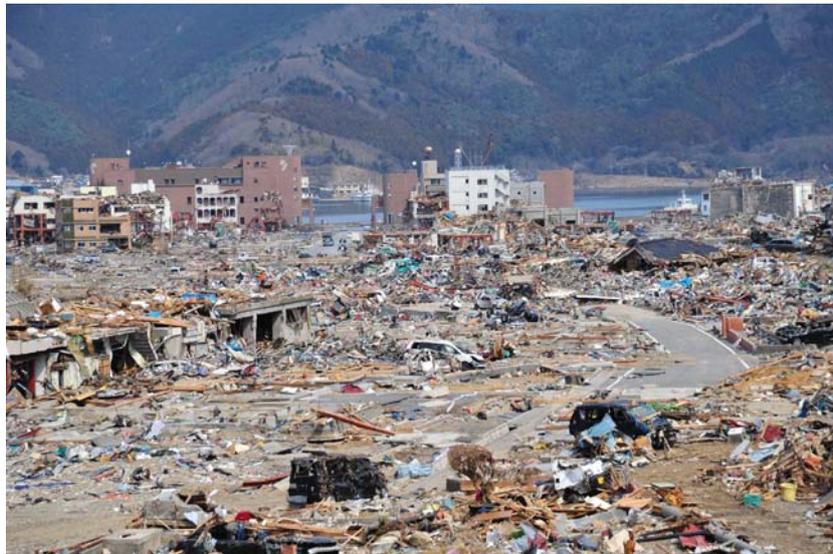
**Figure 5.** Total collapse of constructions in Onagawa area. Near the coast, engineered reinforced concrete constructions can be seen damaged but standing.

Damage to the engineered constructions was limited to broken doors and windows and masonry failures. Masonry walls suffered out of plane failures and were jettisoned in great distance, mainly in buildings constructed near the shoreline. No damage on the supporting structure caused by the tsunami was observed (Fig. 5). Only in certain areas and isolated cases, minor damage to columns was observed, resulting from the impact of debris or objects carried by the water, such as cars and boats.

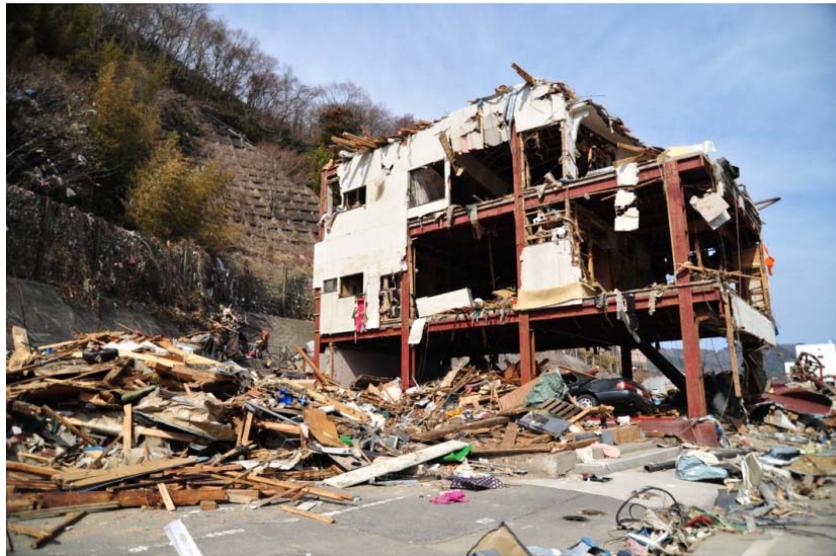
In contrast, the tsunami had important effects on these constructions, both in supporting and non-supporting elements. In most cases masonry walls out of plane punching shear failures were observed, due to tsunami lateral forces and the impact of debris carried by the water, up to the wave maximum run-up height in a given area. In many cases the steel frame buildings were left empty of all infill walls as well as flooring.

deformed) in different areas. It should be noted that the masonry of the metal frame buildings proved to be much more vulnerable than that of the engineered reinforced concrete buildings (Figs. 6, 7).

**Figure 6.** Masonry failures in steel frame building in Onagawa city

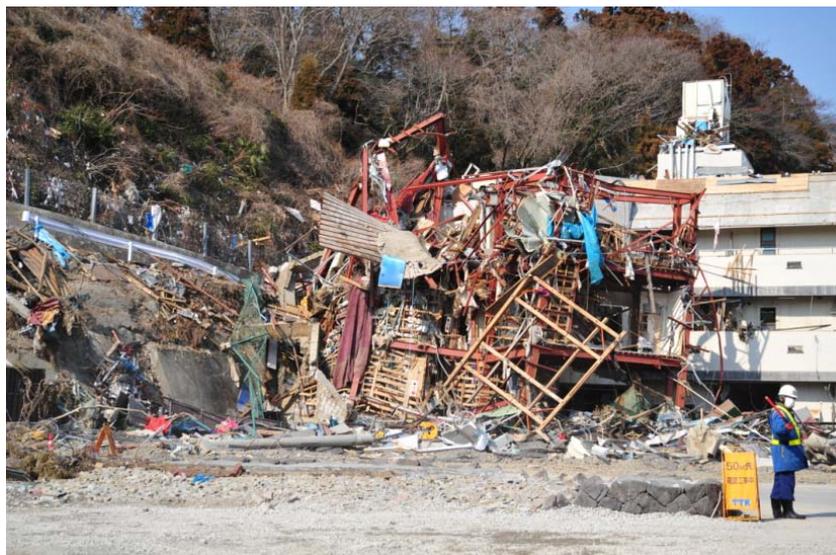
Many of these buildings, mainly those built near the shoreline, suffered great lateral loading on structural elements, resulting in a more or less general deformation of the structure. In some cases all of the steel elements were lifted from their reinforced concrete bases and were carried (totally

**Figure 7.** Total deformation of steel frame building elements in Onagawa city

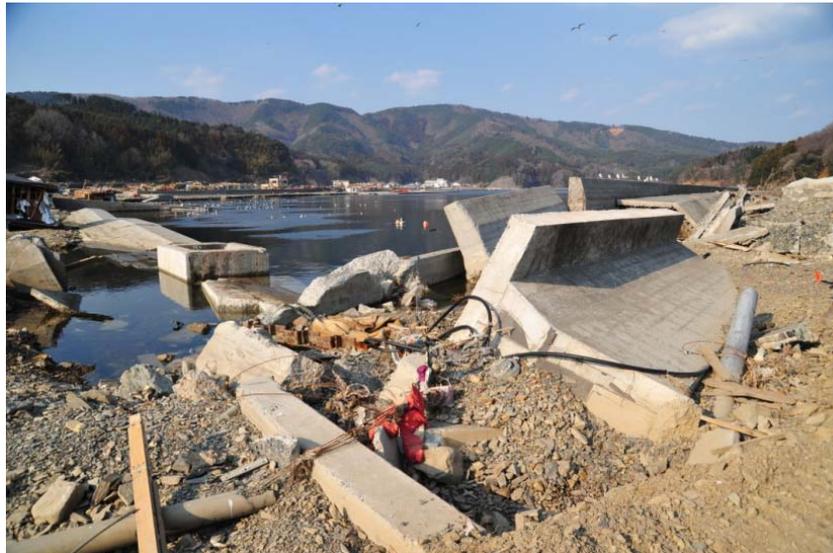
Specifically, failing and deformation of quay walls was observed, caused either by the hydrodynamic forces of the waves, or the impact of objects such as boats and containers.

In many cases the quay walls and the accompanying supporting constructions collapsed or were overturned, due to the intense scour of the foundation materials. Moreover, the seaport constructions proved to be especially vulnerable to receding waters, which caused intense deformation and overturning.

Finally, the piers constructed in order to protect against tsunami waves, could not cope with the observed tsunami, either because of inadequate or underestimated structural design, or because of collapse, resulting in devastating effects on inland areas. In addition, severe failures because of intense erosion were observed in levees and coastal river regulation constructions (Figs. 8, 9).

**Figure 8.** Destroyed port facilities and general alteration of the shoreline in Mizuhama town

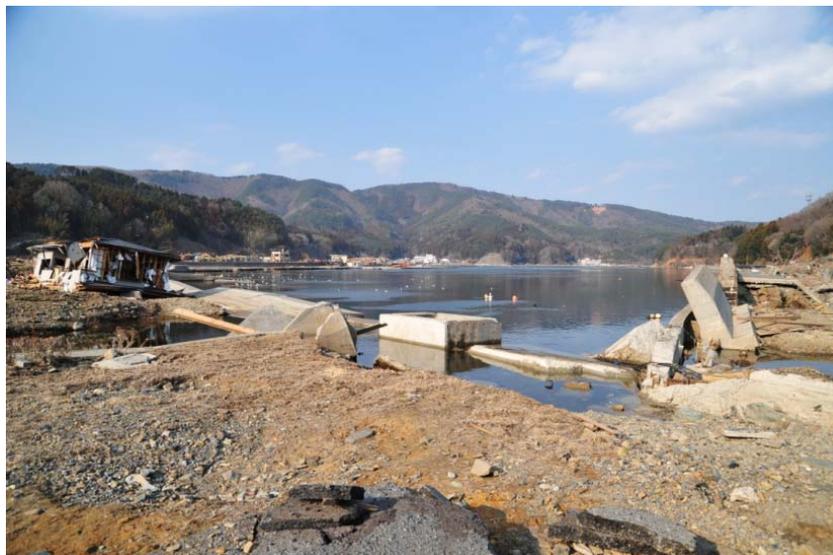
**Figure 9.** Destroyed port facilities and general alteration of the shoreline in Mizuhama town

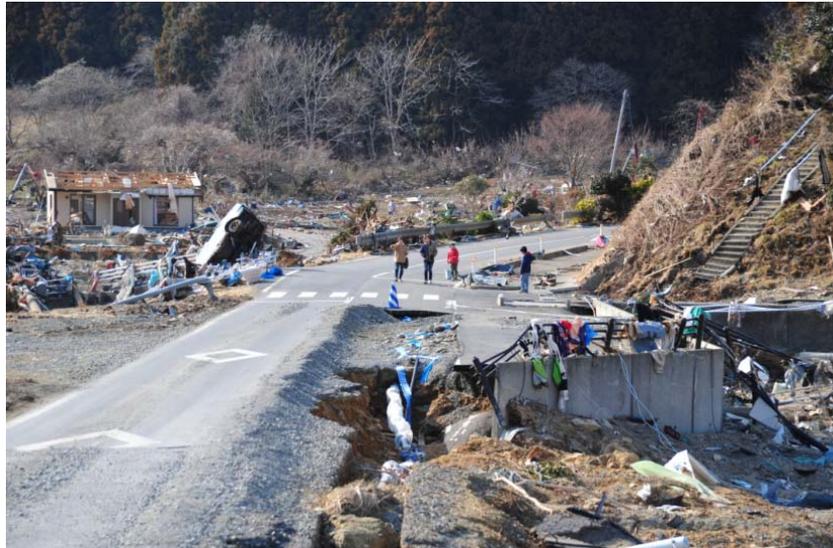
A large part of the coastal road network of the tsunami affected areas was totally destroyed, either by the waves themselves, or by debris impact. Damage was observed on the pavement, mainly caused by the erosion of the substrate material. There are also many cases in which the road deck was transferred in great distance, having suffered intense deformation (Fig. 10).

**Figure 10.** Intense erosion and destruction of road network in Ommaehema town

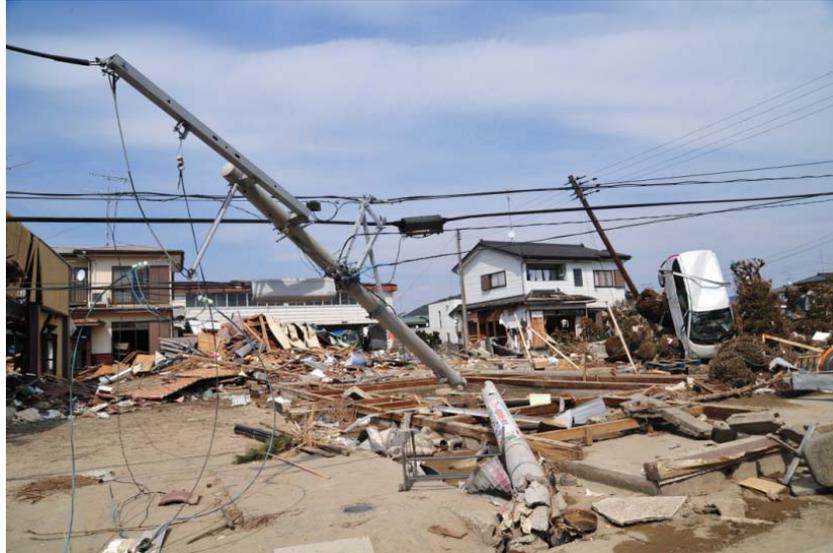
The power generation systems, telecommunication networks and mobile telephony towers were completely destroyed, resulting in the interruption of communications (Fig. 11).

**Figure 11.** Power distribution network damage in Isinomaki town
