The 2011 Eastern Japan Earthquake: Facts and Reconstruction Recommendations

H. Kit Miyamoto & Amir S. J. Gilani

Miyamoto International, Sacramento, CA, USA

Keywords: Japan earthquake, damage assessment, Warning system, Tsunami, seismic detailing

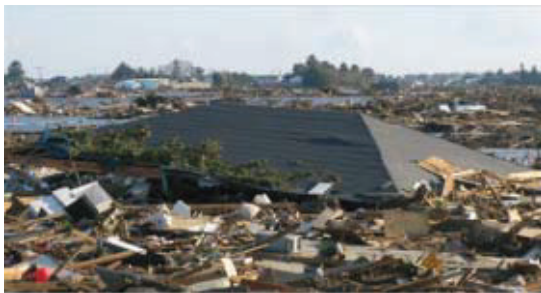
This area experienced tsunami waves of approximately 7 m. the damage was extensive and widespread. Even 5 km from the shore, many houses and structures were destroyed (see Figure 4). Typical Japanese residential housing utilizes wood framing with concrete foundation. This type of construction does not perform well for tsunami surge type of loading. In general the steel and concrete buildings have a much better anchorage to the foundation than the comparable wood construction using silt plates and anchors, which is similar to California construction; see Figure 5. Note in this figure that the superstructure has been washed away.

Figure 4. Collapsed houses 10 km from shore

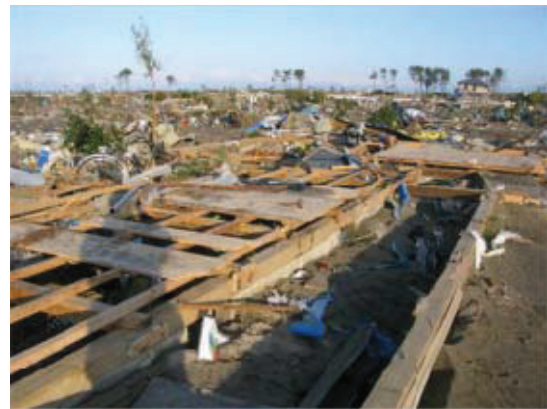
Figure 5. Typical wood frame foundation

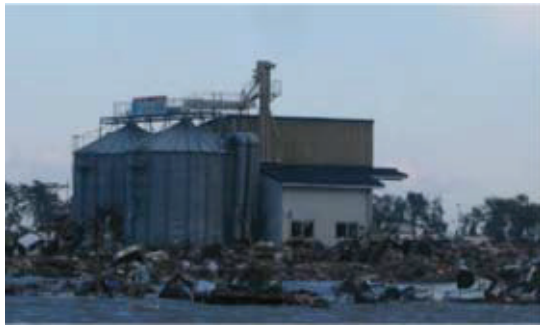
Many industrial buildings survived the tsunami (see Figure 6). This is partly because these buildings are constructed with steel and concrete and have better foundation anchorage from the super structure. In addition, the industrial buildings have seismic detailing. This seismic detailing provides toughness, system integrity, and strength for both seismic and tsunami surge and impact loading. Steel and concrete buildings performed well. For example, the 4-story concrete school building of Figure 7, located less than 1 km from the ocean, experienced 7-m high waves, and remained undamaged. The damage for the gymnasium structure was due to the water surging in from one side at the bottom floor and bursting from the other side. However, there was no evidence of structural damage. 100% of any building standing had either steel or concrete construction.

Figure 6. Survived industrial building.
2.2 Sendai

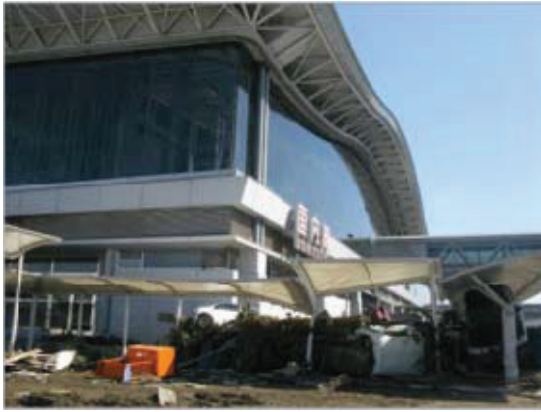
The Sendai airport was closed. The facility is located approximately 5-10 km from the ocean and sustained 2-m tall tsunami induced flood. The main structure itself did not sustain much damage; see Figure 10. Many industrial facilities located close to the port were undamaged (see Figure 11). However, financial losses for this sector are large due to business interruptions. The seawall in this area was about 6 m tall; see Figure 12. There was a lot of damage to the wall likely caused by the erosion and landslide as the result of suction as the water goes over the top. There was no damage on the ocean side of the wall; see Figure 13 Note that the dolos stopped at the place where damage to the seawall becomes more pronounced.

Figure 10. Sendai airport main building

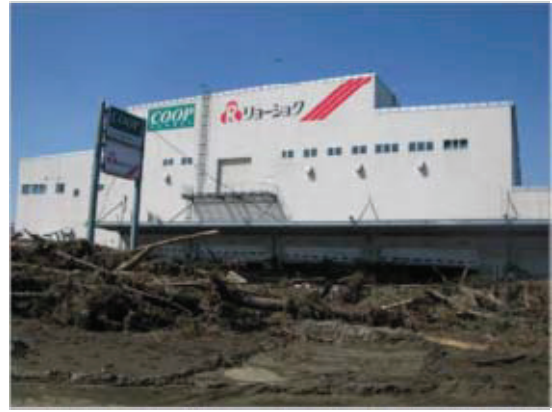
Figure 11. Industrial facility

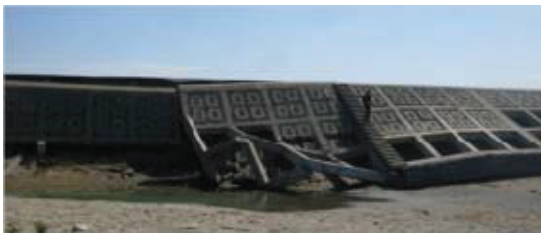
Figure 12. Airport seawall

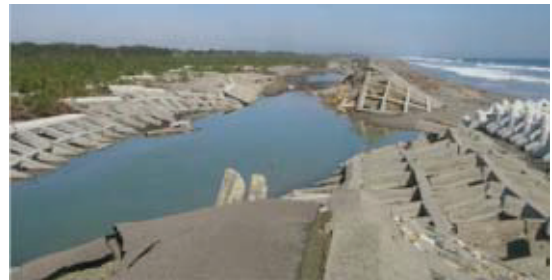
Figure 13. Eroded seawall

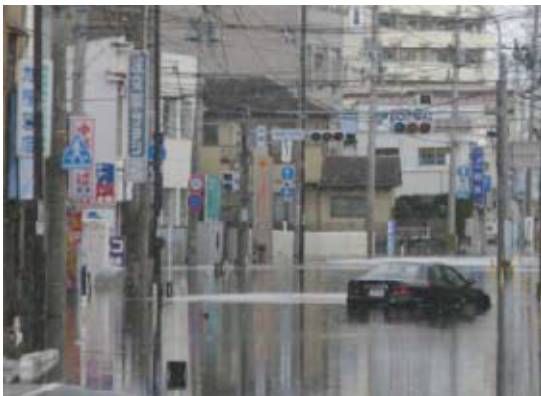
There was major flooding of the main roadway (see Figure 14) and similar shortage of foodstuff and goods similar to Sendai. Transmission towers were damaged; see Figure 15, because the tsunami picked up cars and slammed them to the tower legs.

Figure 14. Flooded major roadway

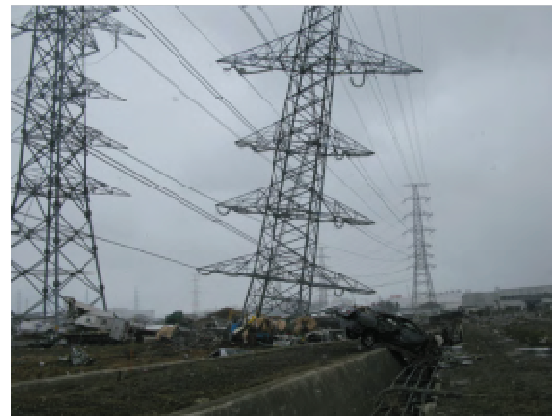
Figure 15. Damaged transmission tower

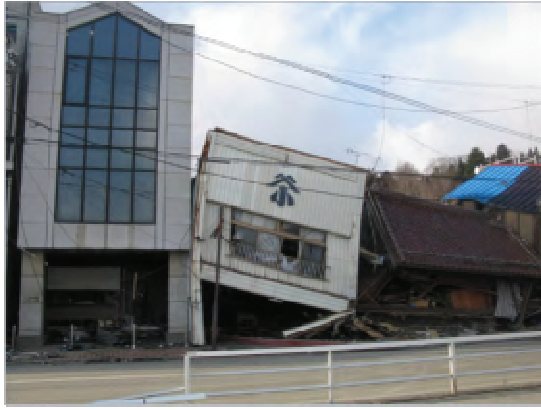
In this area, almost the entire stock of wood buildings was destroyed in the tsunami affected area but modern concrete structures designed per Japanese seismic code performed well; see Figure 16. Light poles and sign structures experienced bending failure at the base; see Figure 17, due to debris impact.

Figure 16. Concrete and wood building,

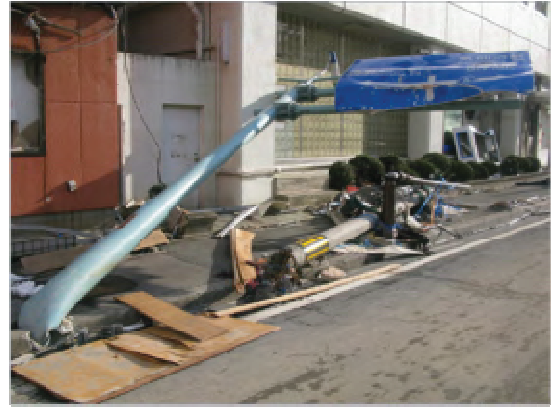
Figure 17. Failed sign structure

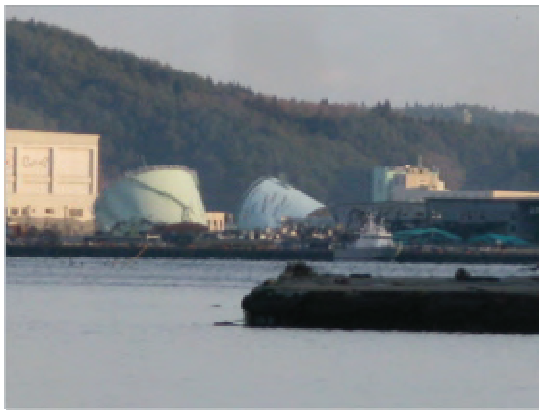
The oil container tanks at the bay failed; see Figure 18, oil poured out and ignited, starting a large fire which contributed to destruction. Similarly when the 7-m tall seawall at the Fujikima nuclear power plant was breached, emergency power was lost. A large number of deep ocean ships were washed several km to town; see Figure 19

Figure 18. Failed oil tanks

- The tall sea walls seem to have slowed down the tsunami velocity in certain areas. However, once water breached them, they were not effective. Emergency and lifeline facilities such as nuclear power plant and gas tanks need to be either relocated to higher grounds or seawalls designed for extreme events be constructed to protect them.

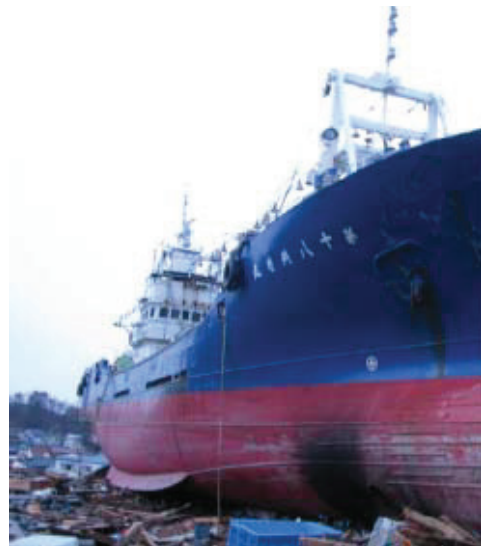
Figure 19. Tuna fishing boat washed in town

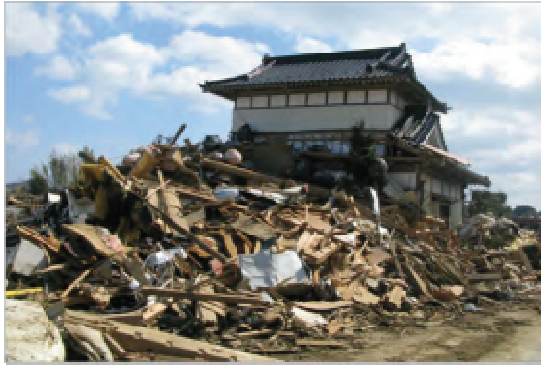
Many residential (see Figure 20) and industrial buildings (see Figure 21) were destroyed. In this area, almost the entire stock of wood buildings was destroyed in the tsunami affected area but modern concrete structures designed per Japanese seismic code performed well.

Figure 20. Residential buildings

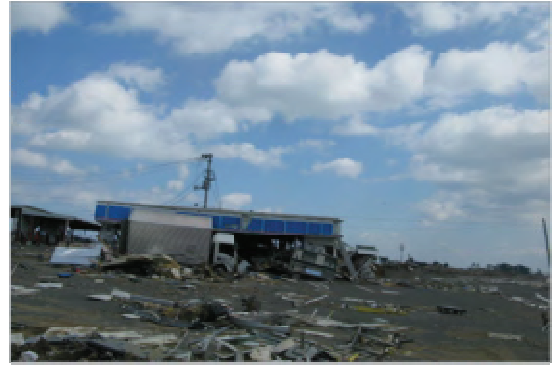
Figure 21. Industrial buildings

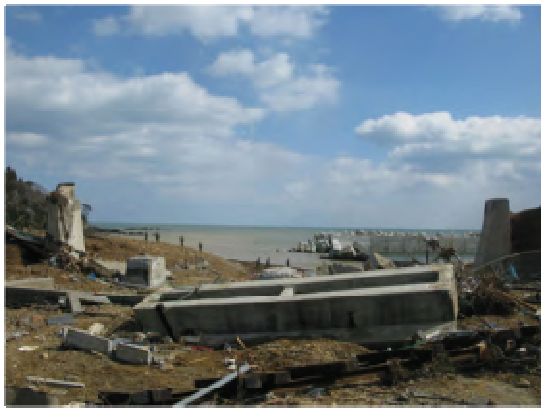
The bridge perpendicular to the inlet bay was washed up and only bridge railing and some portion of pier were left behind; see Figure 22. This particular bridge did not seem to have adequate anchorage. Bridges such as the one in the photo near the inlet of narrow bay were subjected to large impact and perpendicular tsunami wave forces. Steel buildings fared well as shown in Figure 23. The moment frames itself were intact and the nonstructural walls were damaged from the force of tsunami.

Figure 22. Destroyed bridge

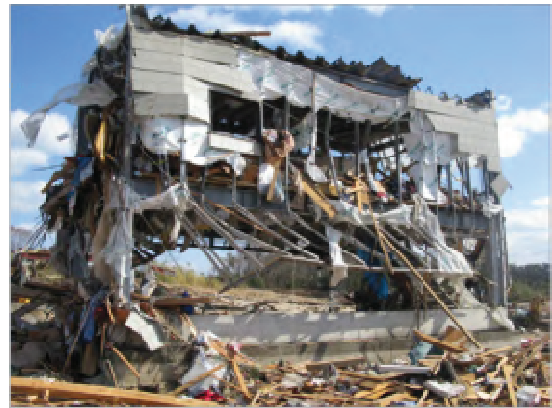
Figure 23. Steel moment frame building

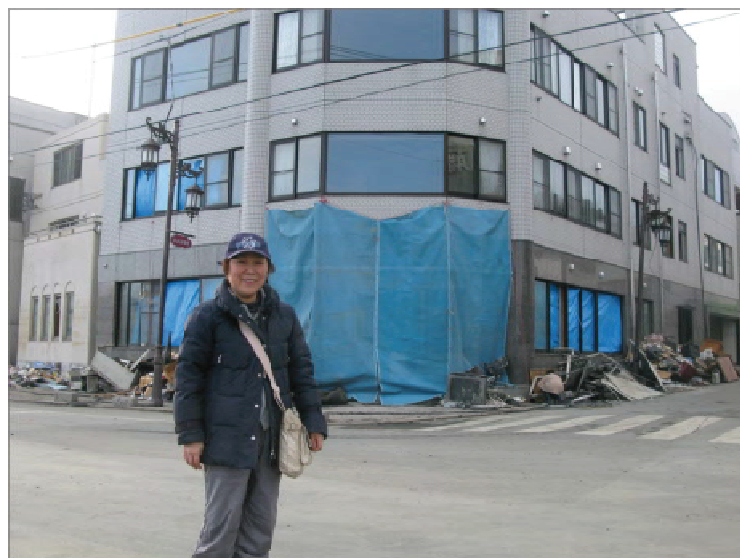
The three-story concrete building shown in Figure 24 did not sustain any damage although located right at the bay. This modern structure was designed and constructed according the current seismic code in Japan. This design provided sufficient strength and ductility for the building to withstand the tsunami forces. This particular building was operational and back in business only one week after the tsunami.

Figure 24. Undamaged and operational building

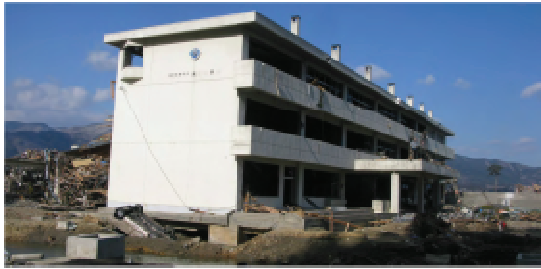
The school building suffered erosion damage at the foundation; see Figure 25. Most of the town 50,000-people was wiped; see Figure 26. Many residential and industrial buildings were destroyed.

Figure 25. School building foundation erosion

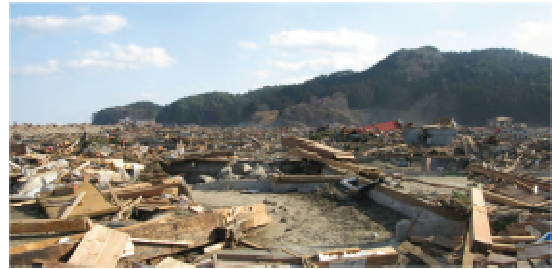
Figure 26. Destroyed wood buildings

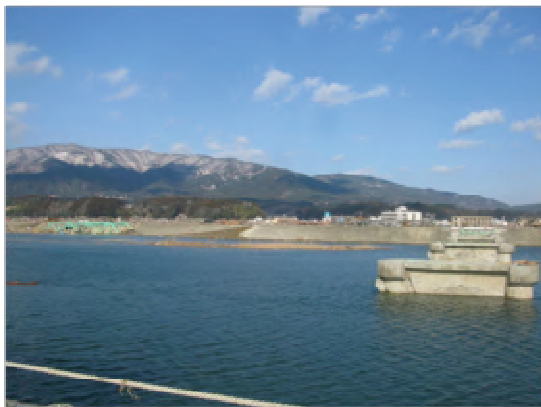
The steel truss bridge superstructure over highway 45 was washed about 0.5 km from its original site; see Figure 27. Also note that the concrete pier walls were severely cracked in shear as shown in Figure 28. The river became a focal point of tsunami wave. It increases the tsunami velocity and height substantially. Modern concrete structures; performed well as shown in Figure 29. However, older concrete buildings did not perform well. As seen in Figure 30, this older building did not have confinement steel and used smooth bars and it collapsed.

Figure 27. Piers and washed away steel truss

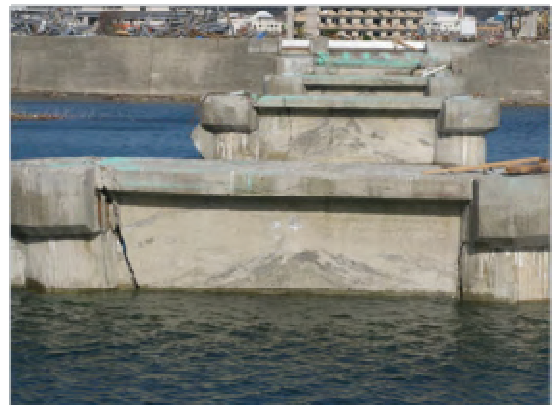
Figure 28. Cracked piers

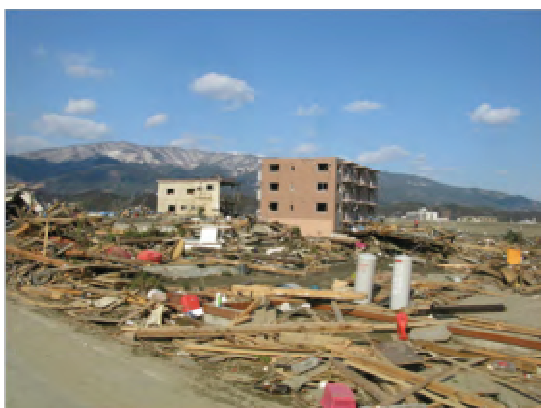
Figure 29. Undamaged newer concrete building

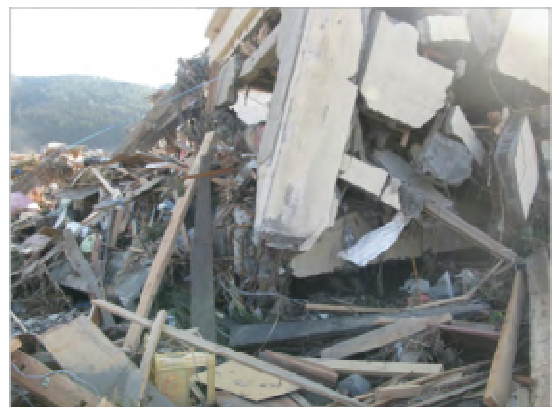
Figure 30. Damaged older concrete building
