Case Study: Los Angeles Water Services Restoration Following the 1994 Northridge Earthquake

SUMMARY: (10 pt)

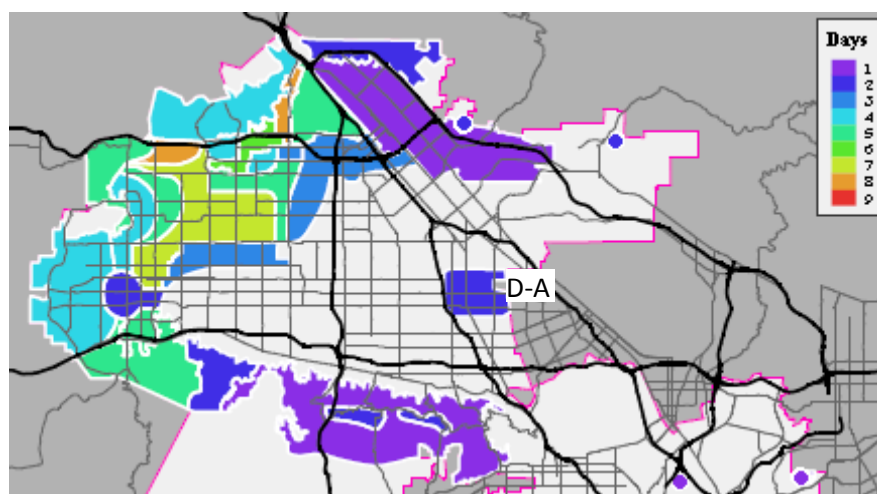
Fig. 2 shows the region that lost all delivery service in the northern area of Los Angeles (refer to Fig. 1

to identify representative area of Fig. 2; covering about 557 km²). The region in Fig. 2 lost water delivery services mainly due to damage in the transmission and distribution subsystems. Los Angeles did not lose delivery services as a direct result of supply subsystem damage; there were sufficient supply redundancies to maintain transmission, if the transmission systems were able to convey water. However, the area marked as “D-A” in Fig. 2 did lose delivery services as a direct result of power service loss to groundwater wells in the water supply subsystem and a critical pump station. One relatively small area south of the Fig. 2 map lost water services for up to 8 hours due to power loss to a pump station. System redundancy was a significant factor in allowing much of Los Angeles to maintain water delivery, as well as aiding in restoration. The majority of Los Angeles can receive water from several supply conduits. Even though the majority of water supply to Los Angeles was immediately cut off by the earthquake, water continued to flow to damaged areas and to those areas not damaged by the earthquake from the many large storage reservoirs located in the city, as shown in Fig. 1, and from MWD via the CRA. This allowed large areas throughout Los Angeles to maintain delivery services. Because this earthquake occurred in the winter, demands were lower, which helped to maintain quantity services in many of the undamaged areas.

Figure 2. Areas without water delivery service in Los Angeles following the 1994 Northridge Earthquake.

In addition to the power service restoration, water delivery services were restored to the many different areas shown in Fig. 2 over the 8 different dates (Jan. 17 to Jan. 24) using a variety of strategies, including:

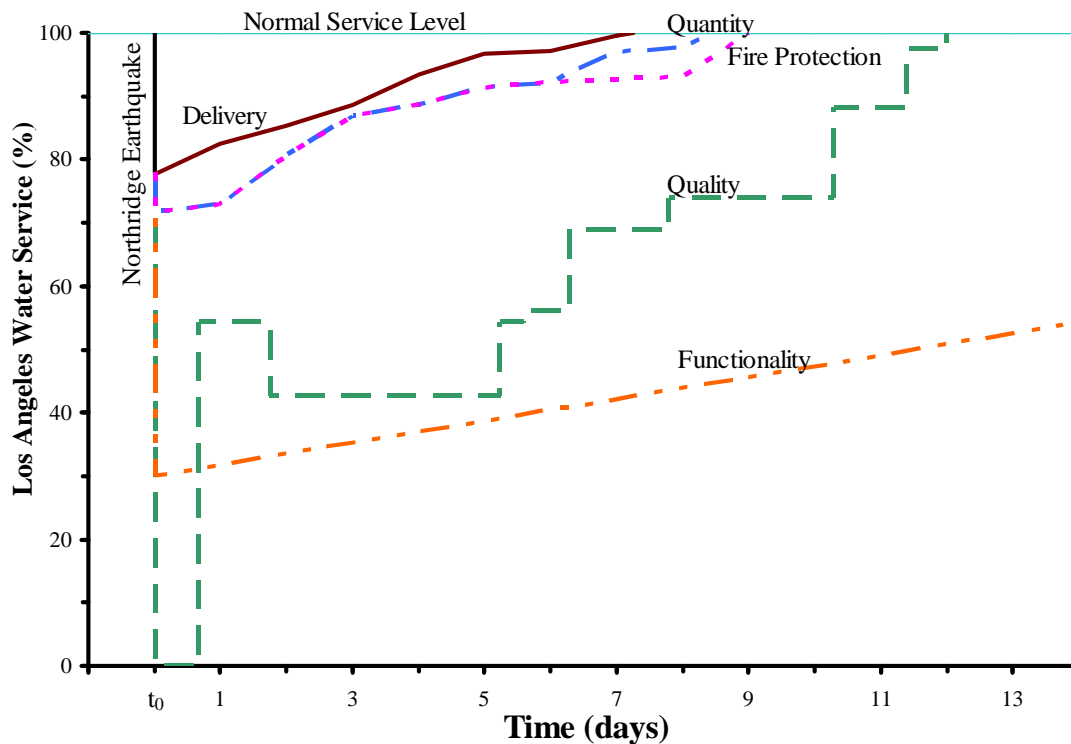
Figure 3 shows the water service restoration curves for the LADWP following the 1994 Northridge earthquake. As seen in Fig. 3 the delivery service dropped to about 78% shortly after the earthquake due to water leaking from broken pipes, draining several tanks, until the total losses resulted in the area shown in Fig. 2. Due to LADWP’s ability to contain the impacted area and initiate restorations rapidly, the delivery services increased soon after the earthquake. The quantity and fire protection services dropped to a low of about 72% at some time on January 17, 1994. Figure 3 plots the accumulation of all service losses and restoration for each day. The quality service dropped immediately to zero because a boil-water notice was issued across the entire city within 3 hours after the earthquake, which was lifted within defined areas starting after one day as shown in Fig. 3. The functionality services initially dropped to about 30% and began to improve soon thereafter as restorations were undertaken. The water delivery, quantity, fire protection, and quality curves are calculated from recorded data. The functional service curve is estimated. As shown in Fig. 3, the water delivery service was restored to 100% at about 7 days, quantity and fire services at about 8 days, and quality service at 12 days after the earthquake. The remainder of this section describes the strategies and activities undertaken that directly affect the restoration curve shapes in Fig. 3.

Figure 3. Los Angeles water system service restorations following the 1994 Northridge earthquake.

Figure 3 shows the functionality service dropped to about 30% but was restored over time as the supply and transmission pipelines were repaired. The functionality service is shown in Fig. 3 to have a relatively linear increase over the 13-day period following the earthquake. The percent restoration values for the functionality services presented here are approximations. Many temporary repairs and rerouting around damage were made within the first week to restore and maintain delivery, quality, quantity, and fire protection services, but this did not significantly increase the functionality service

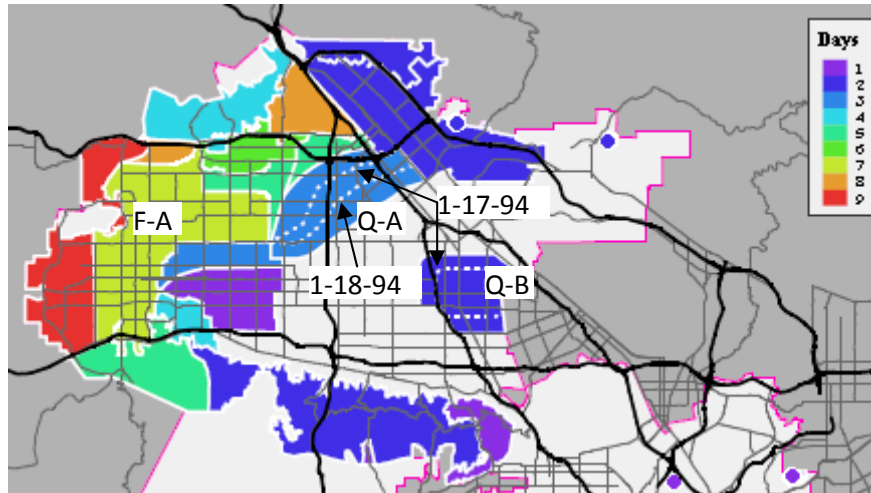
The regional quantity and fire protection service losses were primarily related to the losses in delivery services. Except for two areas in the east San Fernando Valley, identified in Fig. 4 as Q-A and Q-B, the total area of lost water quantity and fire services was contained throughout the city within about one day, and possibly up to 36 hours in some areas. As noted in Fig. 4, areas Q-A and Q-B were contained respectively within 48 and 72 hours; the dashed contours estimate the rate of continued quantity and fire protection services losses. The large areas throughout Los Angeles that did not lose quantity and fire protection services were maintained in the same manner as described for maintaining delivery services in the same areas.

All areas except for the area marked in Fig. 4 as F-A are expected to have had fire protection services restored at or about the same time as the quantity services. Therefore, Fig. 4 is also used herein to represent fire protection service restoration. The F-A area in Fig. 4 had quantity services restored on day 7, but the restoration of fire protection services were delayed until day 9. As a result, the descriptions herein for quantity services also apply to fire protection services, except for area F-A. The reason that area F-A fire protection services were not able to be restored at the same time as quantity services is because the delivery services were accomplished with a limited number of trunk line repairs. The critical GTL and RTL transmission lines were not providing additional water, requiring the Susana Trunk Line (STL), shown at the top of Fig. 1, to provide water to the majority of the San Fernando Valley in addition to an emergency connection to MWD that was providing only a very low flow compared to normal demands. The water volumes were restricted because they had to pass from the 1,372 mm diameter STL through 762 and 406 mm diameter pipes in order to supply the areas normally supplied by the GTL and RTL. As a result, quantity services could be restored in F-A once sufficient pressures were restored but due to limited volumes fire protection services were not restored.

Figure 4. Areas without water quantity service in Los Angeles following the 1994 Northridge Earthquake.

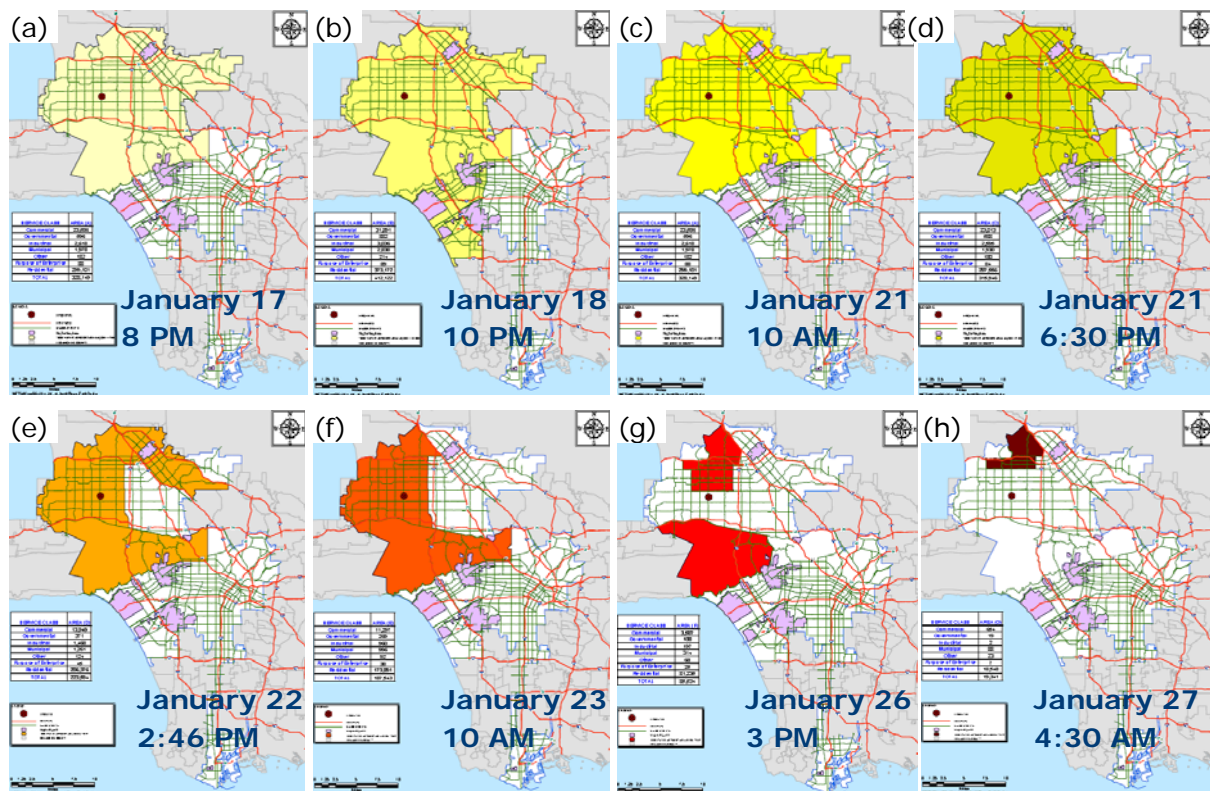
Figure 5 shows the sequential restoration of quality services. As shown in Fig. 3, the quality service remained at zero for nearly one day while the boil-water notice remained in place across the entire city. The California Department of Public Health (CDPH) provided criteria for lifting boil water notices as: (1) earthquake leaks and breaks repaired, (2) chlorine residuals of 2 mg/l, and (3) two consecutive negative coliform bacteria tests. Testing for an area took at least one day. Approval by CDPH was obtained before boil-water notices were lifted. Communicating boundaries of the boil-water areas to the public was a major challenge.

fully advertised until the morning of January 29, 1994, 12 days after the earthquake. During those 12 days, the notices were lifted nearly sequentially in the seven areas shown in Fig. 5 (Figs. 5a and 5c cover the same area) as water pressure was restored and sampling indicated that water was safe.

Figure 5. Areas without water quality services in Los Angeles following the 1994 Northridge Earthquake.
