# Seismic Isolation Retrofit of Susono City Hall Situated above Lava Tubes

**H.Nakamura, T.Ninomiya & T.Sakaguchi** Housing and Construction Inspection Section, Susono City Office

#### SUMMARY:

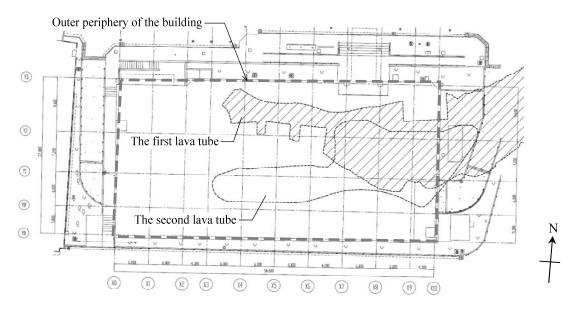
Figure 2. Lava tubes beneath Susono City Hall (Plan)

The boring survey was carried out at 37 points during the construction period of the city hall building in 1975 to get the whole picture of the lava tube. The survey revealed that there were two tubes at different levels at around 7.8 to 10.2 m and around 12 m beneath the ground surface. The upper lava tube was estimated to be about 78 m long and 7 to 15 wide in EW and NS directions, respectively, and about 0.4 - 1.7 m high.

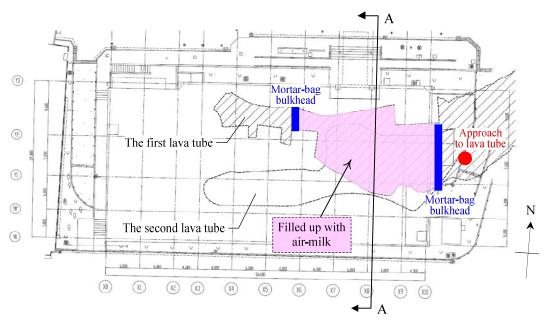
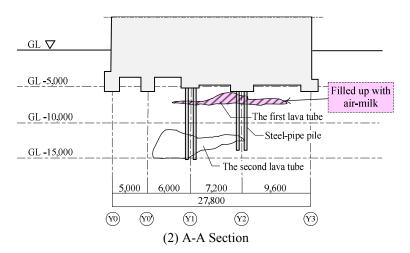
Figure 4. First lava tube filled up with air-milk

It was decided that the hollow of the upper level lava tube, namely the first lava tube, would be filled up with foamed concrete prior to the seismic isolation retrofit, to prevent the collapse of the tube and to avoid the stress concentration around the jagged surface of the lava tube due to both vertical dead load and lateral seismic forces.

For filling up the first lava tube, there installed in the lava tube enclosed with mortal-bag bulkheads 9 pipes to inject air-milk, 8 air-pressure release pipes and 9 contact sensors which are pairs of electric wires at crowns of the tube to detect if the air-milk touched the crowns. It took three-days to inject total 234m<sup>3</sup> air-milk in the enclosed lava tube In this process, the filling progress was monitored through one existing access pit to the tube, signals from mortar contact sensors and mortar leaks through the air-pressure release pipes (Table 4).
