# Lessons Learned from the 2008 Wenchuan Earthquake and Recent Research on Seismic Design of Highway Bridges

**WANG Dongsheng, SUN Zhiguo, ZHAI Xuebin**

*Institute of Road and Bridge Engineering, Dalian Maritime University, China*

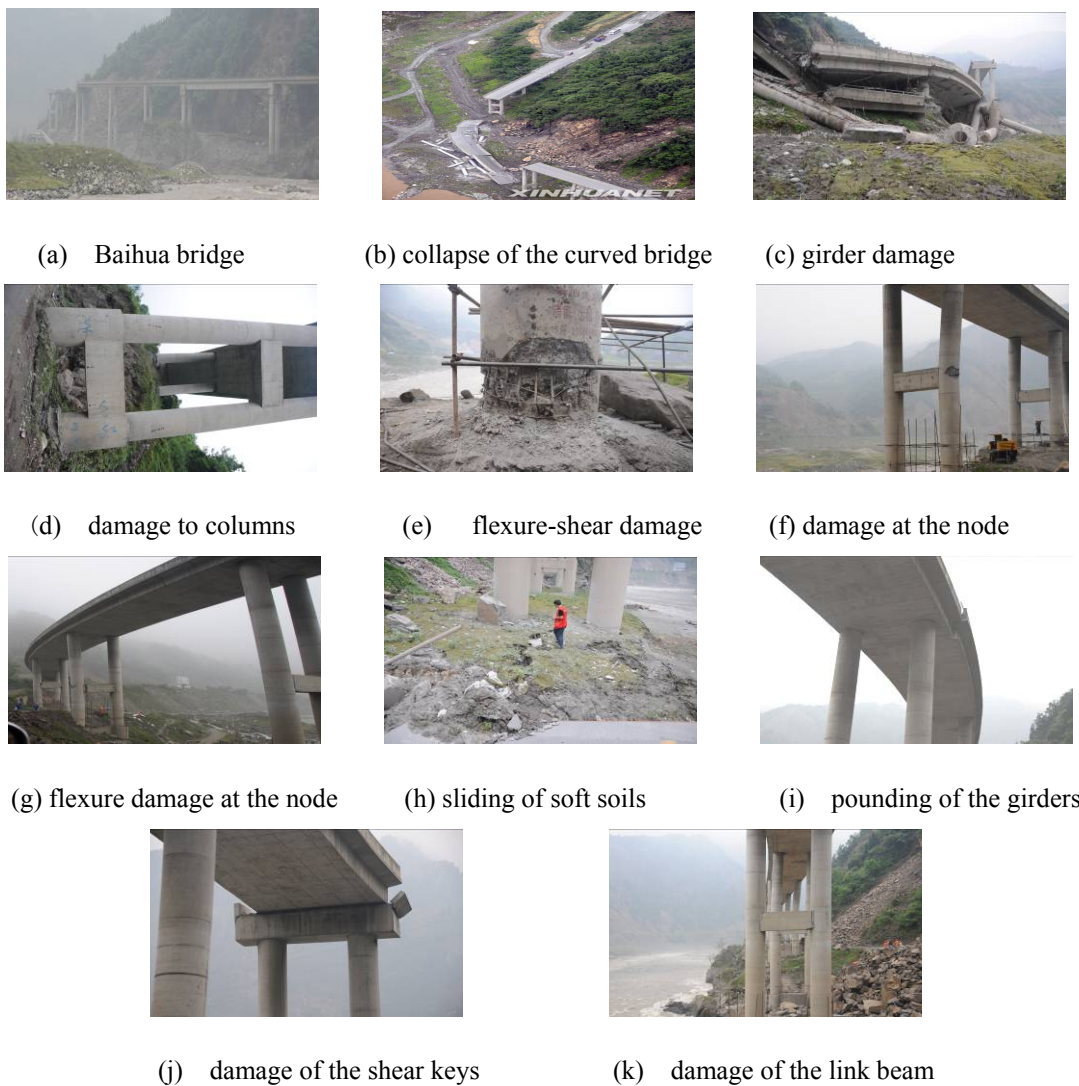
**Fig. 2** Damage of Baihua bridge

Baihua Bridge was composed of a five-span curved girder bridge and the straight multi-span continuous bridges, and Its girders were supported by the pier directly without the cape beam. It was about 2-3km from the epicenter of the Yingxiu town or the Yingxiu -Beichuan fault. The main damage was integral collapse of 5 span curved beams (Figure 2(a) and Figure 2(b)), broken and stacking of part of the deck body(Figure 2(c)). Other seismic damage included: pier bending damage(Figure 2(d)), pier shear damage(Figure 2(e)), pier beam joint shear damage(Figure 2(f)) or plastic hinge formed at the bottom of the column(Figure 2(g)), pile foundation displacement and tilt caused by subsiding and sliding into the river middle of soft soil(Figure 2(h)), the transverse, longitudinal displacement and collision of main girder, as well as the damage of shear keys (Figure 2(i), Figure 2(j)).

Reasons for the seismic damage to Baihua Bridge are considered as: (1) Support length is not long enough and lack of longitudinal, vertical restrainers at in-span hinges; (2) Strong seismic effect made the curve girder separate from the piers, and finally the beam collapsed and the pier damaged. The first beam falling down seemed to be at the end of the side away from the Yingxiu Town.

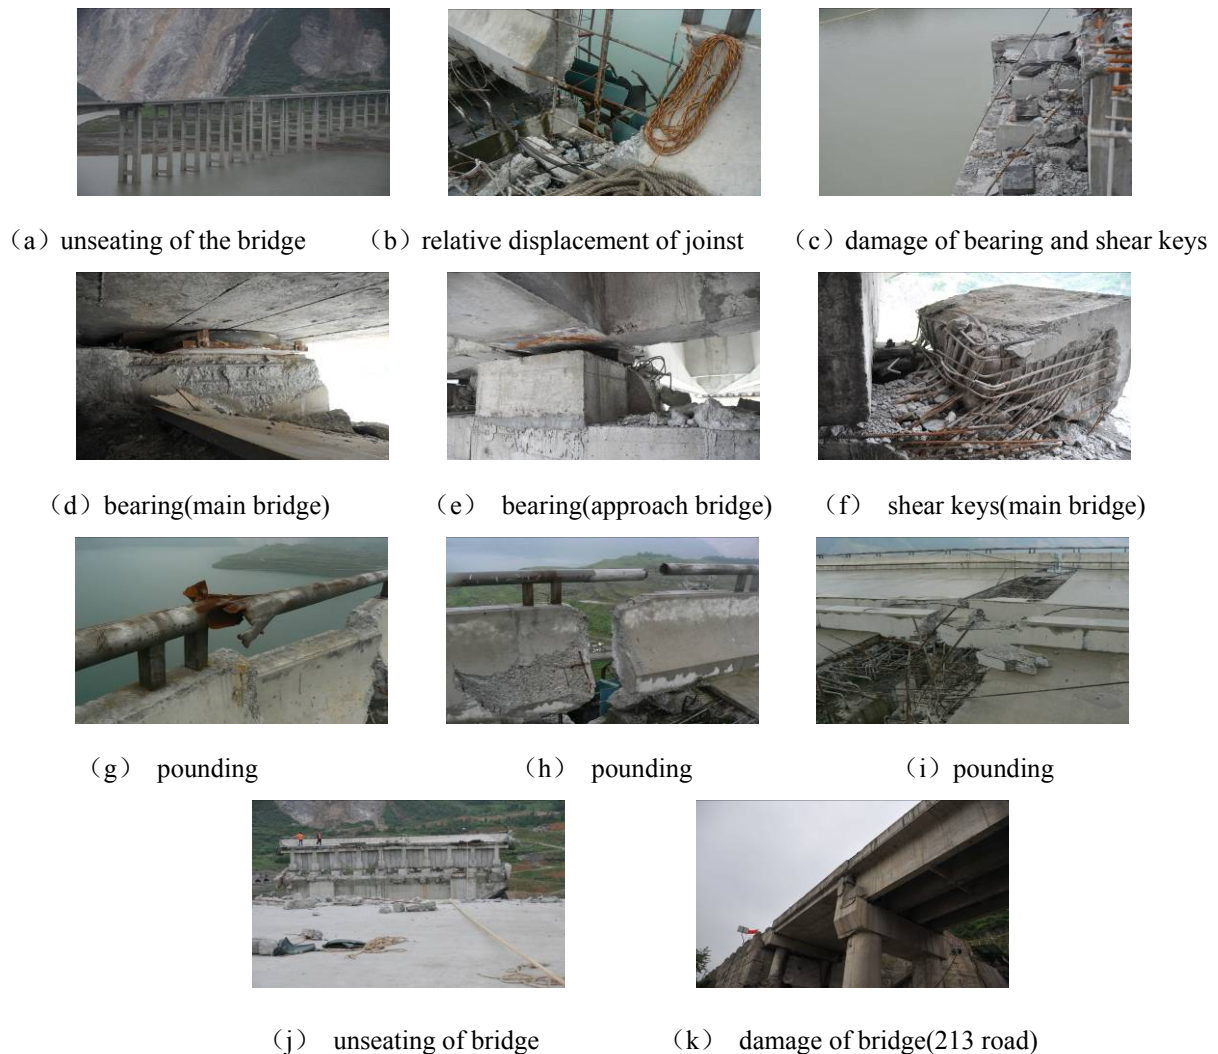
**Fig.4** Damage of Miaoziping bridge

Major seismic damages were that a span of simply supported bridge fell down at the expansion joint (Figure 4(a)), and the main bridge and approach bridge were slightly misaligned laterally (Figure 4(b)). Other damages included the damage of bearing and stop block of the main and approach bridges (Figure 4(c), 4(d), 4(e), 4(f)); the collision at the expansion joints between main and approach bridges,

as well as that between approach bridges, which mainly occurred at handrails, guardrails and isolation belt (Figure 4(g), 4(h), 4(i)). Seen from the damage condition, the collision was much more complicated than imagined. Special check was done to the collision at the expansion joint between approach bridge segments of similar pier height, and there was no obvious traces of collisions(Figure 4(j)). The piers had some cracks when check by robots under the water.

Miaoziping Bridge is the only one long-span bridge with high pier about hundred meters and that has been hit by earthquake so far. Judging by the stop block damage of the bridge of the State Highway 213, which was almost perpendicular to the Miaoziping Bridge (Figure 4(k)), the ground motion was mainly along the Miaoziping Bridge longitudinally. One reason for the seismic damage was the amplification effect of high piers' flexibility to displacement response, the other was that the box girder was heavy and damage to the bearing and block more easily happen.

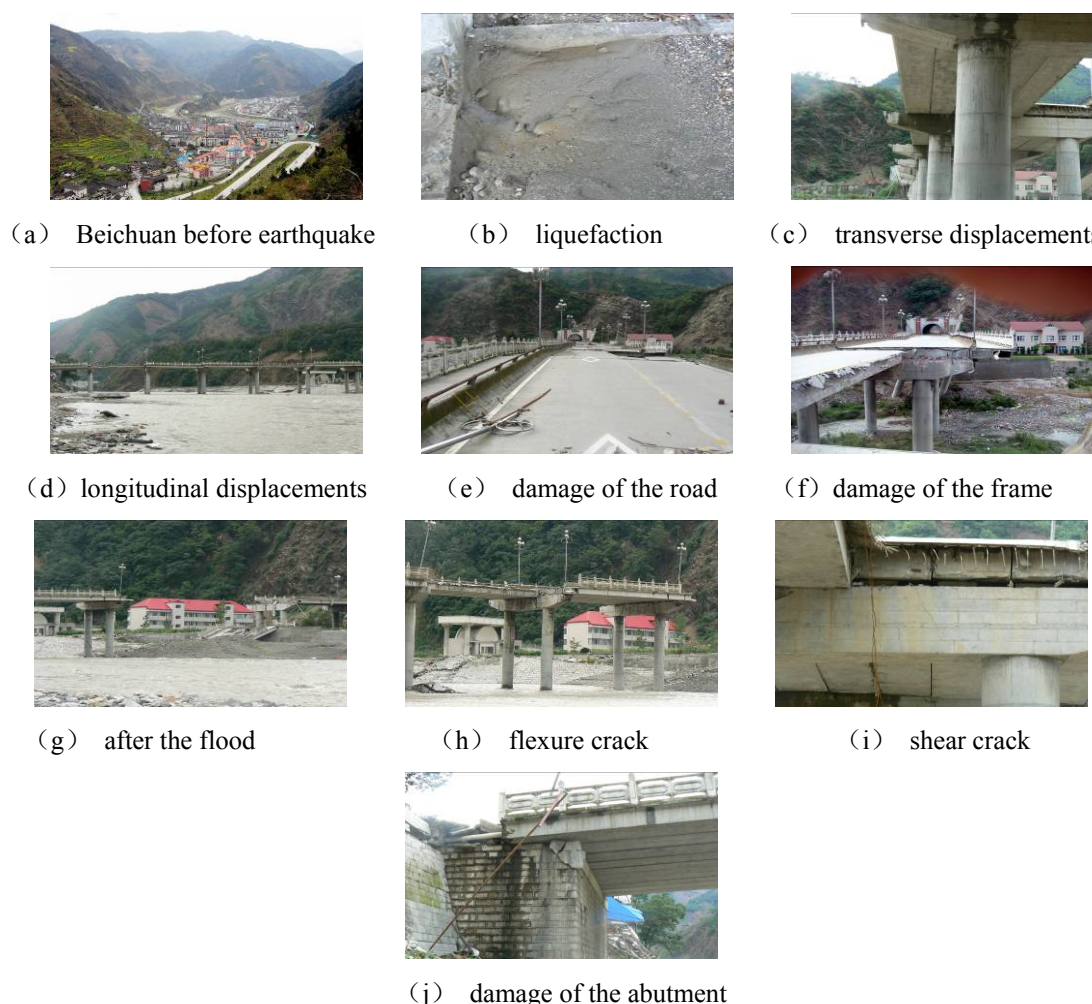
**Fig.5** Damage of Longwei bridge

Beichuan County is located in wide valley, and the site of Longwei Bridge had liquefaction (Figure 5(b)). Major seismic damages of Longwei Bridge are listed as follows. 1) There was transverse and longitudinal displacement of main girder, and transverse displacement was more than 2 meters. The stop block was damaged, and partial girder fell down. 2) Because of different transverse displacement, the bridge deck longitudinally, meanwhile one end of the beam separated from the

support and pad, and the deck became rugged (Figure 5(c), 5(d), 5(e)). 3) The pier of the 7<sup>th</sup> span far away from Beichuan tilted significantly, and nearly collapsed, and now it has been shattered by the flood water (Figure 5(f), 5(g)), at the top of the column adjacent to the collapsed span formed flexure hinge and certain bent cap beam had oblique shear crack (Figure 5(h), 5(i)). 4) The abutment (Beichuan bank) had no displacement on the whole, but the wing wall had a transverse crack, and the front wall might be crashed. The girder got almost 2 meters into the ground in the longitudinal direction and uplift (Figure 5(j)).

Major reason for the damage of Longwei Bridge was that strong transverse and longitudinal seismic effect near fault, and the tilting and nearly-collapse of the 7<sup>th</sup> span's columns were caused by site liquefaction.

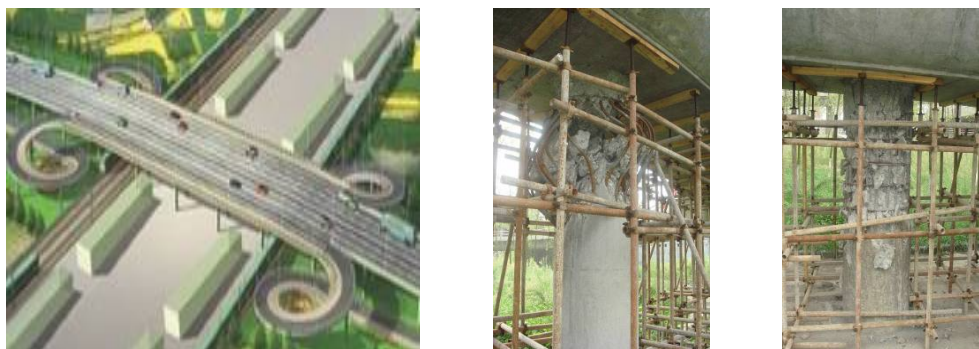
**Fig.7** Damage of Huilan ramp bridge (R=20m)

The curved bridges have much different response characteristics, effects of bending-torsion interaction of the superstructures and the others made it more fragility than the straight bridges. During 1971 San

Fernando earthquake and 1994 Northridge earthquake the SR14/I15 interchange had suffered both damages, the from was due to the narrow seating length and falling down of the deck happened, the latter was due to the short columns with flexure-shear damage(Williams D et al,1979; Fenves G et al,1998). With the same reasons The Baihua bridge and Huilan interchange were also damaged during Wenchuan Earthquake. More attention should be paid to the seismic deign of the curved bridges (Sun Zhiguo et al, 2012 ).

The Huilan interchange, constructed in 2004 in Mianzhu City, consisted of a viaduct and four horizontally circular ramp bridges with continuous box girders. Field investigations found that the seismic damage to the ramp bridges was especially heavy (Fig.7, Fig.11); one or two short piers in all but one of the ramp bridges experienced severe failure, and the box girders over the failed piers were fractured. Other piers of the ramp bridges suffered minor-to-moderate damage, including concrete cover spalling, concrete cracking, and slippage damage of the rubber bearings. The viaduct suffered only slight damage, including slippage damage of the rubber bearings and pounding damage of the superstructure.

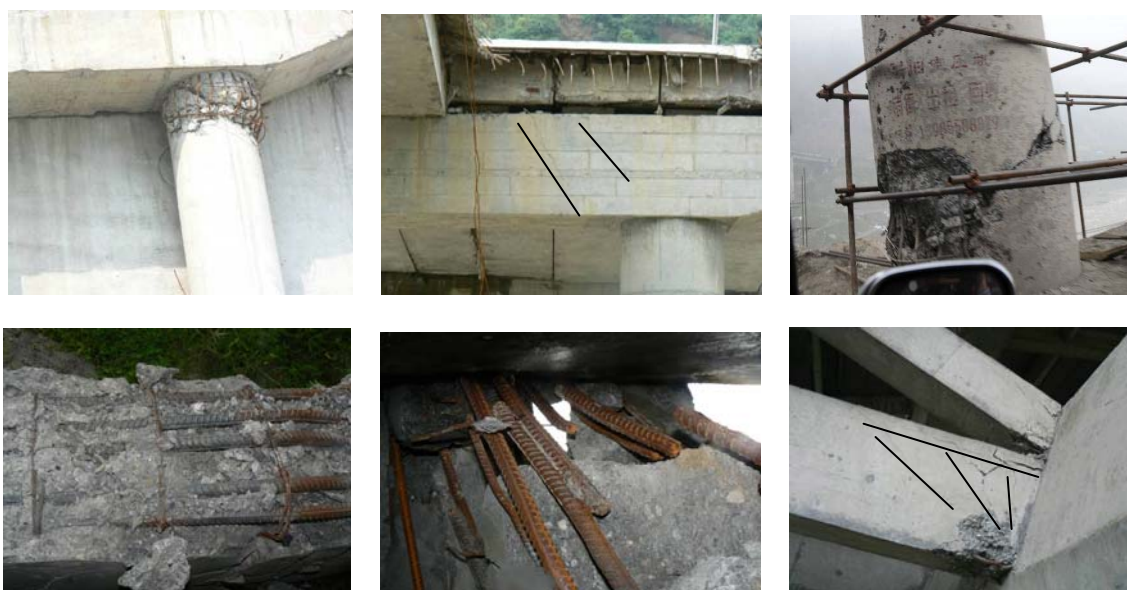
**Fig.8** Shear damage and design details of RC members

The poor bearing conditions of the bridges also have some isolation effects, which lead to the decrease of seismic loads carried by bridge columns and the damage of bridge columns is usually not severe, but some inductile damage of columns, arch ribs or cap beams due to shear or combined shear and flexure should be concerned.

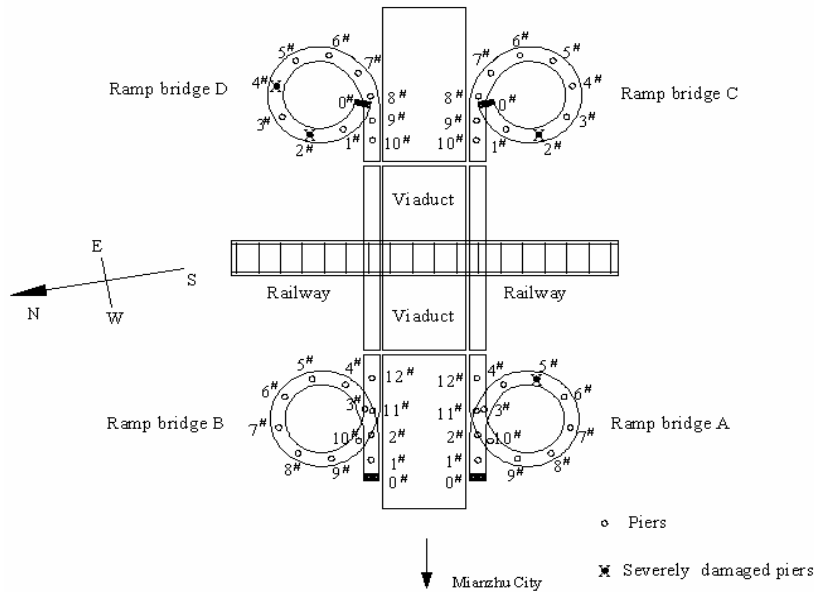
**Fig. 11** Schematic diagram of the Huilan interchange and ramp bridge piers

The seismic performance of the bridge was evaluated by finite element modeling and compared with field observations. It was found that the bearing on top of the shortest pier, Pier 1, was damaged first. Then, the seismic action was concentrated on the next shortest pier, Pier 2, which had the largest flexural stiffness. Pier 2 first yielded in flexure, and, as the lateral displacement increased, the ultimate response of this pier was dominated by its shear capacity and it eventually failed in flexure-shear mode.
