A Novel Post-Earthquake Damage Survey Sheet: Part I- RC Buildings

**B. Taskin, K. Guler, U.M. Tugsal, M. Gencoglu, M. Celik, Z. Hasgur,
M. Aydogan & A.I. Saygun**
Istanbul Technical University, Turkey

Keywords: Post-earthquake damage assessment; RC buildings; Survey sheet

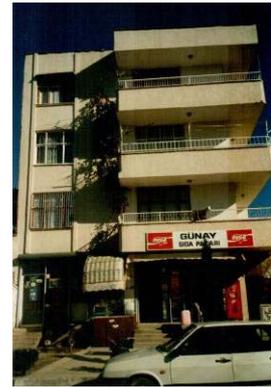
Figure 4.1. Building-A

Building-A: is a 5-story RC building experienced slight damage during June 27, 1998 Adana-Ceyhan Earthquake. According to the damage report, there are 15 columns at the ground floor which is the most damaged story and two of the columns experienced moderate flexural damages with a width of 1mm~2mm. Besides, damages to non-structural elements and story drifts more than 15mm due to

extreme amount of soil settlement are taken into account in the related form. A photo from the frontal view of this building is given in Fig. 4.1. The Overall Structural Damage THO is calculated as 18.0 also indicating Slight Damage rank.

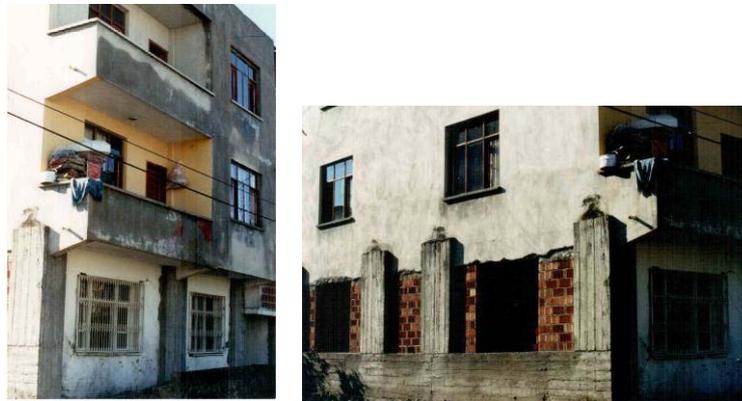
Figure 4.2. Building-B

Building-B: is a 3-story RC building experienced moderate damage during the same earthquake. According to the damage report, there are 14 columns at the ground floor which is the most damaged story and four of the columns are non-damaged; two of the columns experienced slight flexural damages with a width of $<1\text{mm}$; 6 of the columns experienced moderate flexural damages with a width of $1\text{mm}\sim 2\text{mm}$ and two of the columns experienced heavy damages with a width of $\geq 2\text{mm}$.

Damages to non-structural elements are taken into account in the related form. Photos from the frontal and side views of building-B after a non-engineered retrofitting are given in Fig. 4.2. The Overall Structural Damage THO is calculated as 37.0 indicating Moderate Damage rank.

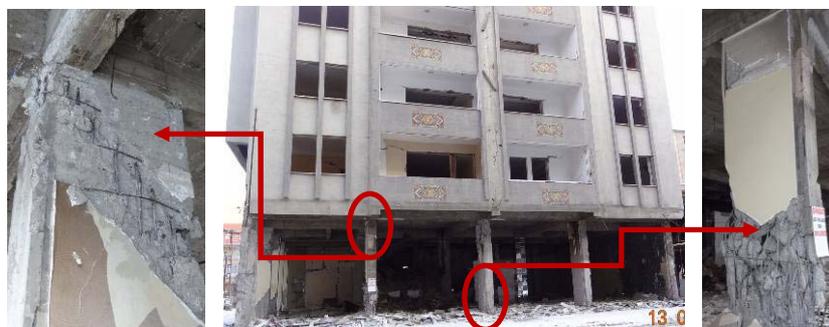
Figure 4.3. Building-C

Building-C: is a 5-story RC building experienced heavy damage during October 23, 2011 Van Earthquake. According to the damage report, there are 17 columns at the ground floor which is the most damaged story and four of the columns are heavily damaged due to the shear failure at the joints and buckling of longitudinal rebars; two of the columns are moderately damaged at the joint because of corrosion at rebars. Damages to non-structural elements are taken into account in the related form. Photo from the frontal view of this building and detailed joint pictures are given in Fig. 4.3. The Overall Structural Damage THO is calculated as 44.0 indicating Heavy Damage rank.

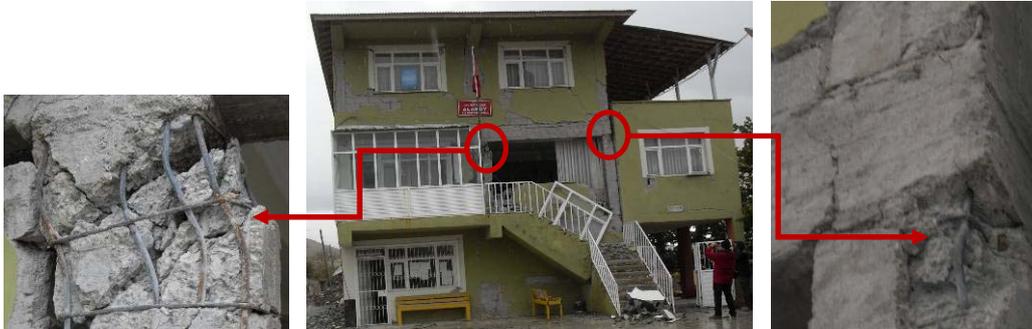
Figure 4.4. Building-D

Building D: is a 3-story RC building experienced heavy damage during October 23, 2011 Van Earthquake. According to the damage report, there are 17 columns at the first floor which is the most

damaged story and three of the columns are heavily damaged due to the shear failure at the joints and the buckling of longitudinal rebars by loss of confinement and crushing of core concrete; three of the columns are moderately damaged at the joint due to the corrosion of rebars. Damages to non-structural elements are taken into account in the related form. Photo from the frontal view of this building and detailed joint pictures are given in Fig. 4.4. The Overall Structural Damage THO is calculated as 47.0 indicating Heavy Damage rank.

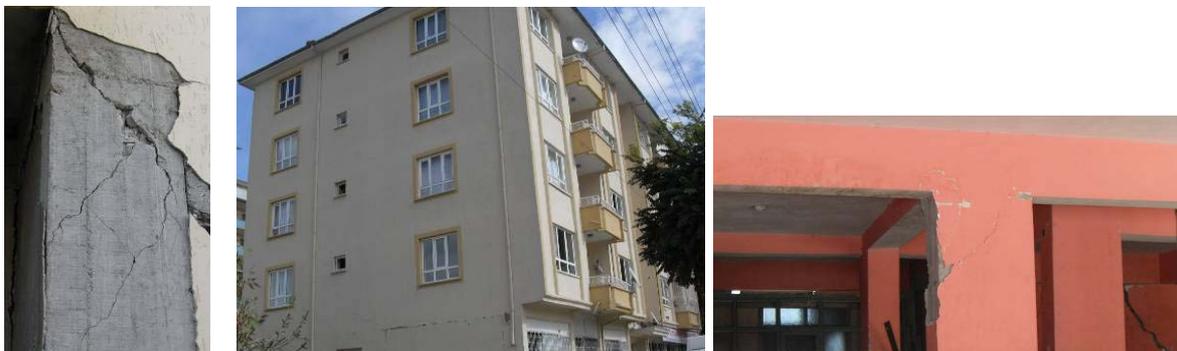
Figure 4.5. Some pictures of Building-E after the first earthquake

Building E: is a 5-story RC building experienced moderate damage during October 23, 2011 Van Earthquake. However, 16 days after, another earthquake struck the same region increasing the existing damages in the structures. According to the damage report, there are 34 columns at the ground floor which is the most damaged storey. After the first earthquake and two of the columns is heavily damaged due to the shear failure at the joint; three of the columns are moderately damaged at the joints due to shear cracks with a width of 1mm~2mm. Damages to non-structural elements are taken into account in the related form. Photo from the frontal and side view of this building and detailed joint pictures are given in Fig. 4.5. The Overall Structural Damage THO is calculated as 37.0 indicating Moderate Damage rank.

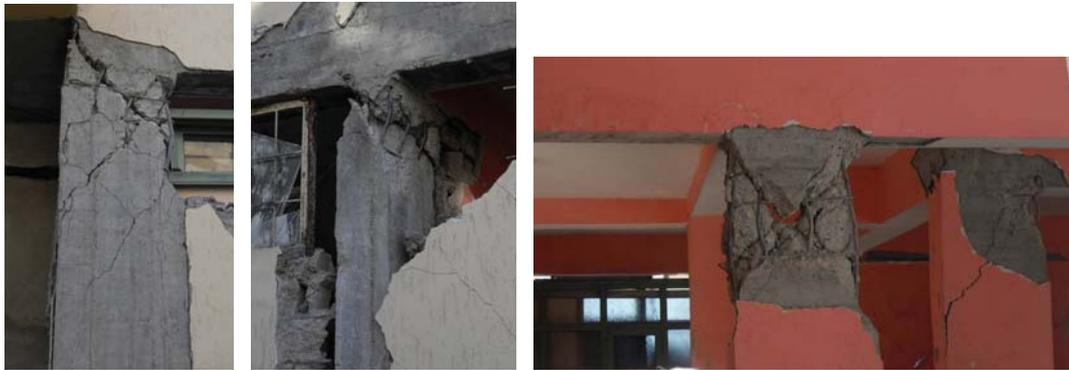
Figure 4.6. Pictures of Building-E after the second earthquake

After the second earthquake, the building is inspected by the same reconnaissance team and it is seen that the existing damages of these elements are developed. According to the second report, the building's damage state increased to heavy level due to 11 of the columns which are heavily damaged due to significant shear cracks at joints and buckling of longitudinal rebars; 10 of the columns are moderately damaged due to different damage classifications. The Overall Structural Damage THO is increased to 76.0 indicating Heavy Damage rank. Fig. 4.6. shows the latest damage state of this building.
