# Preliminary Report on Disasters Observed in Narashino City due to Liquefaction During Great East Japan Earthquake

**Munenori Hatanaka & Masataka Tani**

*Chiba Institute of Technology, Narashino, Japan*

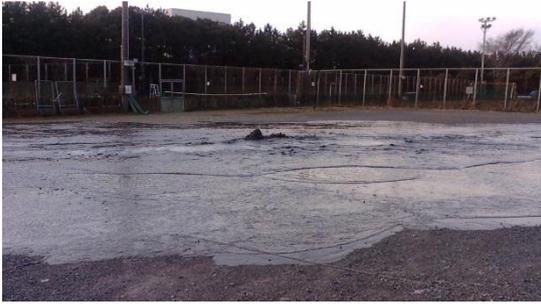
Figure 11 shows a moment of sand volcano occurred just during the Great East Japan Earthquake at Akanehama district. A large amount of sand spread can be seen. Figure 12 indicates a large amount of sand spread over the road and many electric poles were settled and inclined at Sodegaura district. Figure 13 shows a two-story wooden house settled and seriously tilted, and it was not able to live after the earthquake. Figure 14 also indicates a sand spread and an inclined wall at Kasumi. Figure 15 shows the destruction of a side ditch at Sodegaura district. Figure 16 indicates the distribution of the damaged houses in residential area of reclaimed land obtained in the first damage investigation performed by Narashino city. The degree of damage of houses was clarified in three categories, heavily damaged, half damaged, and partially damaged, only based on the inclination of the houses.

Figure 11. The moment of sand volcano at Akanehama district (photo by Kunikyo )

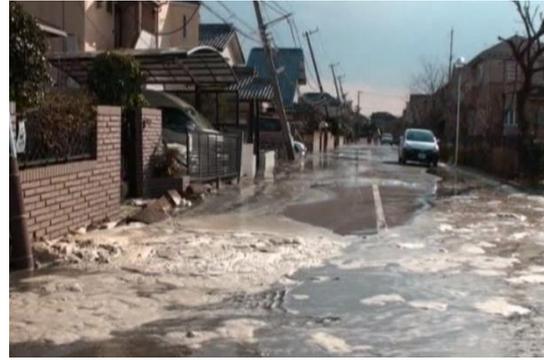
Figure 12 Sand spread over the road and inclined electric poles at Sodegaura district

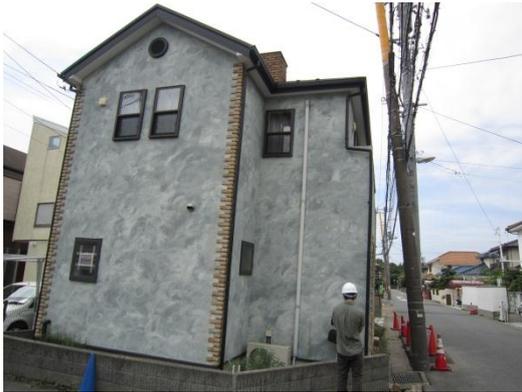
Figure 13. Settlement and inclination of a house at Kasumi district

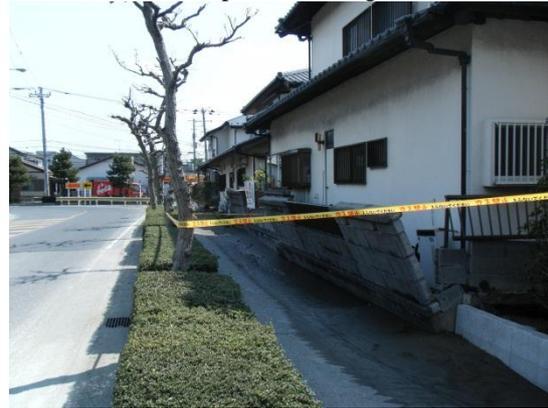
Figure 14. Sand spread and an inclined wall at Kasumi district

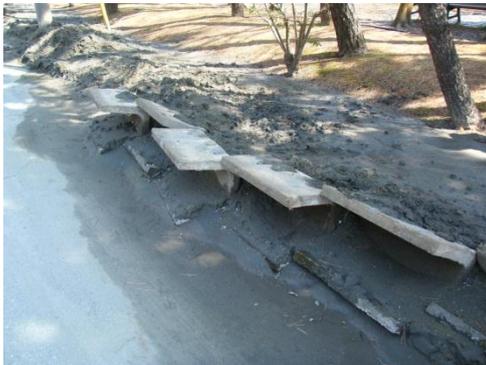
Figure 15. Damage of side ditch along the road at Sodegaura district.

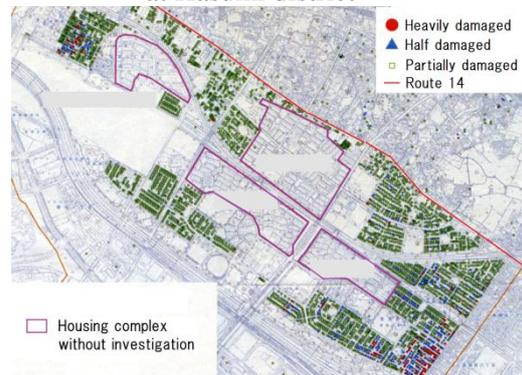
Figure 16. Distribution of damage of houses in reclaimed area investigated by Narashino city

As shown in Figure 16, the major heavily damaged houses (red circles) located on both the first and second reclamation lands. This result implies that such a short interval of about 10 years has little effect on the liquefaction strength of the reclaimed land. On the otherhand, even in the area constructed in the same period of recalamation, there is a big difference in the degree of damage of houses, depending on the locations as shown in Figure 16. This result suggests that, not the duration after the completion of the reclamation, but the method and the soil materials used for reclamation may have more significant effect on the liquefaction strength of these reclaimed land. However, there is no detail data about them now. The local difference in the depth of the ground water table, thickness and compactness of the fill layer may have significant effects on the occurrence of the liquefaction. As a result, it needs more data on soil profile to analyze the difference in the degree of damage for indivisual houses.

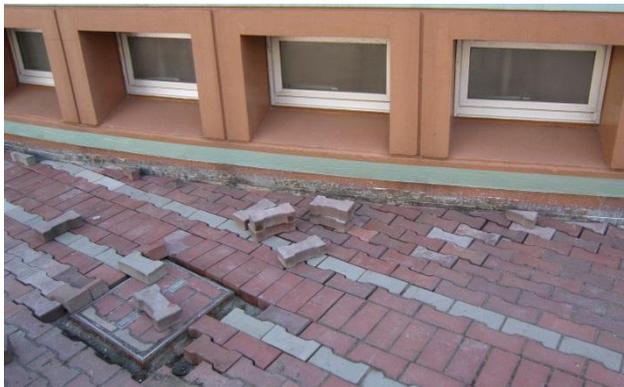
Figure 22. Subsidence of ground at M1 point

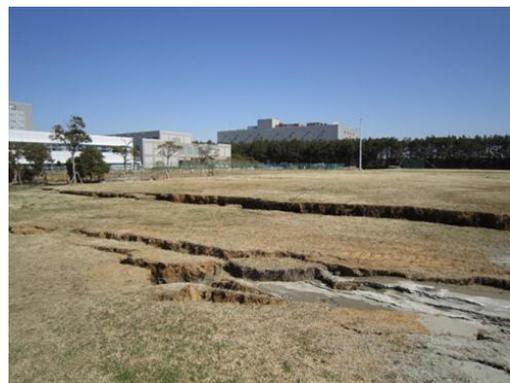
Figure 23. Ground cracks with little sand spread at M2 point

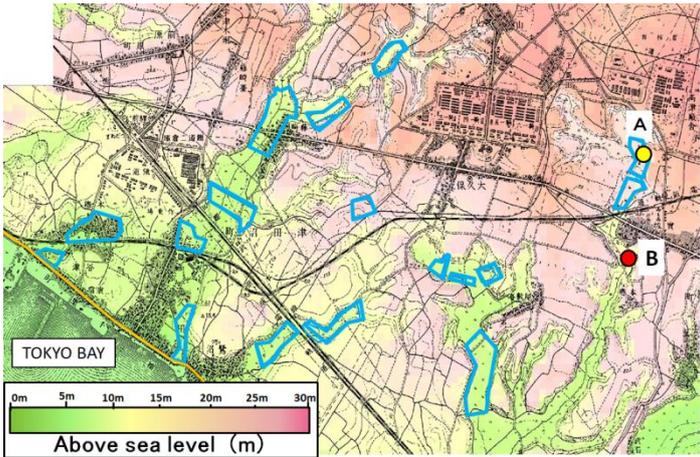
The major damaged area of houses in northern region of Narashino City (17 areas enclosed by blue lines in Figure 24) based on the first investigation performed by Narashino city were plotted on the old map of 1917. At that time, south of the Route 14 is still a sea. It is clearly shown in Figure 24, the damaged area well agrees with the area of old river and valley, such kinds of ground often consist of loose soil layers with high ground water level. The damage was also investigated in the present study about six months after the earthquake. In 17 areas unlike the southern region of reclaimed land, most of houses were damaged due to the deformation of foundation soils caused by the earthquake ground motions. Figure 25 shows such a case of damaged foundation of a two-story wooden house

Figure 24. Major damaged area of houses in natural soil deposit area north of Route 14

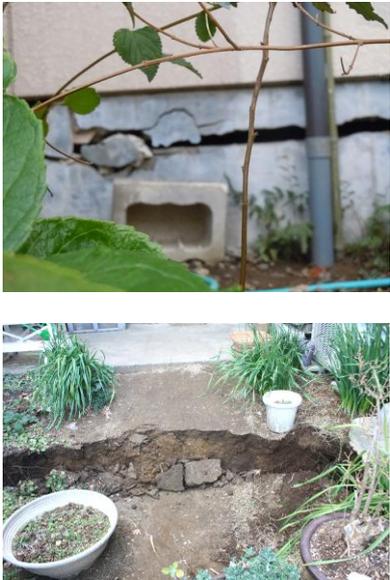
constructed on the embankment (Point A). Figure 26 shows the soil profile and the SPT N-value of this site. As shown in Figure 26, the surface soil layer to a depth of about 5 meter from the ground surface consists of soft cohesive soils, which is not a liquefiable soil but has a high possibility to deform. Moreover, the underlain sand layer has high SPT N-value of about 20. This alluvial sand layer is also a non-liquefiable soil layer, and it may transfer strong ground motion to the surface soil layer. Only a few houses damaged due to sand liquefaction in natural soil deposit area were observed. Figure 27 shows such a case of ground subsidence (Point B). The maximum subsidence of the ground surrounding a one-story wooden house with pile foundation due to sand liquefaction is about 40 cm as shown in Figure 27. Figure 28 indicates the soil profile and the SPT N-value at this site. The subsidence of ground estimated by using the simplified procedure is about 10 cm, which is smaller than the observation results. In this case, the shallow ground water table (GL:-1.5m) and about 4 m in thickness of the loose surface sand layer are the major factors to cause large amount of subsidence.

Figure 25. Deformation of Foundation soil and damage of foundation (point A)

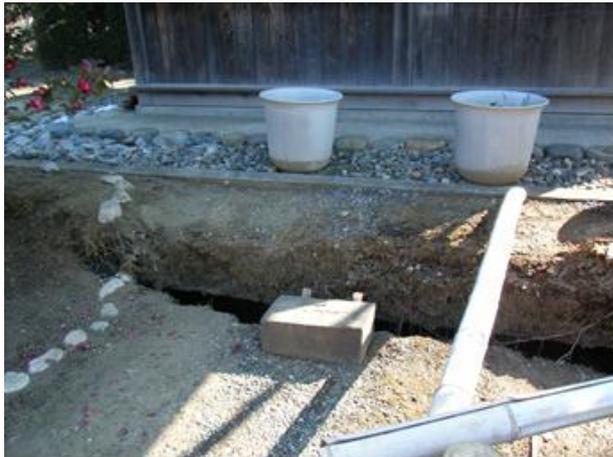
Figure 27. Subsidence of ground due to liquefaction at point B
